LOWER SOUTH FORK AND UPPER SKOKOMISH RIVER

Hydraulic and Geomorphic Analysis and Recommendations for Action

August 1997

Project # SC-97014-1

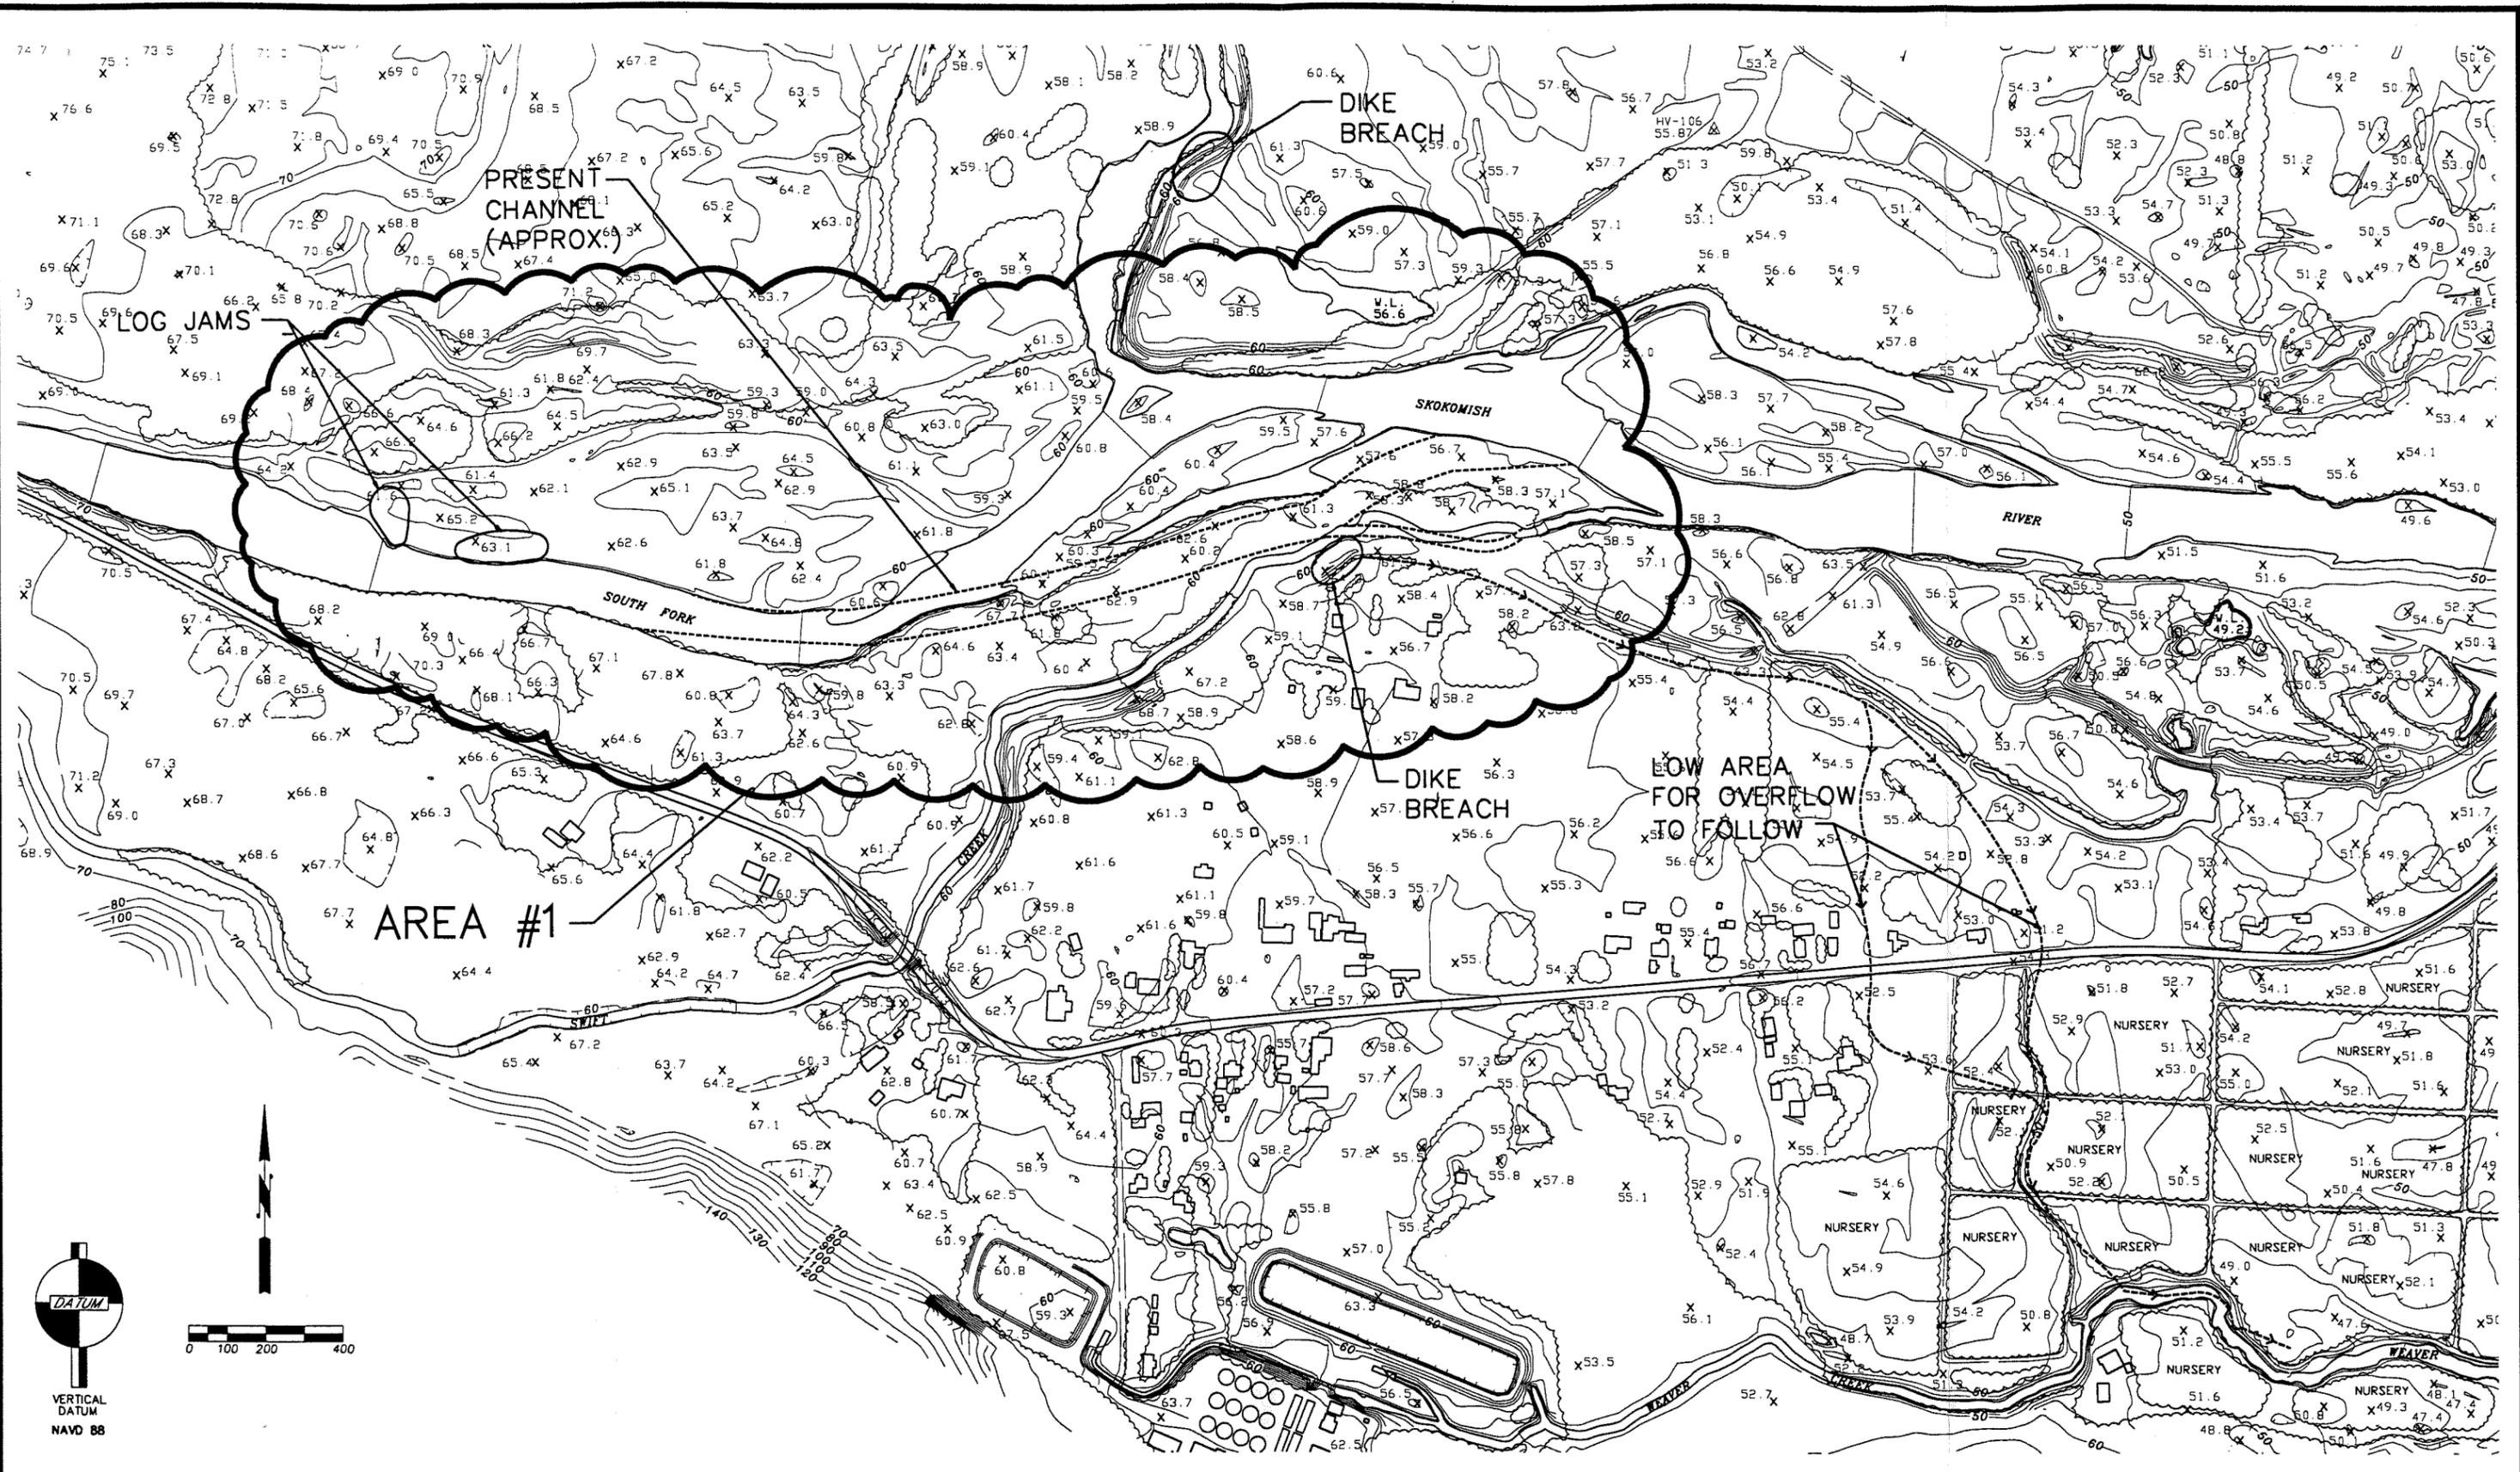
BANK EROSION FIGURE 2.1(A)

A site visit of the upper Skokomish River, and lower South Fork was made on July 18, 1997 to observe channel conditions in this portion of the river system. The following material briefly documents the areas of concern which were observed on this visit (see Figure 2.1 for these locations).

- **Area 1**, near the confluence of the North Fork and South Fork of the Skokomish River, from approximately 1/2 mile downstream to approximately 1/2 mile upstream from the confluence.
- **Area 2** is upstream on the South Fork above the first sharp bend in the vicinity of Five Mile Creek.
- **Area 3** is upstream a little farther on the South Fork at a location downstream from the high cliff near the sharp turn in the River. The location is about opposite of where the continuation of the Sunnyside Road is located as it crosses the North Fork and continues on to the South Fork.
- **Area 4** is further upstream where the river comes down from the canyon and makes a sharp bend at the upper end of the Guy Parsons' property.

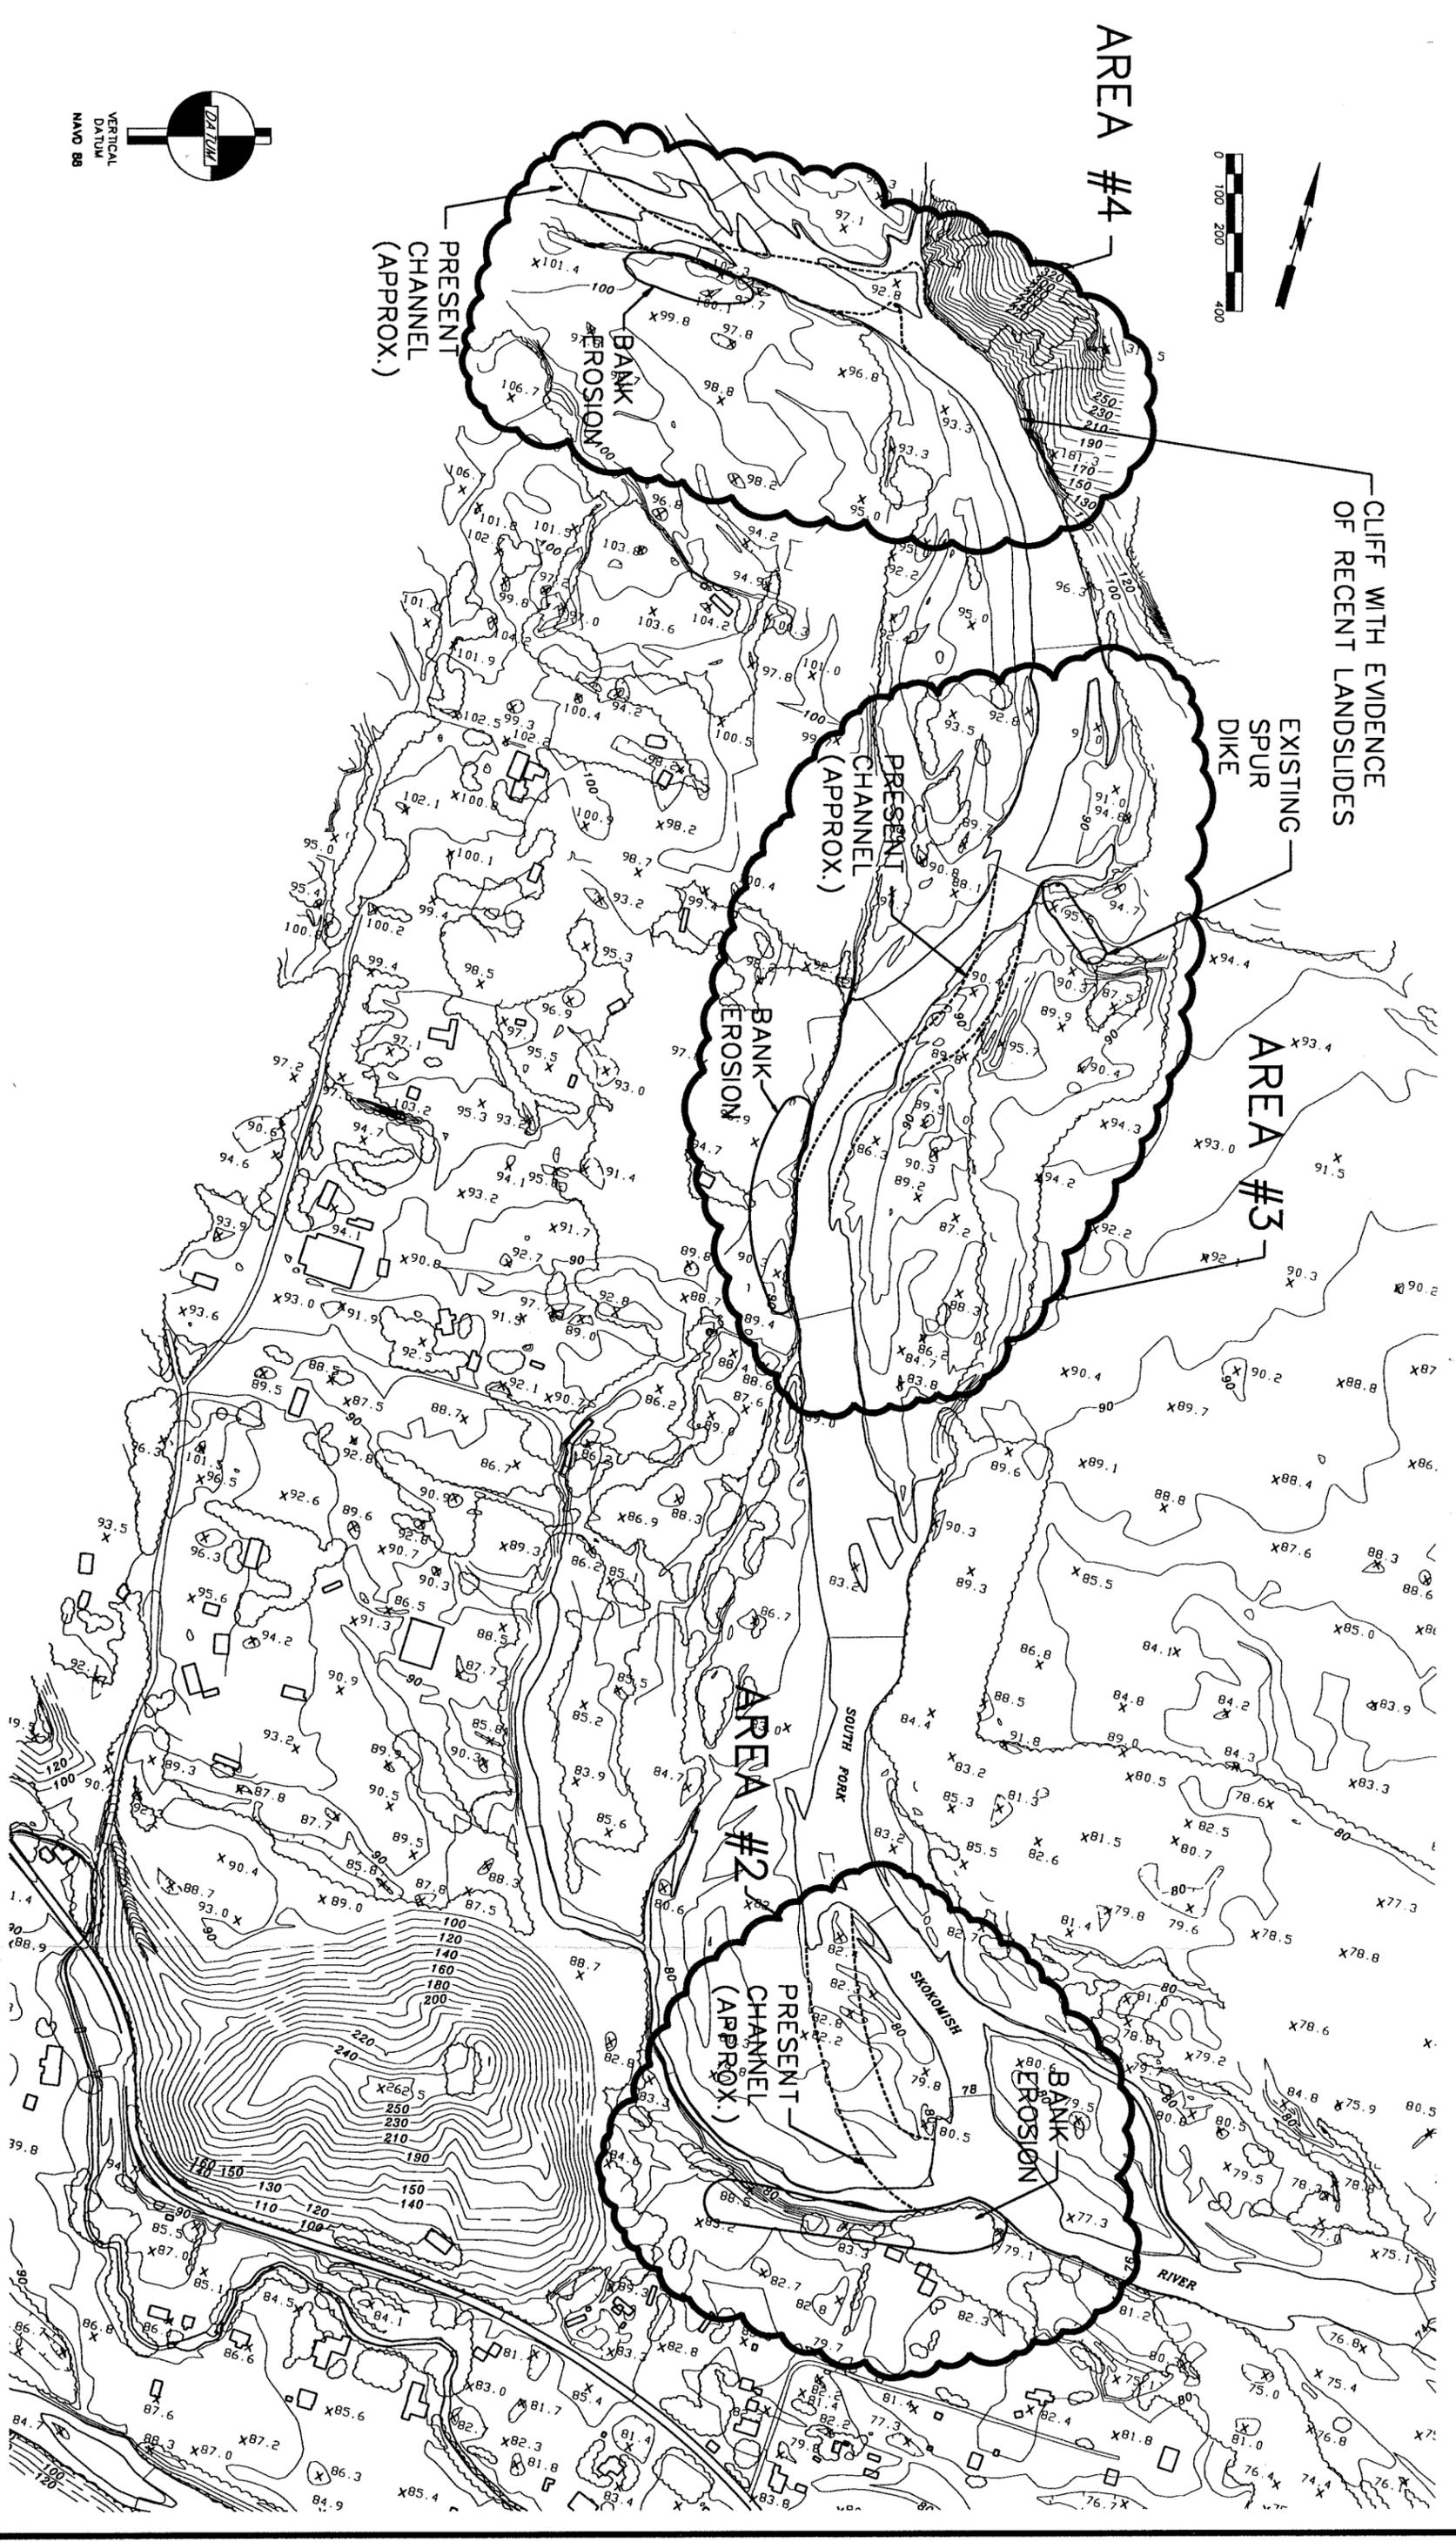
BANK EROSION
FIGURE 2.1(B)

The bank erosion is further described below and in the accompanying photos:

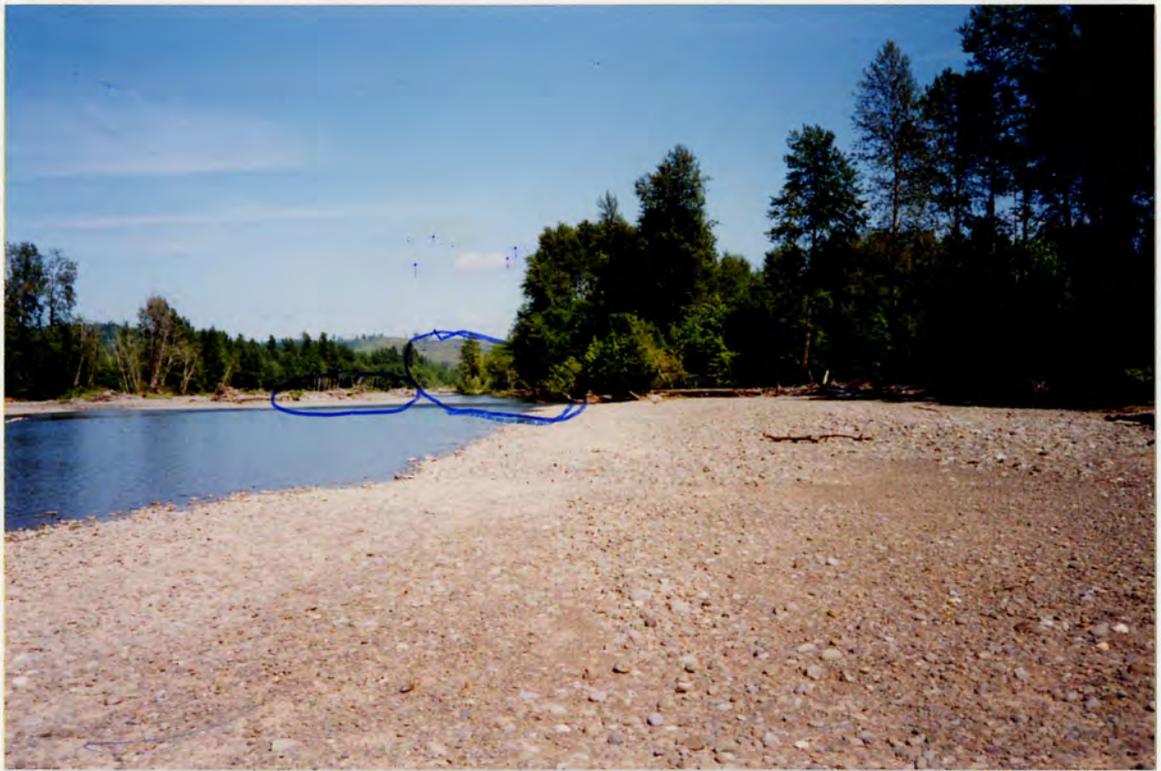
At Area 1, the South Fork of the Skokomish River has shifted southward near the confluence of the North Fork and the South Fork and has removed as much as 200 feet of riparian area just at the location where the South Fork and North Fork previously came together. The South Fork now has moved south 200 feet and the confluence point of the rivers during low flow has changed to a point approximately 1,000 feet downstream. The river has moved south assuming a portion of the Swift Creek location and has split so a portion is flowing down into the bed of Swift Creek. Both flows continue separately another 700 feet downstream to where they finally join together. In the location where the South Fork has shifted the farthest south it is flowing right near the toe of the existing dike. During the March 1997 flood event the dike was overtopped which caused a breach that washed out a portion of this dike. The water flowing through the breach continued down through the Fultz property, down across the Skokomish Valley Road, and into Weaver Creek. There is significant concern that high water this coming year could result in a major avulsion at this location. If such an avulsion were to occur, which changed the main Skokomish River channel to the Weaver Creek corridor, significant private property and public infrastructure would be damaged or destroyed and potentially life-threatening conditions could result.

AREA 1: Photo from upstream of confluence looking easterly. Bank erosion and shift of South Fork to the south is circled on photo.

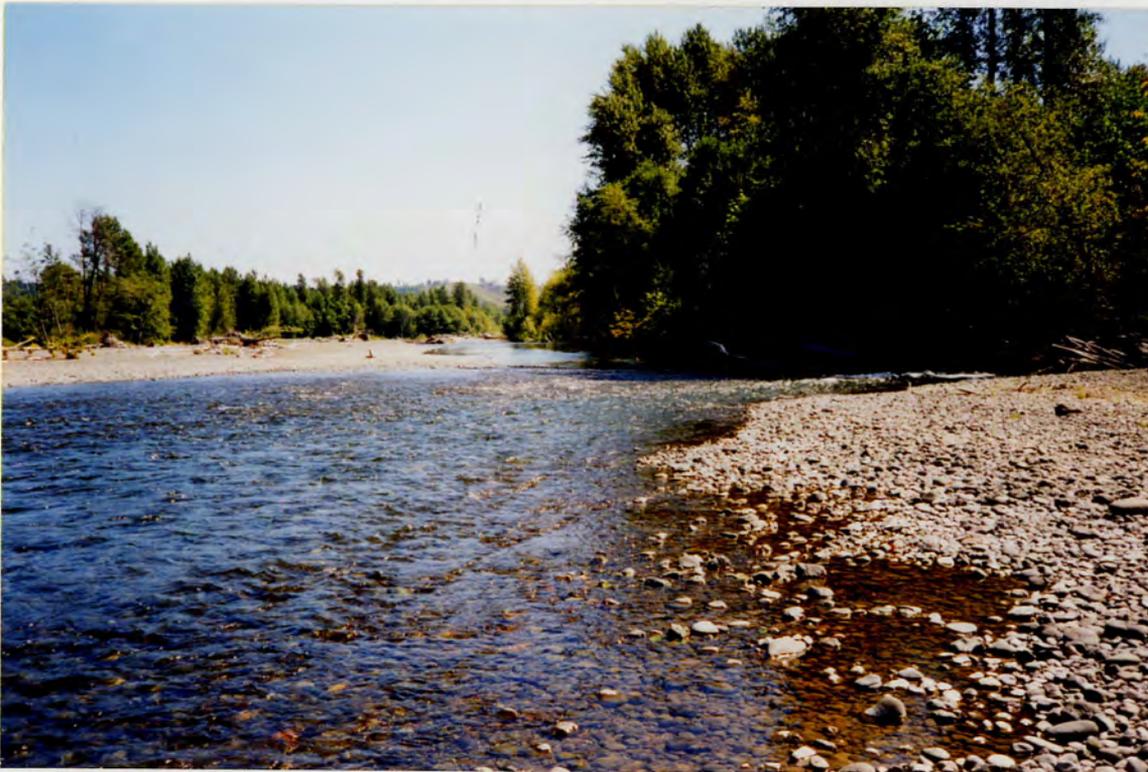
During the field review it was also noted that the dike had been breached on the north side of the river at the confluence and approximately 500 feet upstream on the North Fork. During the

AREA 1: Close-up view looking easterly upstream from confluence. South Fork channel has shifted southerly, removing riparian area and eroding toe of dike. Dike was also breached during March 1997 event.

- Repair any breaches in the existing dikes as shown in Area 1, as well as the breach on the North Fork and any other breaches which may be known to the County in the area of immediate concern. Protect these areas with rock or rock and cabled timber.

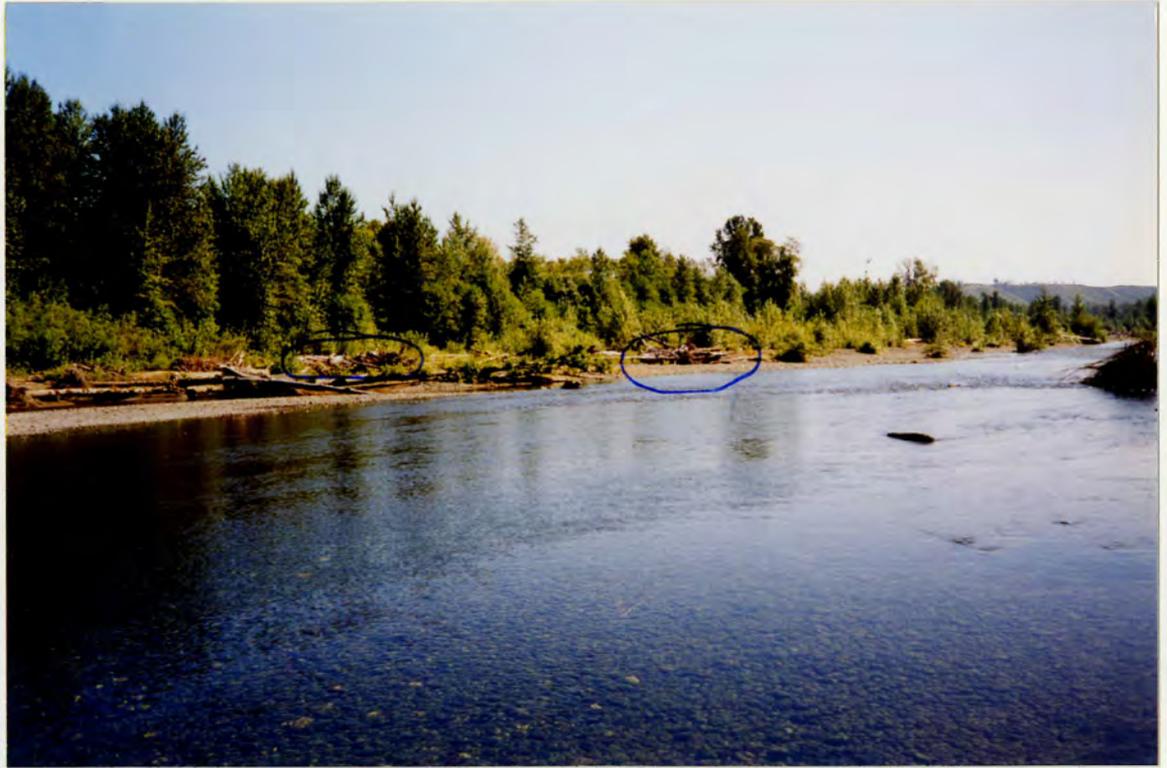
AREA 1: Photo of log jams at the upper end of gravel bar. View is looking northeasterly from across channel. Log jams are circled.

- Removal of obstructions in the existing channel in Area 1, specifically the two logjams at the upper end of the gravel bar just upstream of the confluence, as well as other significant obstructions.

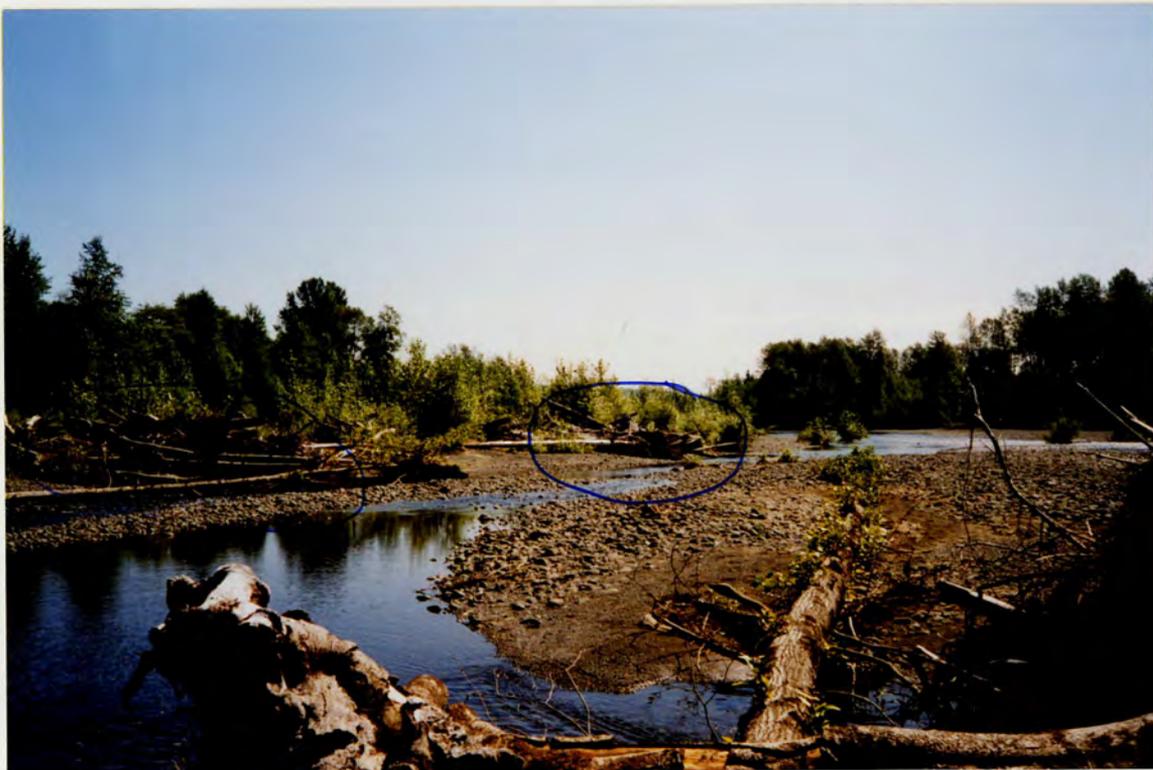
AREA 1: Photo of log jams at upper end of gravel bar. View is easterly.

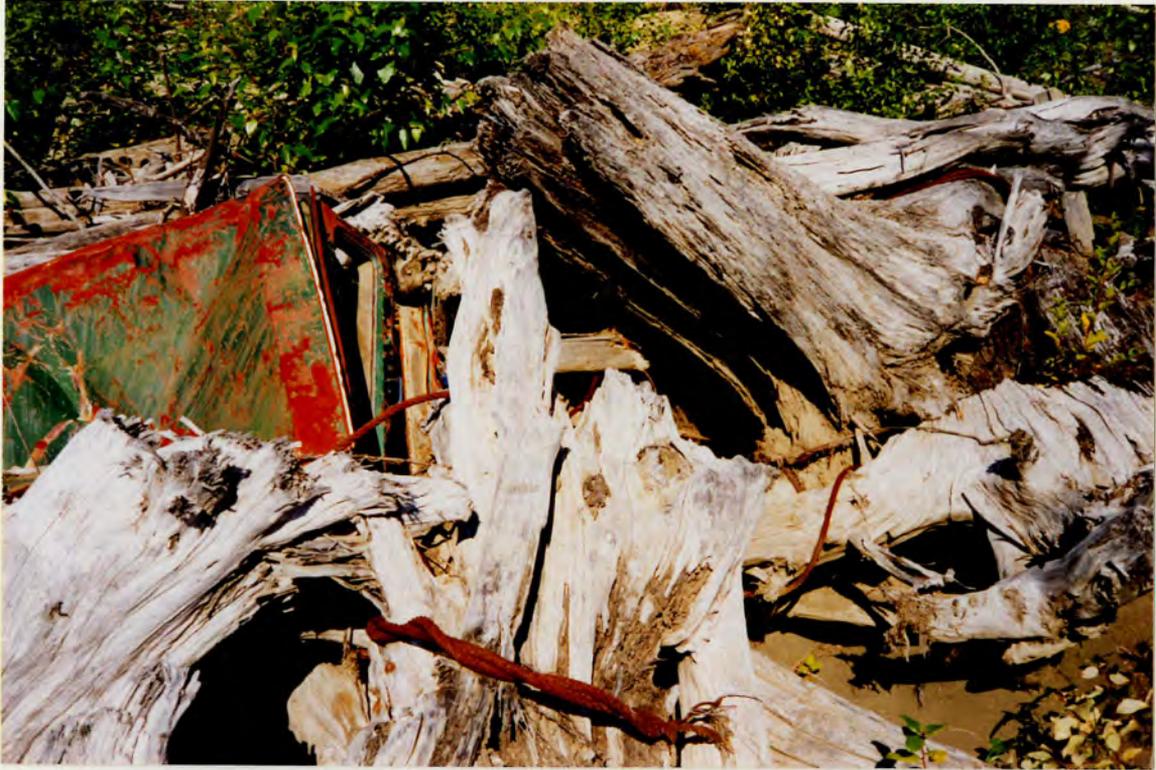
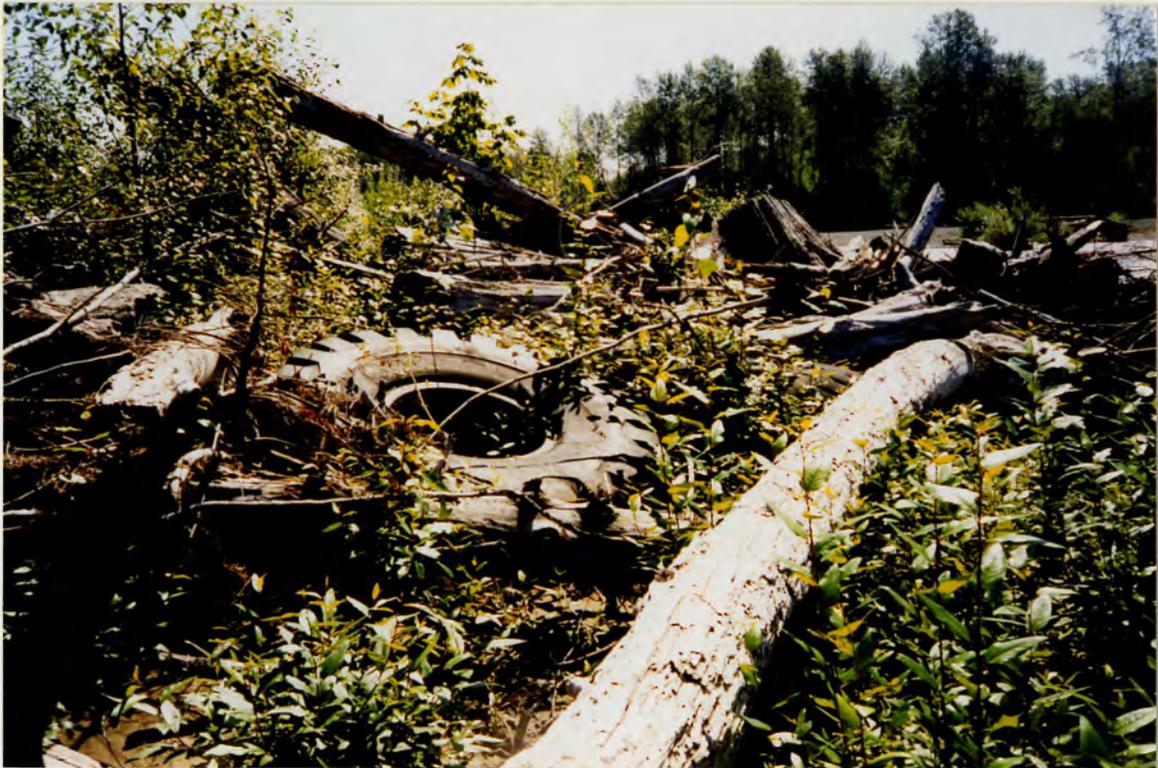
AREA 1: Photos show composition of easterly log jam at upper end of gravel bar.

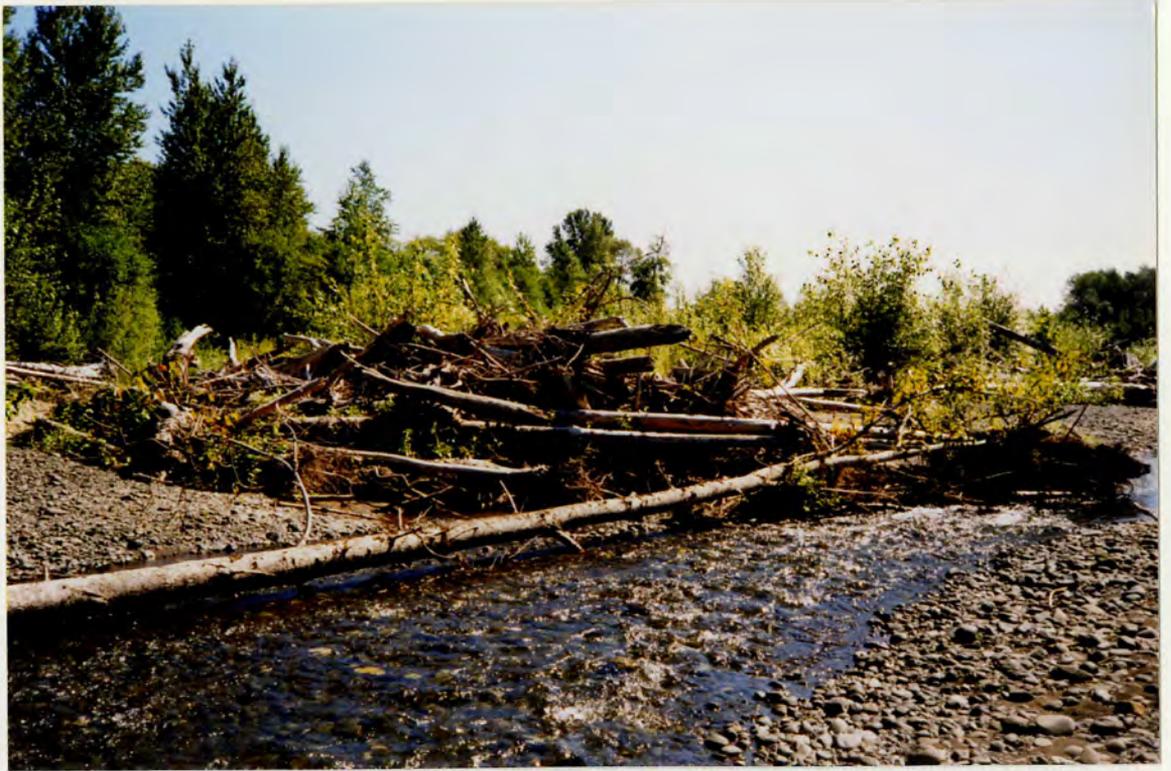
Area 1: Close-up of most westerly log jam at upper end of gravel bar. View is easterly.

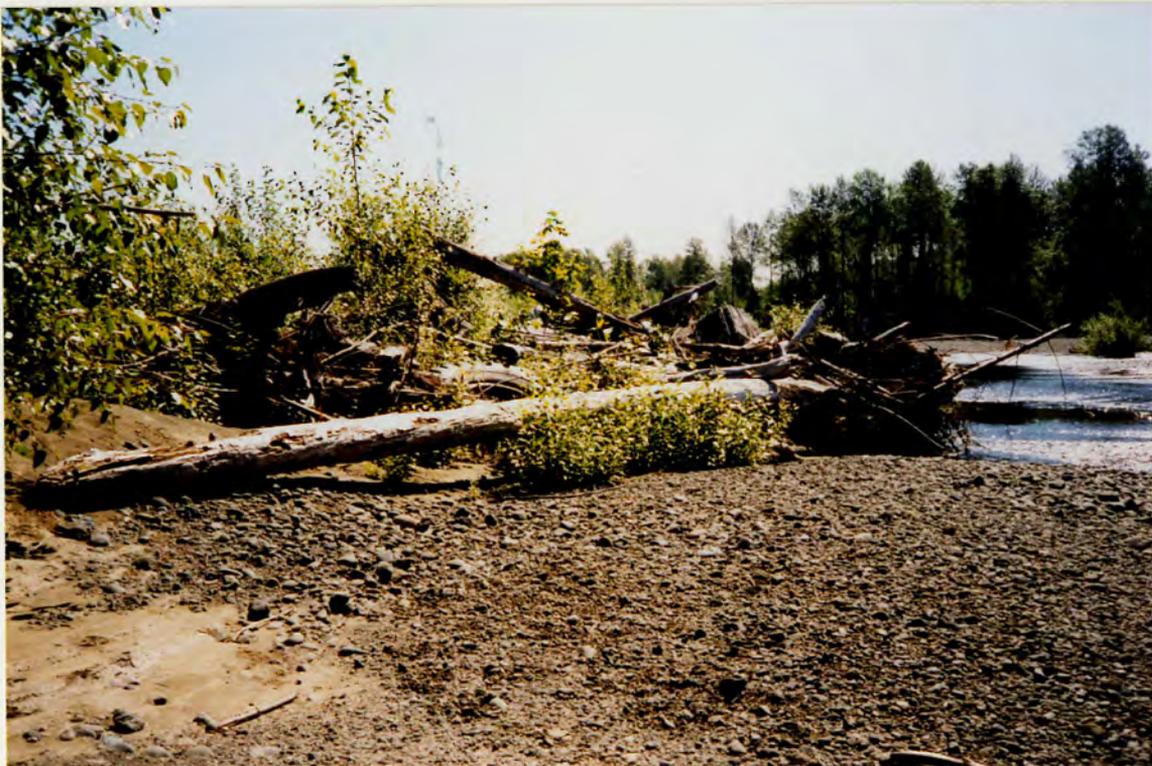
Area 1: Close-up of easterly log jam at upper end of gravel bar. View is easterly.

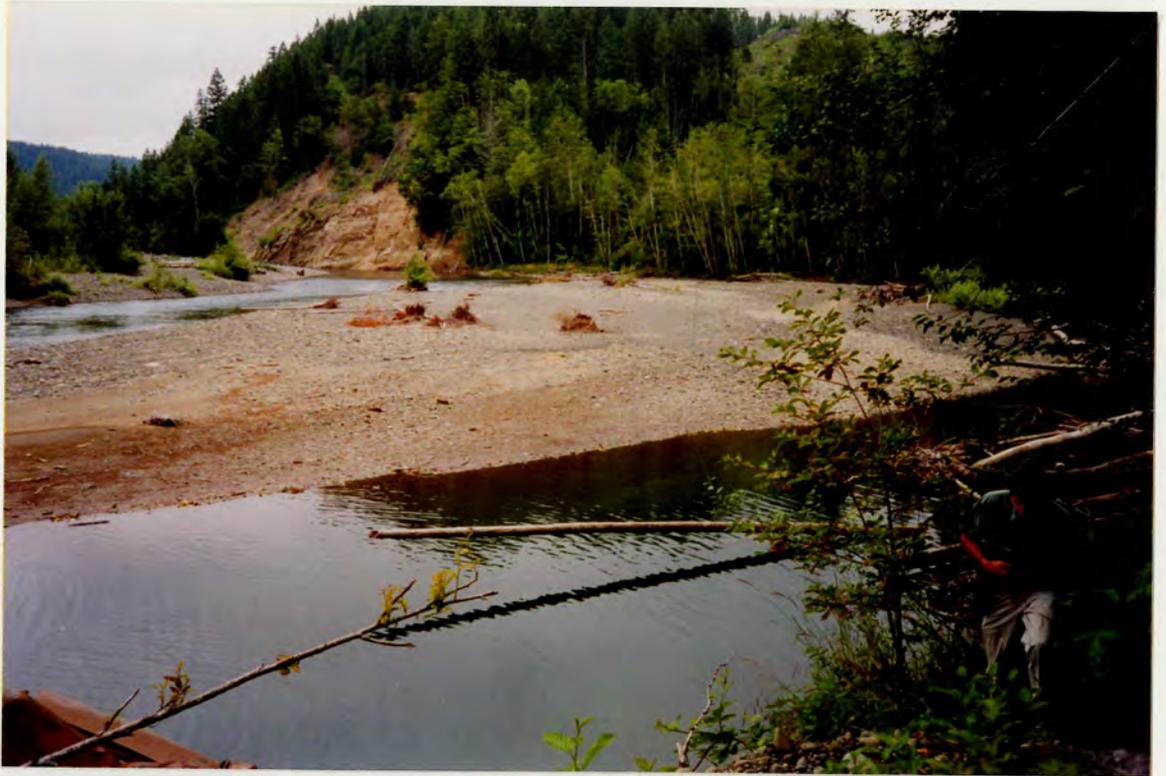
Area 3: Photo from spur dike looking northerly towards cliff and slide area.

The first issue the County had at this location was that the property owner, Mr. Jerry Richert, has applied for a permit to reestablish a spur dike that he had constructed previously, and which has eroded away at the end. It had also been reported that he may have already started re-establishment of this dike; however, there was no evidence that any work had been done to it recently.

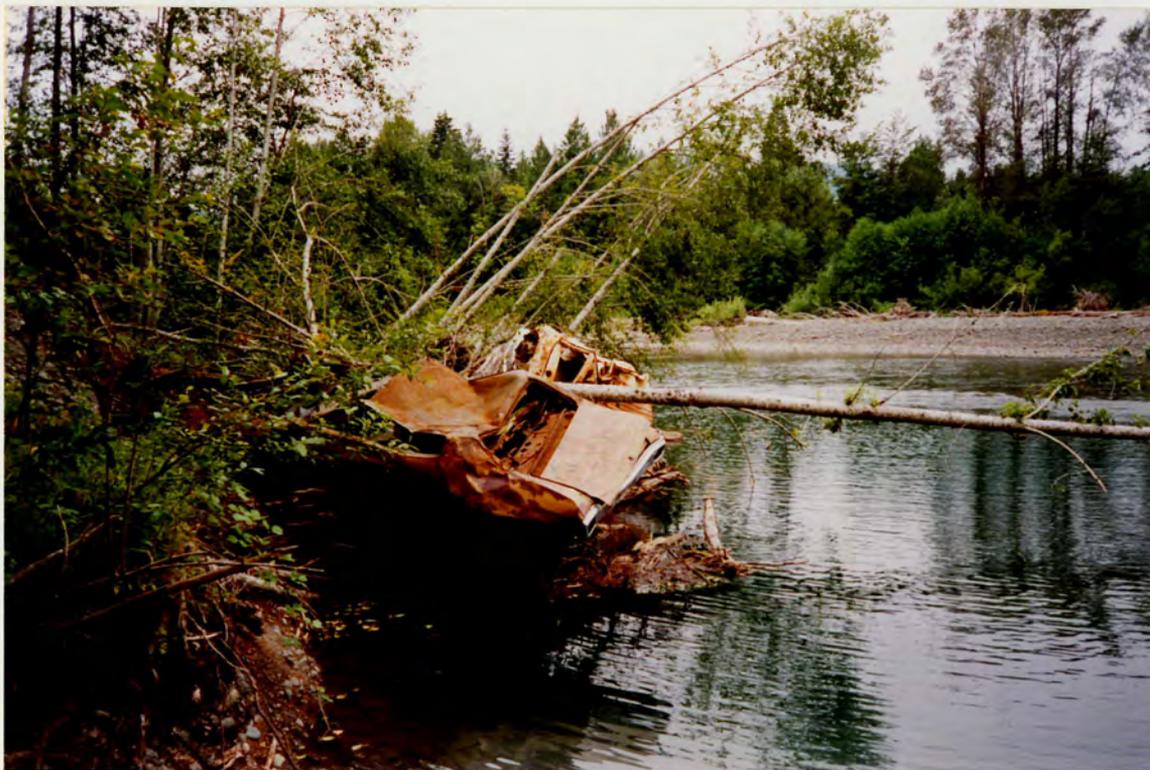
AREA 3: Old car body at end of spur dike.

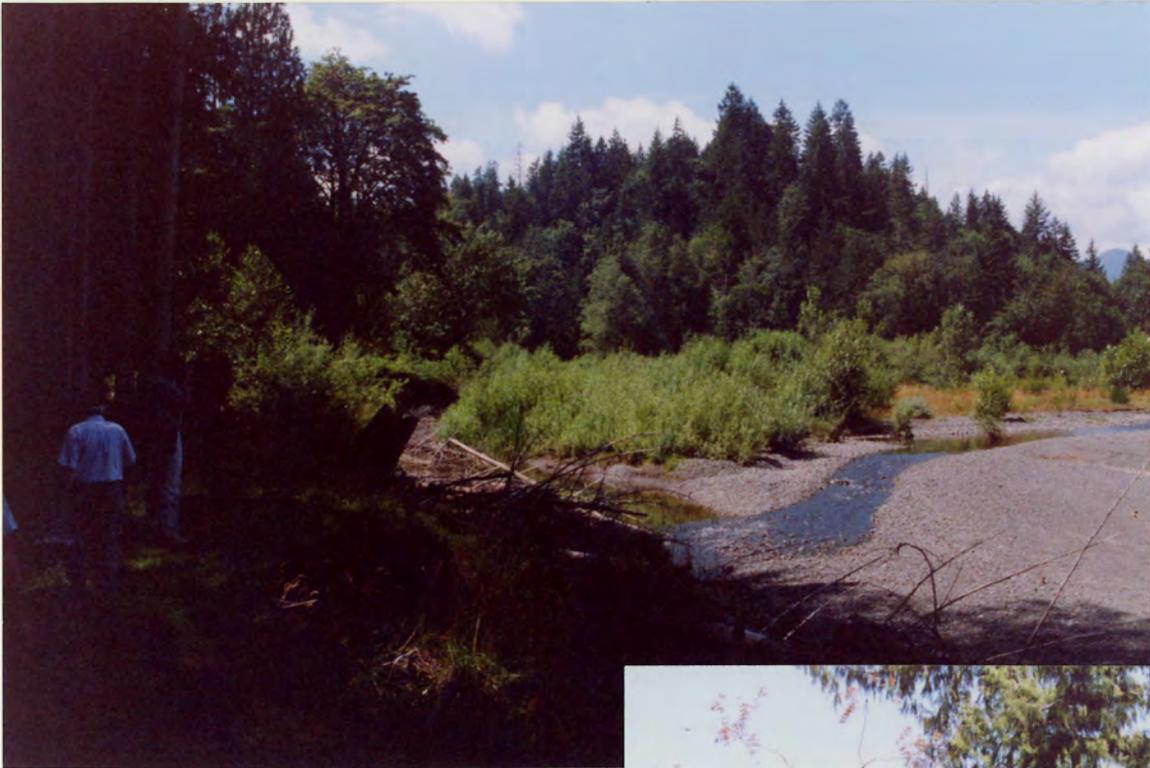
Area 2: Bank erosion. View from top of bank looking northwesterly.

The issue at Area 2 is bank erosion on the south bank, which has eroded away some private property. The channel has changed from where it is shown on the map. This change resulted from the March event. The channel is now flowing more directly against the south bank and has caused considerable bank erosion before continuing on around the bend.

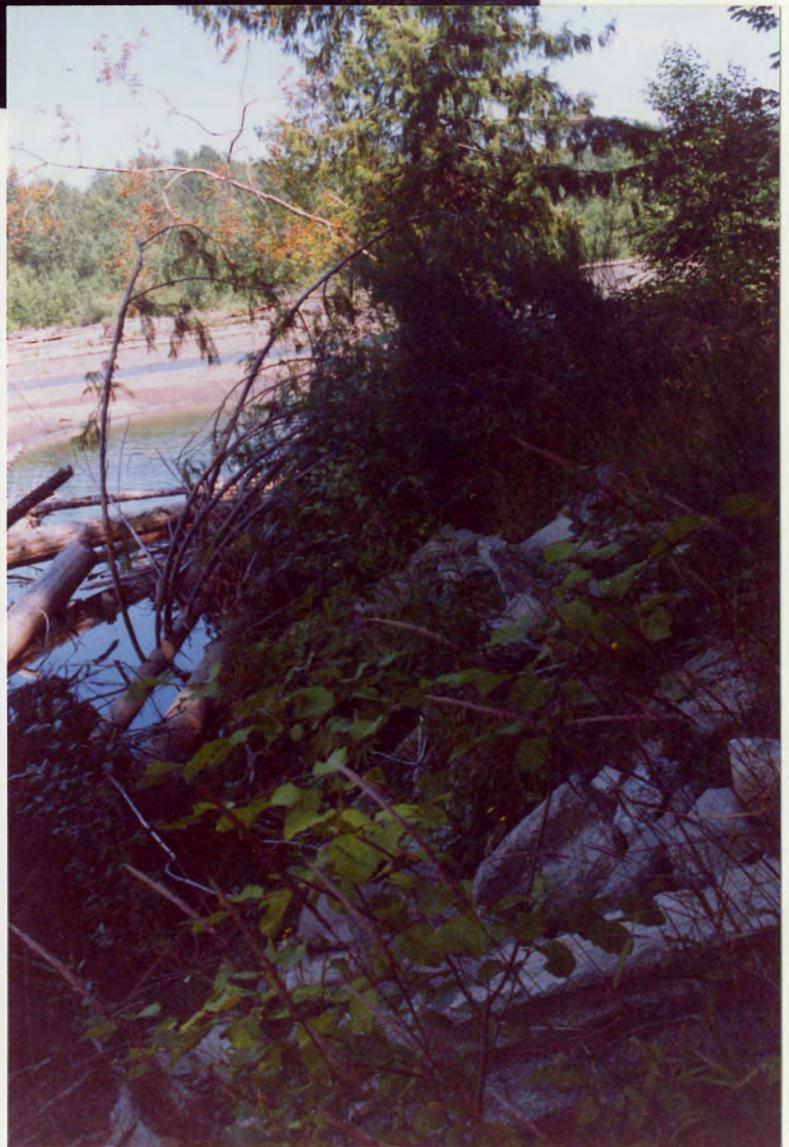
AREA 2: Bank erosion. View from top of bank looking easterly.

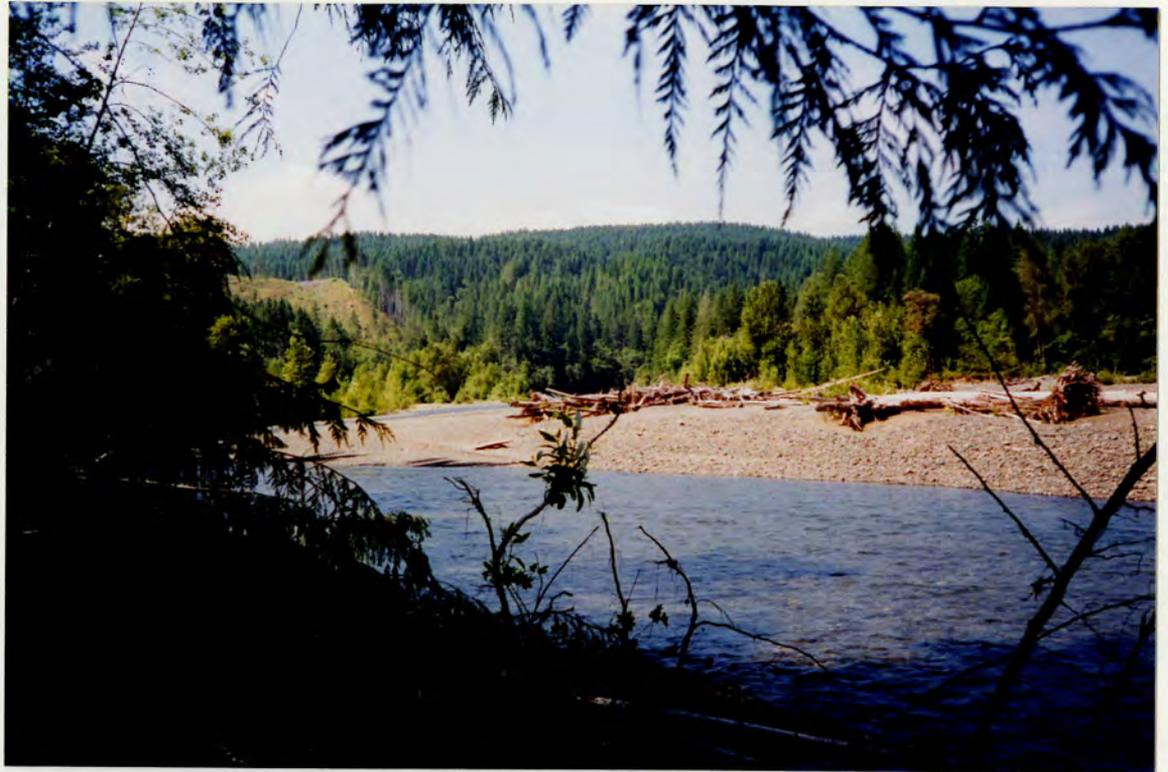
Area 4: Photo where South Fork comes down from the canyon. River Channel has moved southerly, steadily eroding south bank. Photo looking northerly - upstream.

The river at this location has eroded the south bank and the channel has also shifted to the south. Mr. Parsons, the owner, indicated that the river had consumed as much as 200 feet of his bank in the last several years. As the river shifts south it also has a more direct alignment aimed at the large cliff just to the east. This cliff is reported to have had recent landslides, which were evident to us from the appearance of the scarp. The material had slid down into the South Fork, reportedly even damming it for some number of hours before the water broke through and carried the slide material on downstream.

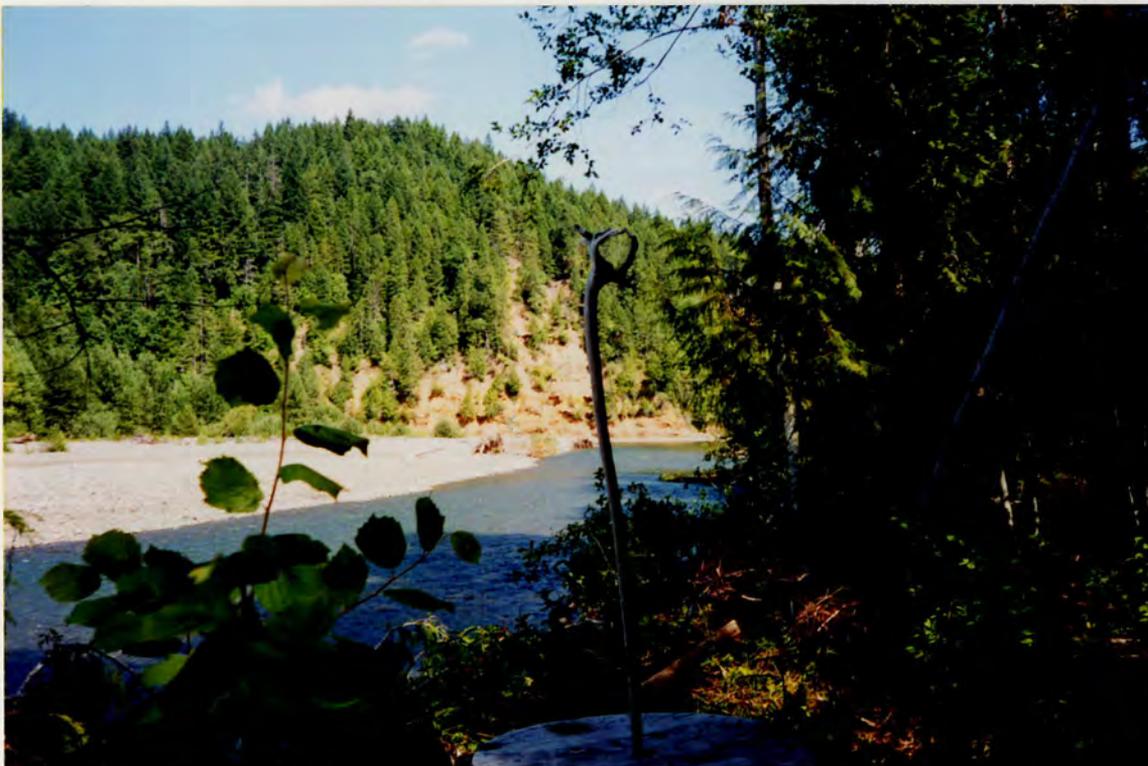
Area 4: Photo looking northeasterly from bank erosion area. Cliff and landslide area in background. River has moved southerly eroding bank area, then turns sharply and runs straight at the cliff which then turns it back southerly.

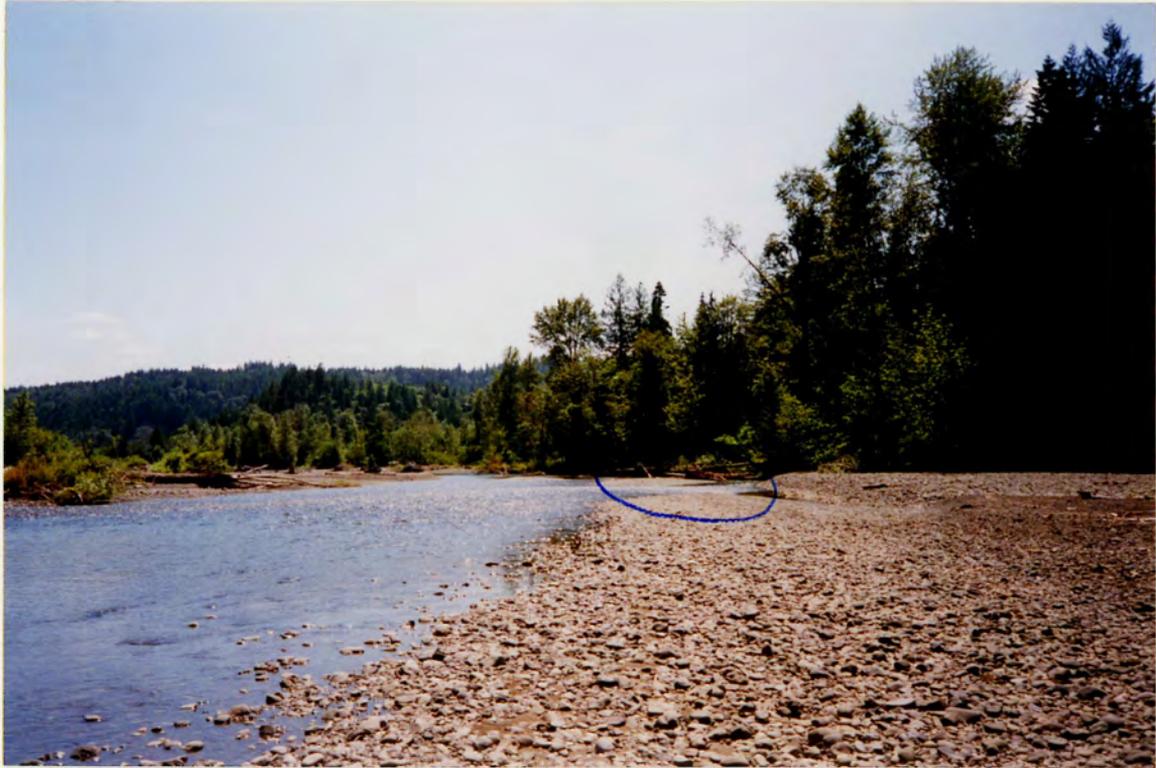
Area 3: Photo looking southwesterly
at bank erosion area.

The second issue is the bank erosion on the west bank. The property owners on the west bank would like something done to stop this erosion. They have objected to Mr. Richert's application to reestablish his spur dike because they fear additional erosion of their property will be the result. We witnessed that the river is definitely eating away at the west bank, however, there has also been erosion of the spur dike on the opposite side of the river.
