SOUTH FORK OF THE SKOKOMISH RIVER AND VANCE CREEK

Hydraulic and Geomorphic Analysis and Recommendations for Action

June 1999
(Revised September 1999)

Project # S-C 99033

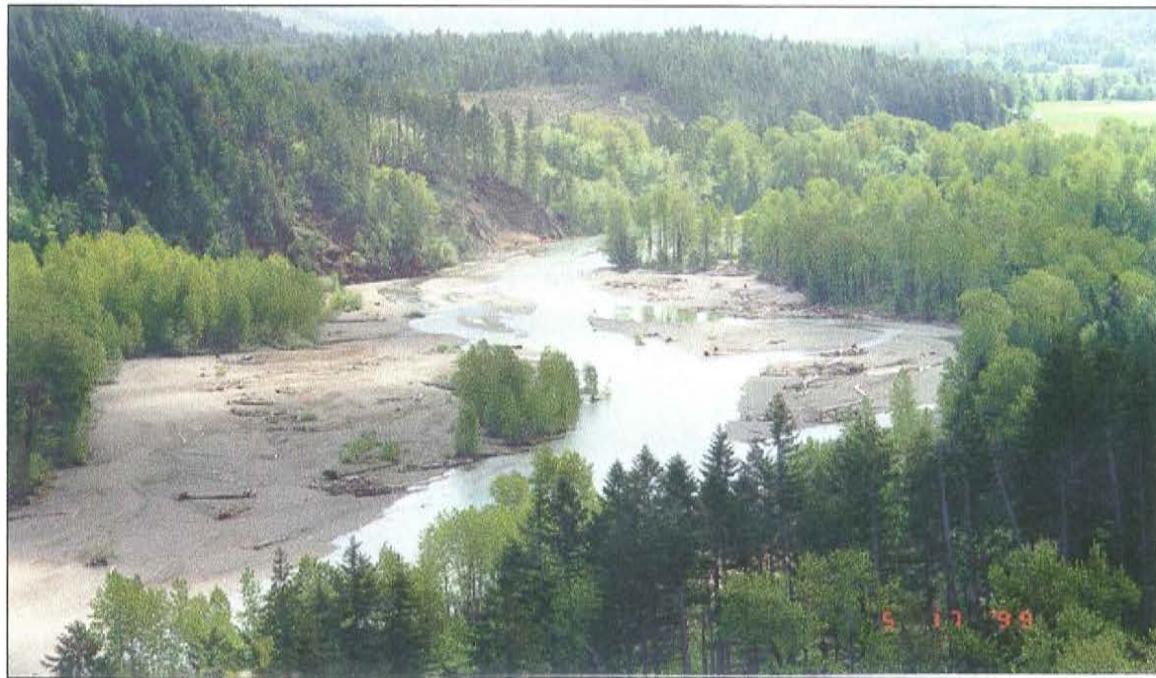
PHOTO – 1: South Fork Skokomish River – McKay Flats
looking southeast between RM-S 2.36 and RM-S 3.18

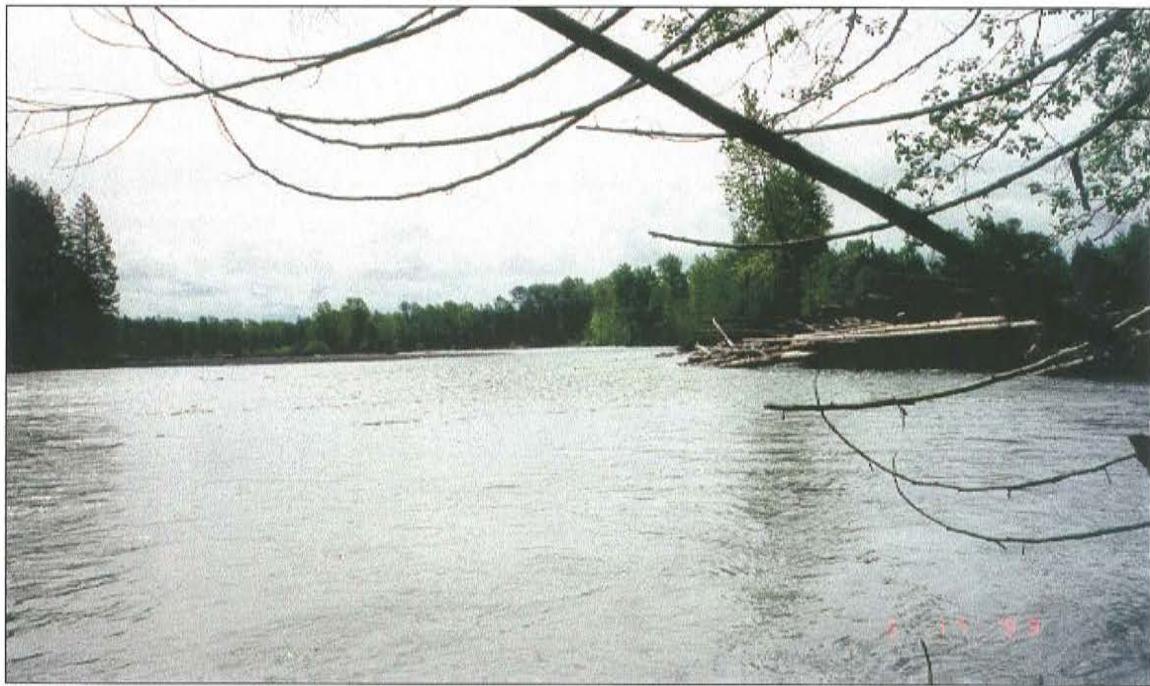
PHOTO – 2: South Fork Skokomish River – Where River
comes out from the canyon approximately at RM-S 3.18 –
Log Jam on the right

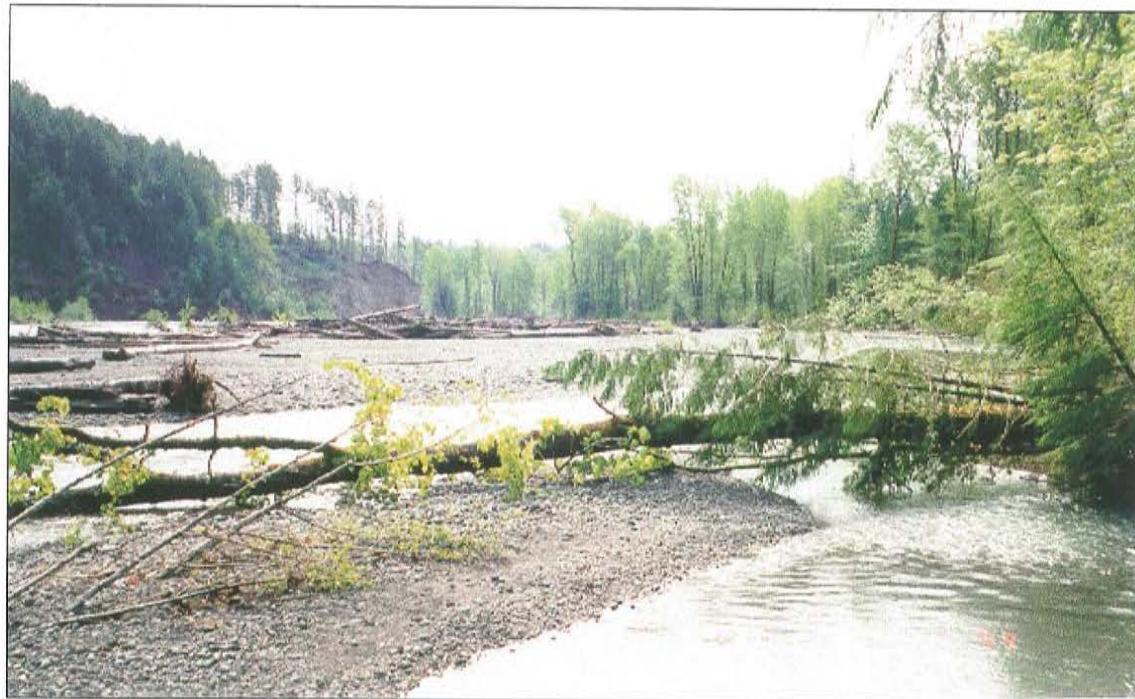
PHOTO – 4: South Fork Skokomish River – Terry Bence's property at approximately 500 feet from RM-S 2.86 looking downstream

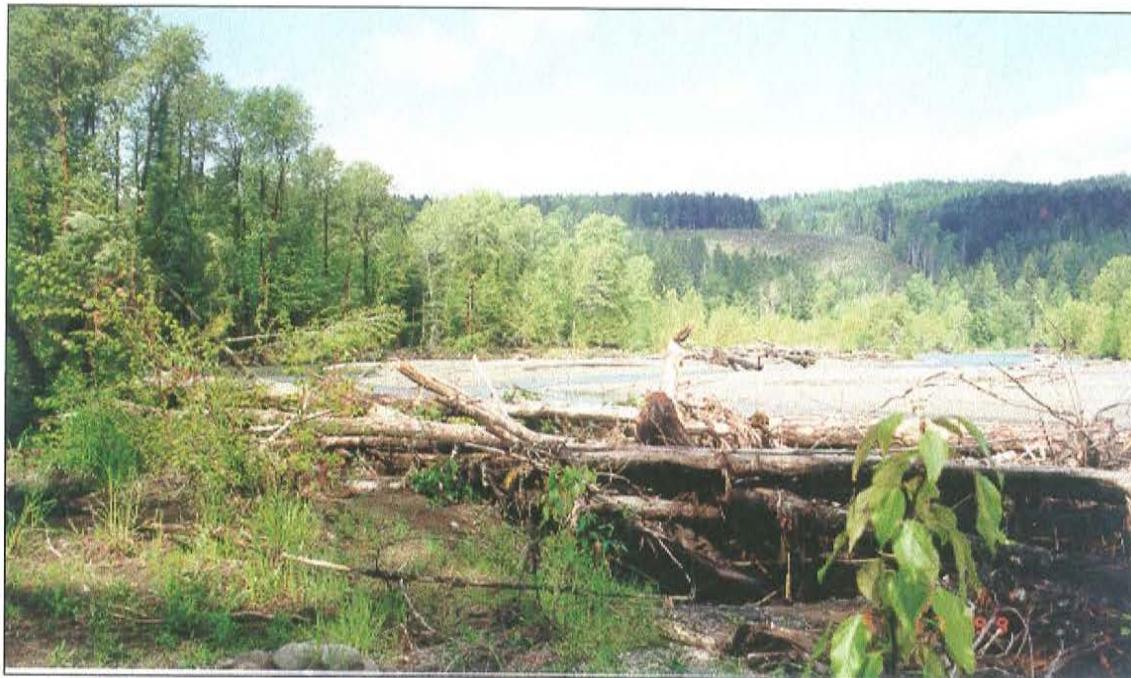
PHOTO – 5: South Fork Skokomish River – Tom Schreiber's property at approximately 500 feet from RM-S 2.4 looking upstream

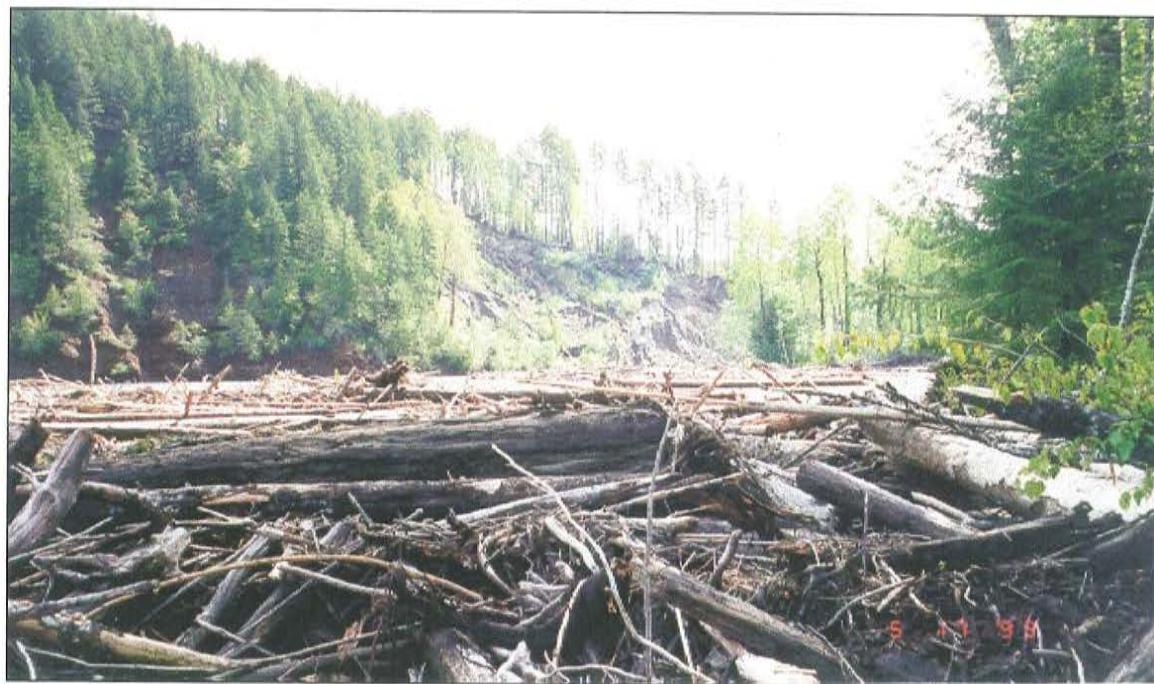
PHOTO – 6: South Fork Skokomish River – Tom Schreiber's property at approximately 500 feet from RM-S 2.4 looking downstream

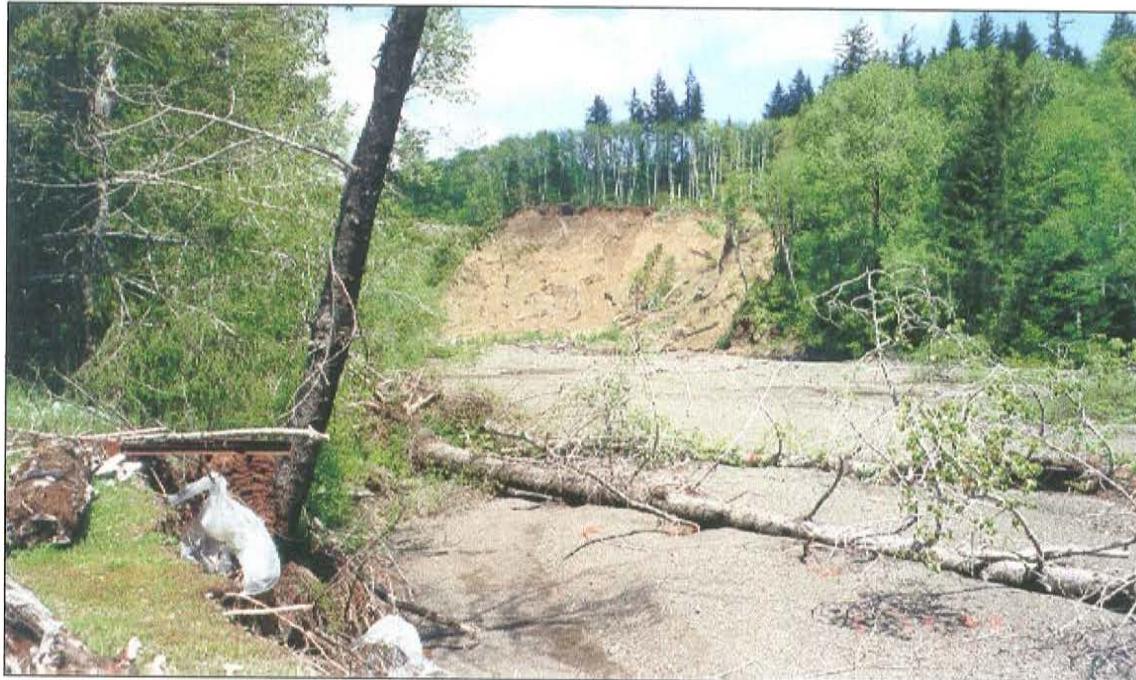
PHOTO – 8: Vance Creek – Robinson & Godding's property looking upstream from high bank towards slide between RM-V 2.03 and RM-V 2.20

In addition to the generally increased sediment load from the watersheds of the South Fork and Vance Creek, landslides can potentially supply sudden increases of sediment and can alter channel geometry and hydraulics. An existing landslide was observed in the portion of Vance Creek being evaluated in this analysis between River Mile 2.0 and 2.4 opposite and upstream from the Robinson-Goddings property.

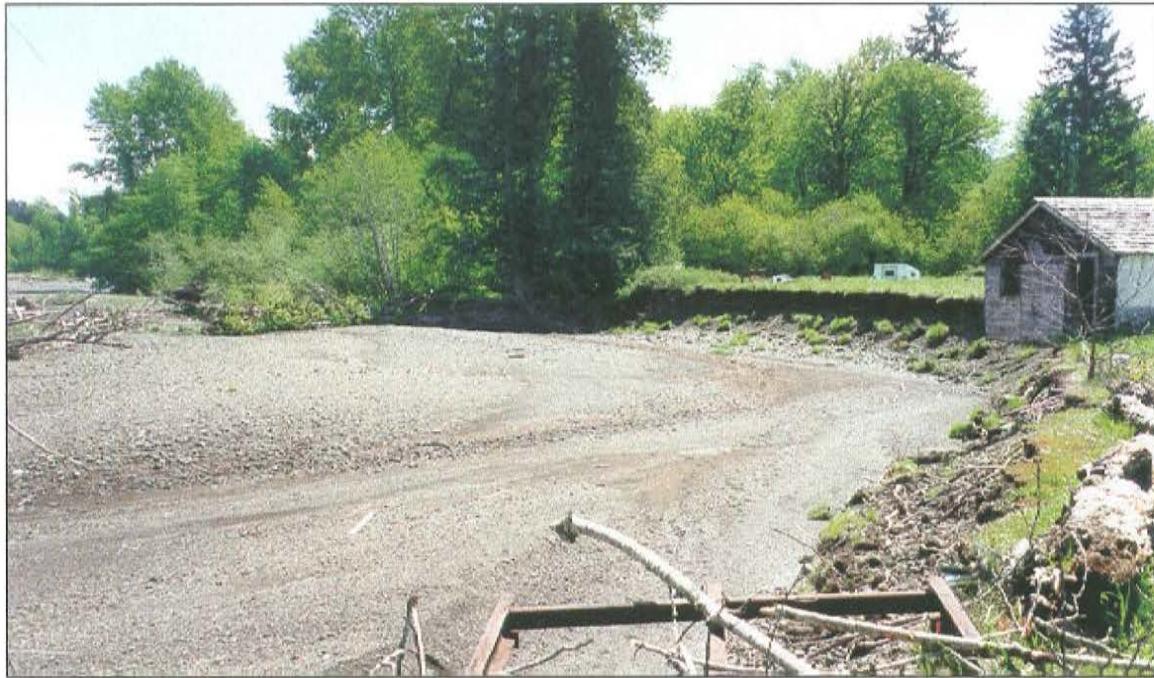
PHOTO – 9: Vance Creek – Robinson & Godding's property looking downstream from high bank between RM-V 2.03 and RM-V 2.20

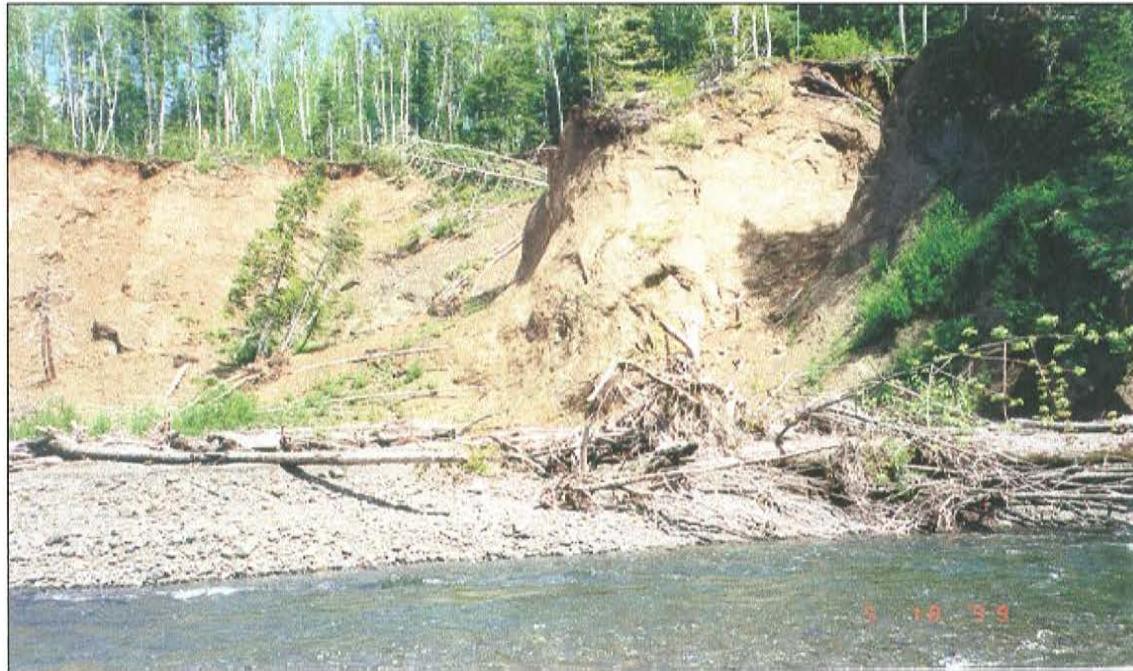
PHOTO- 10: Vance Creek – Robinson & Godding's property upstream slide face across river between RM-V 2.03 and RM-V 2.20

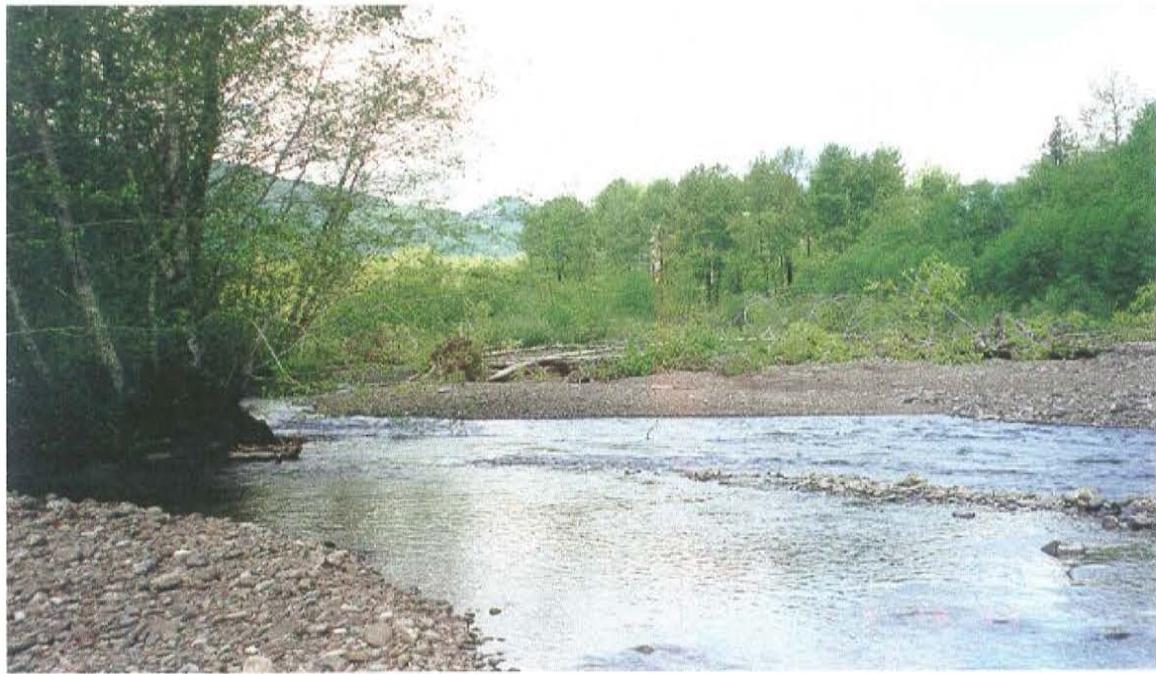
PHOTO – 11: Vance Creek – Robinson & Godding's property looking downstream from channel edge between RM-V 2.03 and RM-V 2.20

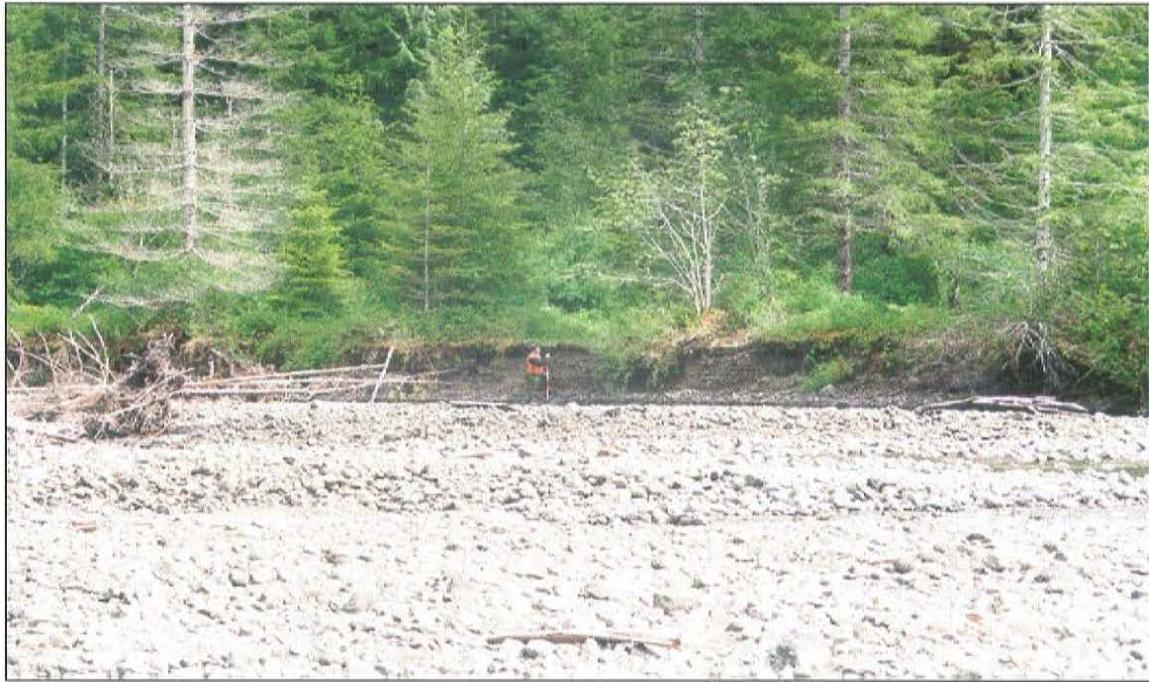
PHOTO – 12: Vance Creek – RM-V 3.53 at cross section location: Note bank height

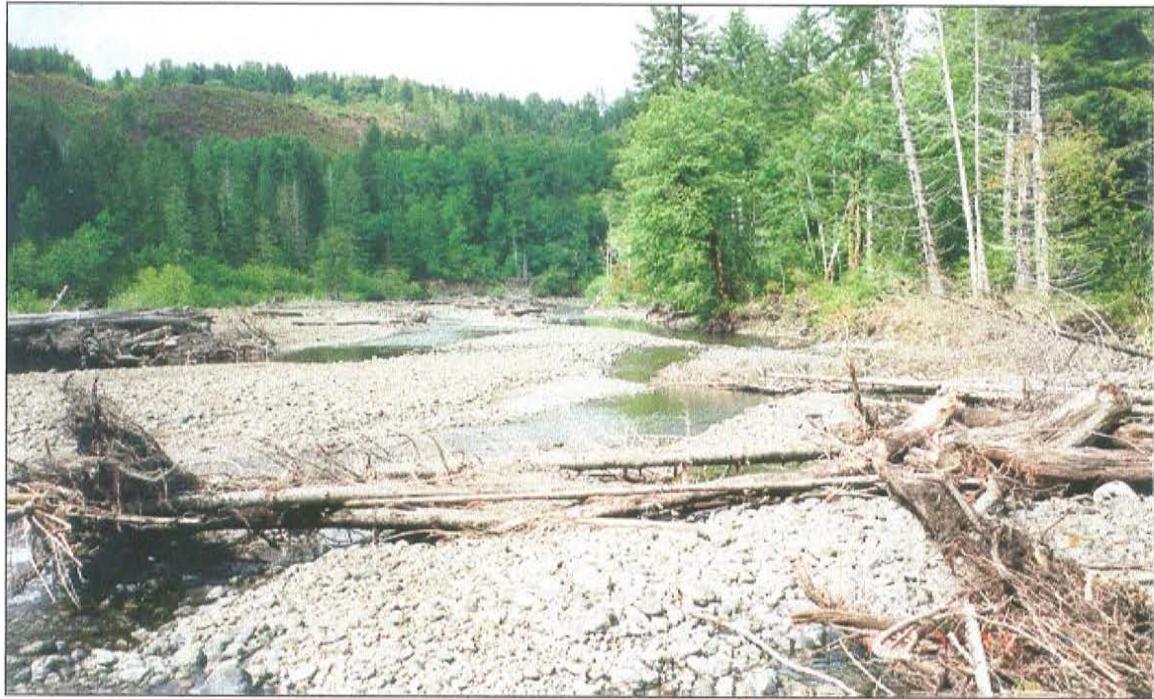
PHOTO 13: Vance Creek – RM-V 3.53
looking downstream

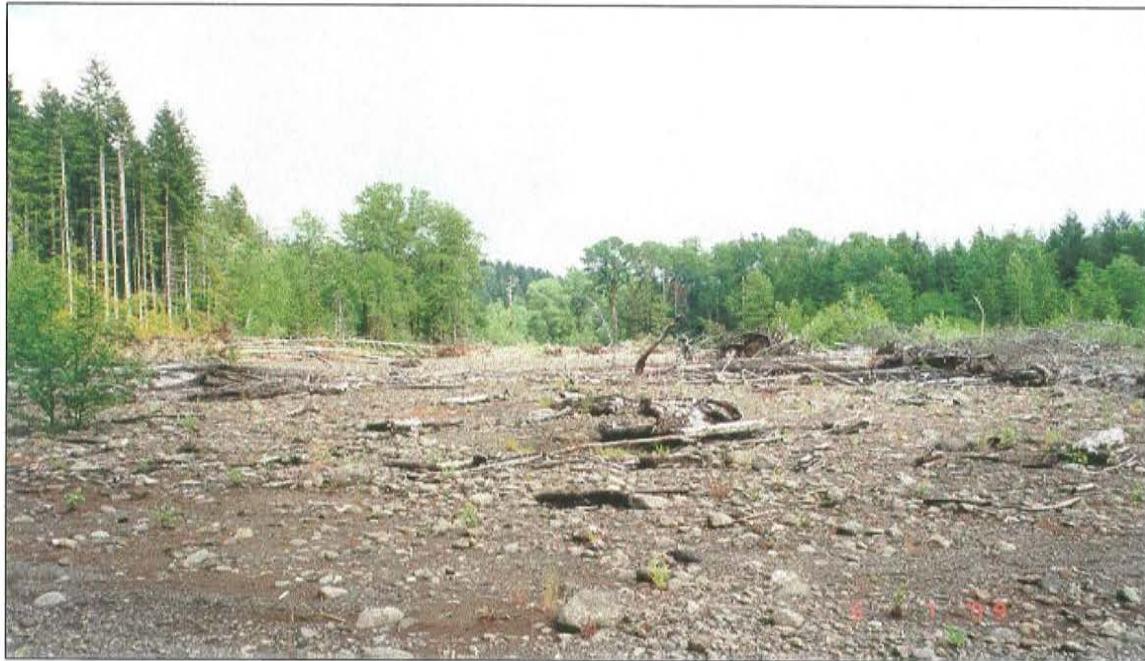
PHOTO – 14: Vance Creek –
approximately RM-V 3.4 looking downstream
