# HWA GEOSCIENCES INC.

HWA Project No. 2006-172-300

Subject: **INFILTRATION EVALUATION  
WATER QUALITY PROJECT PLANNING  
POTLATCH "BUBBLE" AND CORE RESERVATION PLANNING AREAS  
MASON COUNTY, WASHINGTON**

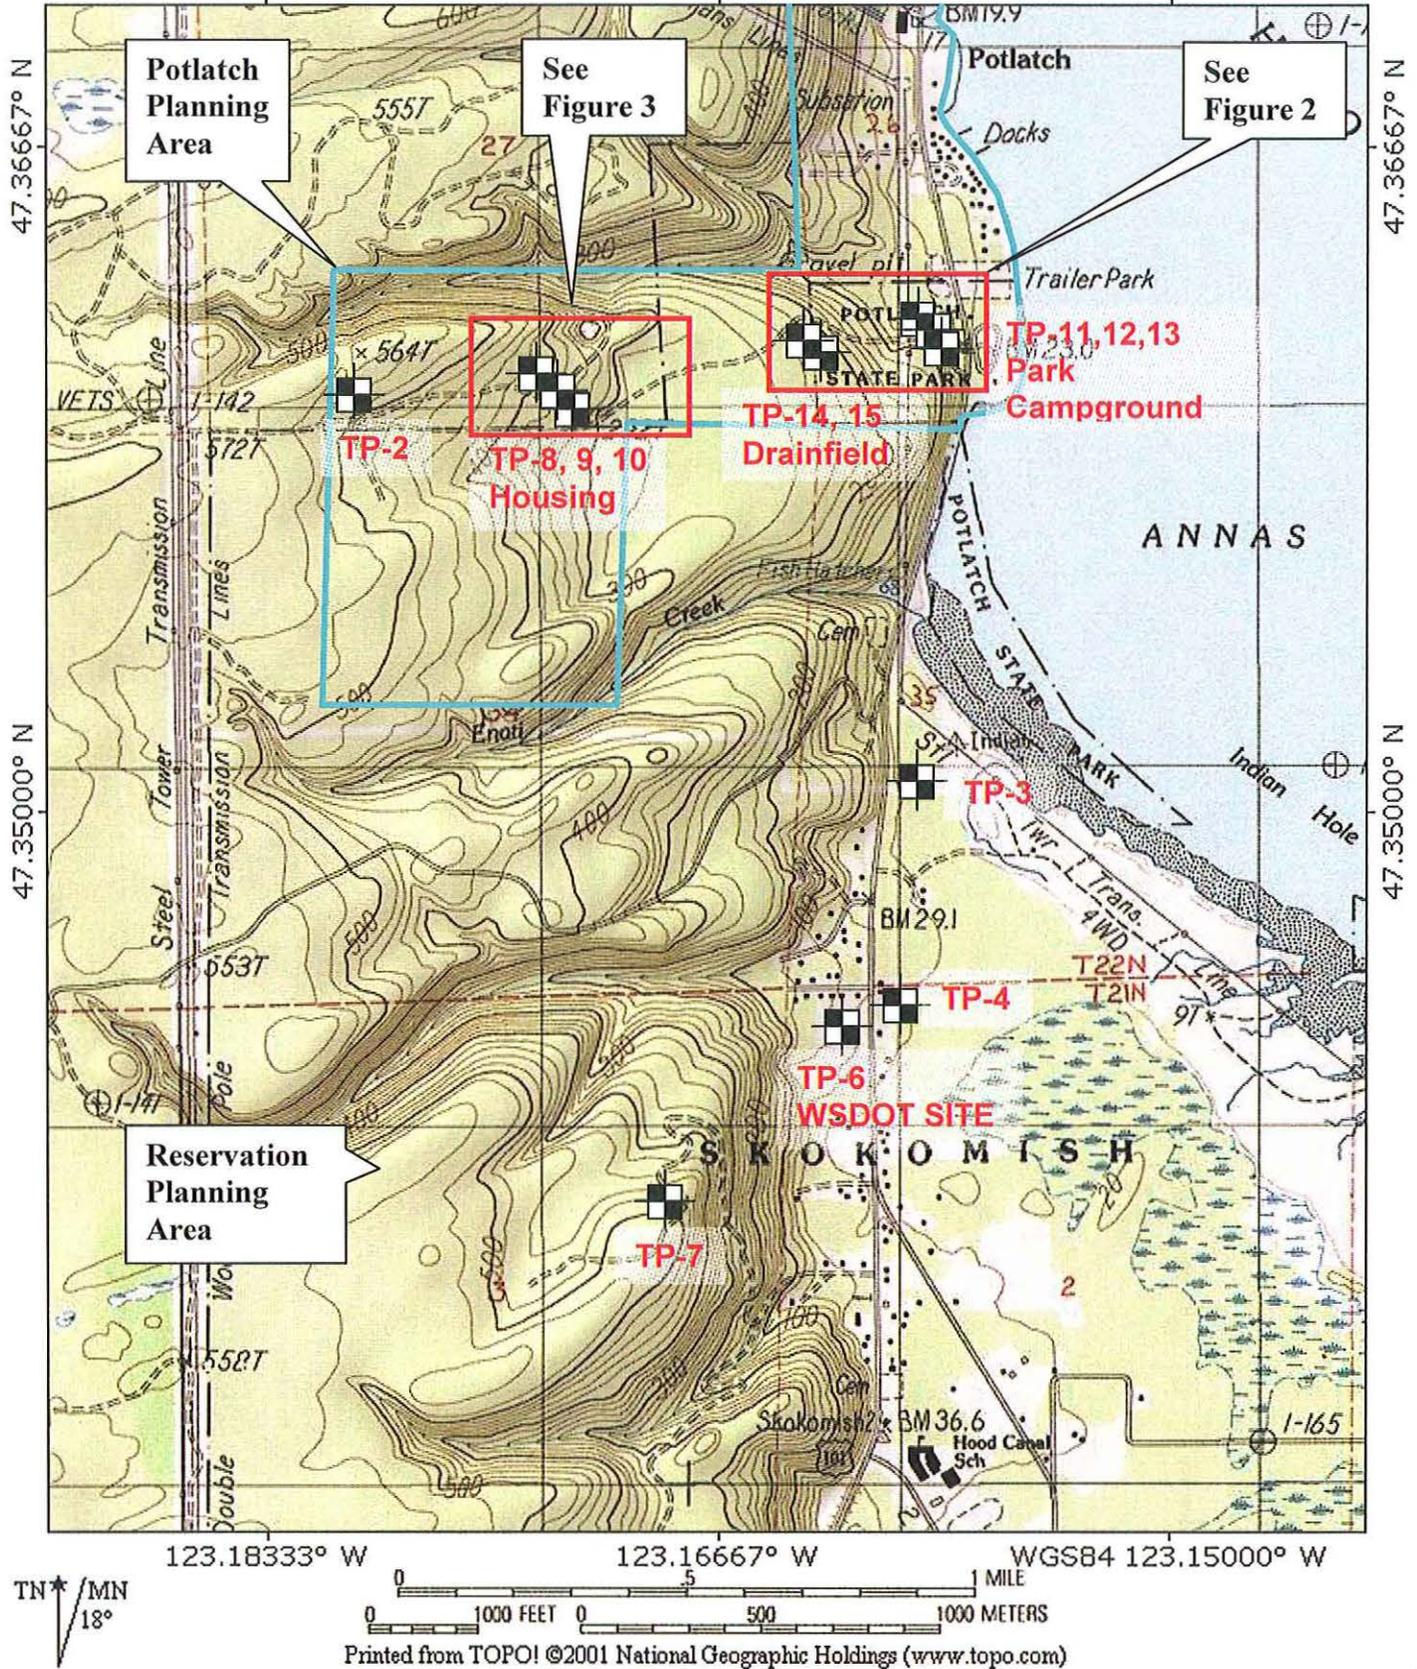
**EXPLORATION LOCATIONS**

MASON COUNTY  
 WATER QUALITY PROJECT PLANNING  
 POTLATCH BUBBLE & RESERVATION AREAS

The goals and objectives of this study were to evaluate the infiltration potential and site suitability of selected sites. Figures 1, 2 and 3 show the location of the areas investigated, which included:

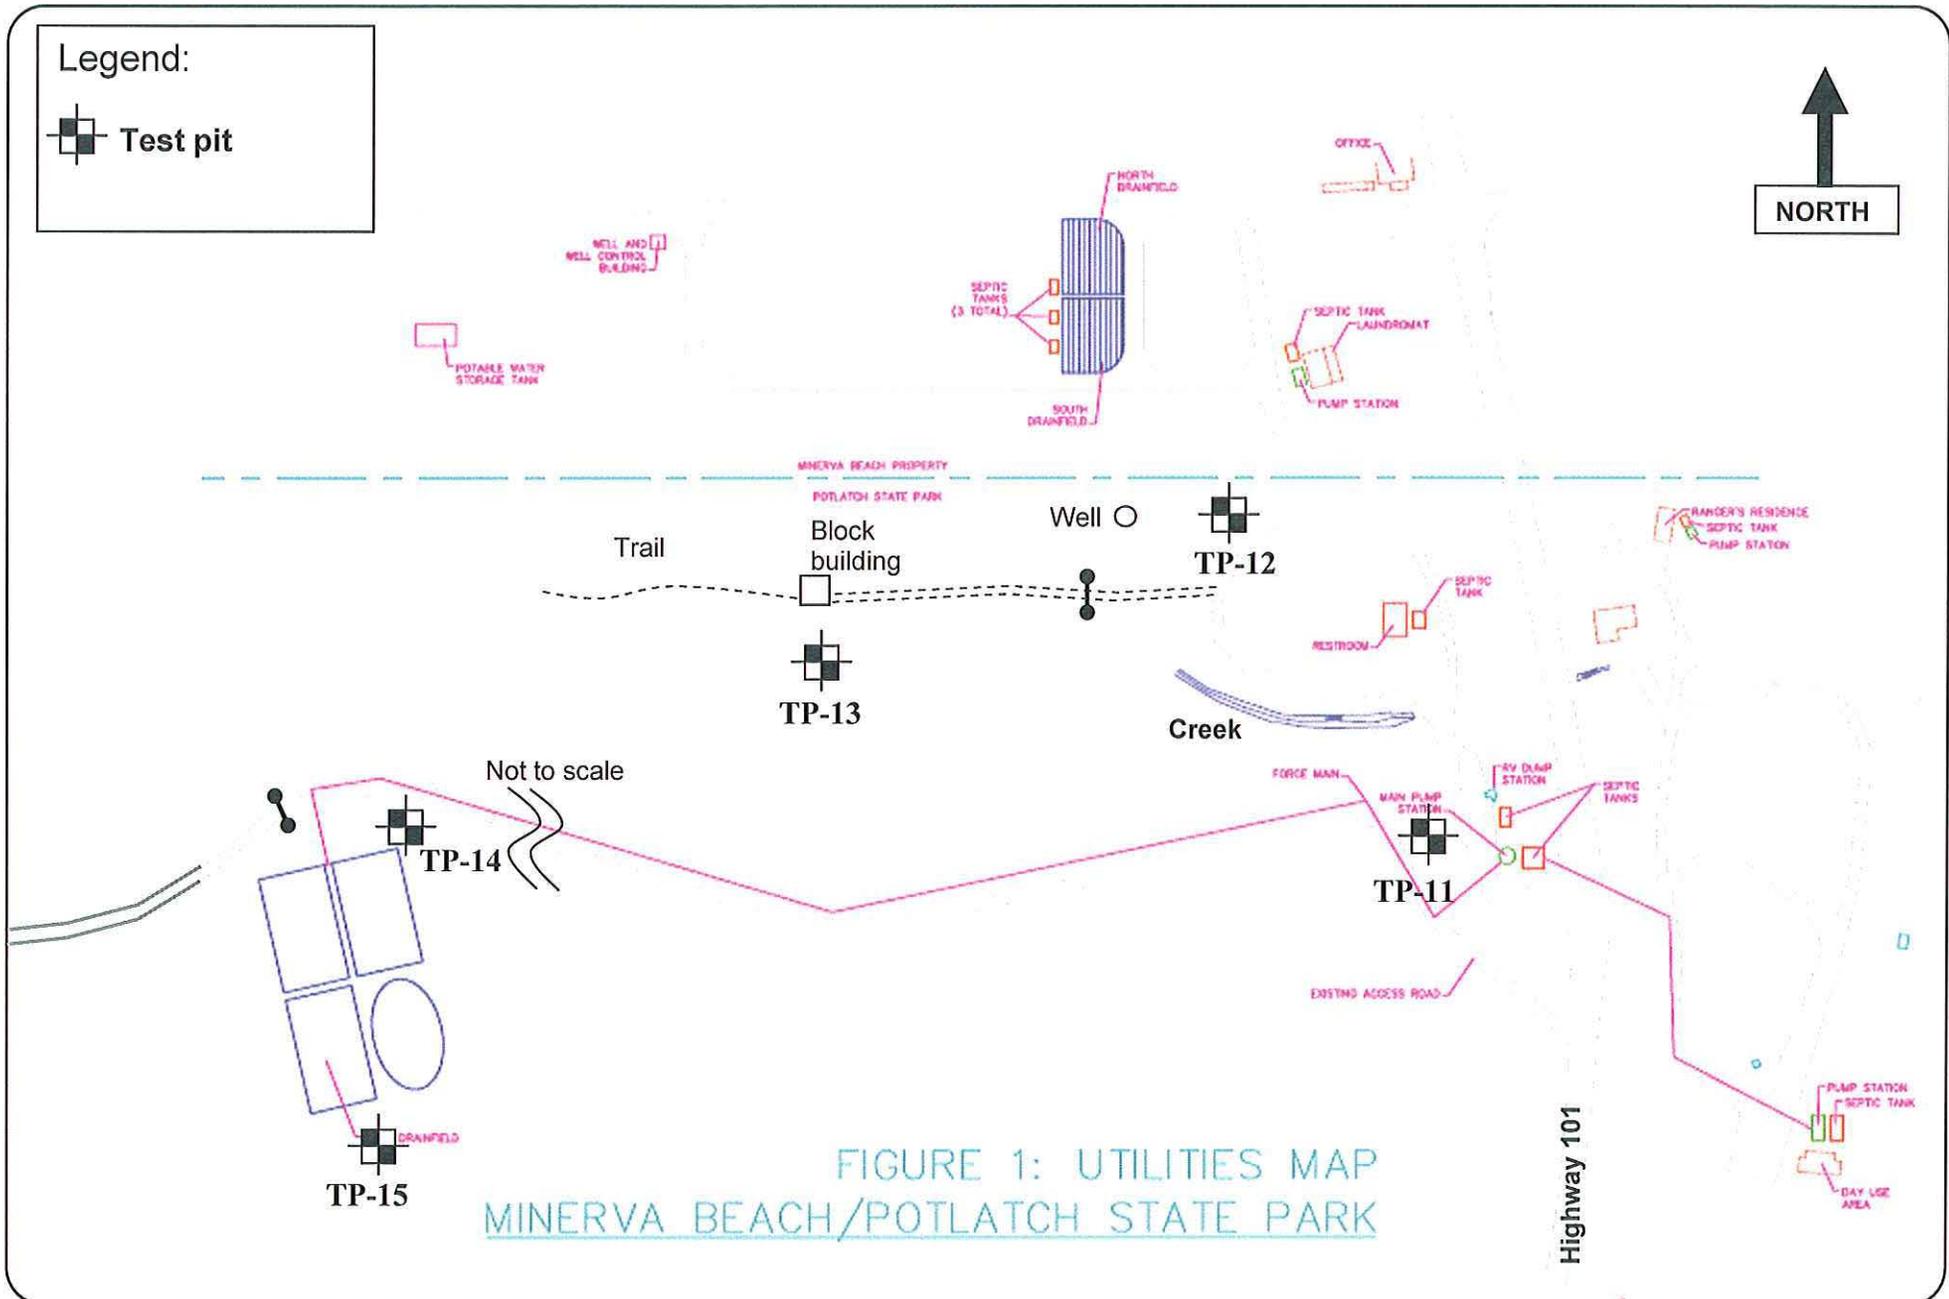
FIGURE 1: UTILITIES MAP  
MINERVA BEACH/POTLATCH STATE PARK

EXPLORATION LOCATIONS – POTLATCH STATE PARK  
CAMPGROUND AREA

HWA monitored the excavation of three test pits in this area, designated TP-11, TP-12, and TP-13. Figure 2 shows the test pit locations. A Washington State Parks archaeologist observed all excavations, and we understand no cultural resource issues were identified during excavation at the campground area.

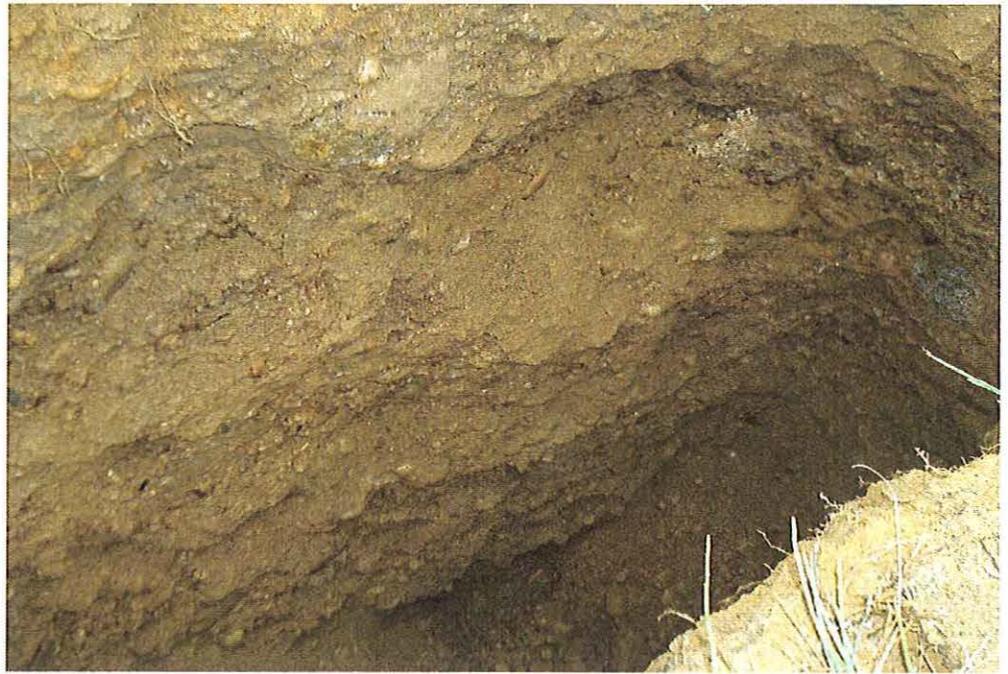
LOG OF TEST PIT  
 TP-2

DEPTH (feet)	SYMBOL	USCS SOIL CLASS.	DESCRIPTION	SAMPLE TYPE
0			Topsoil + gravel	
	SM		Dense or very dense gray and brown silty SAND with gravel and cobbles, slightly stratified, diamict texture, moist [SANDY TILL/DRIFT]	
3	SP SM		Brown & gray silty fine to coarse SAND with gravel and cobbles to 1', moist. Some silt seams. [OUTWASH, SILTY]	○
6			Dense brown & gray silty SAND with gravel and cobbles, moist. Some 1-2" brown silt seams, non plastic.	○
9	SP		Gray fine to coarse SAND, moist. Angular, clean sand.	
12			Test pit terminated at about 10 feet below the ground surface. No ground water encountered during this exploration.	
15

PHOTOGRAPH OF TEST PIT

TP-2 - This test pit encountered stratified silty sands with silt layers to a depth of eight feet, and clean sands (outwash) from eight feet to the maximum excavated depth of nine feet. Deeper soils appeared more permeable, although additional exploration in this area would be required to assess the feasibility of rapid infiltration. Infiltration facilities in these conditions would require overexcavation of surficial lower permeability soils, or installation of subsurface infiltration facilities (trenches, galleries, etc.) to a sufficient depth to access suitable soils.

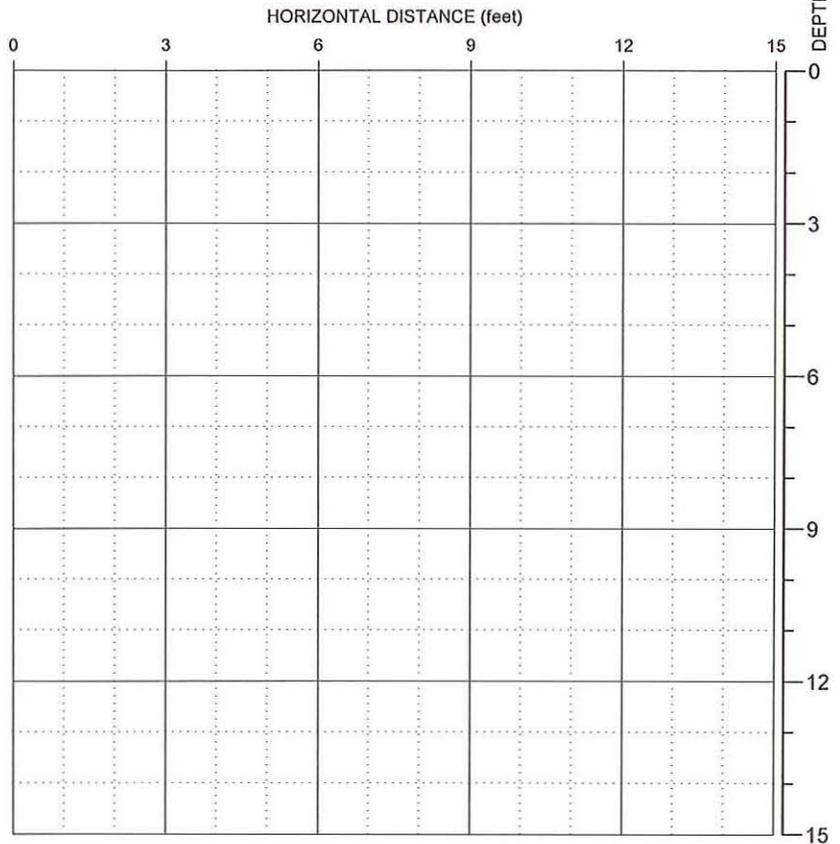
SKETCH OF SIDE OF PIT

DEPTH (feet)	SYMBOL	USCS SOIL CLASS.	DESCRIPTION	SAMPLE TYPE	SAMPLE NUMBER	MOISTURE CONTENT (%)	OTHER TESTS	GROUNDWATER
0		SM	Brown, silty SAND with gravel, roots, moist to wet.					
3		SM	Blue-gray, silty SAND with gravel and cobbles, wet. Some silt seams.	○				
6				○				
9								
12								
15

Test pit terminated at about 5 feet below the ground surface.  
 Ground water observed at about 1.5 feet depth.  
 Caving noted below 3 feet.

TP-3 - This test pit was located east of Highway 101, at the edge of a mapped wetland area. Soils encountered included silty sands with gravel, with a high ground water table (1.5 feet below grade). Ground water, where encountered, is noted on the test pit logs. HWA conducted this study in winter, during a period of high seasonal ground water. Soil moisture/ground water conditions will likely change in response to rainfall, time of year, creek stage, and other factors. Shallow ground water in this area likely drains to Hood

Canal, to the east. This area is unsuitable for rapid infiltration due to low permeability soils, high ground water, and the presence of wetlands. This area may be suitable for discharge of reclaimed water to wetlands.

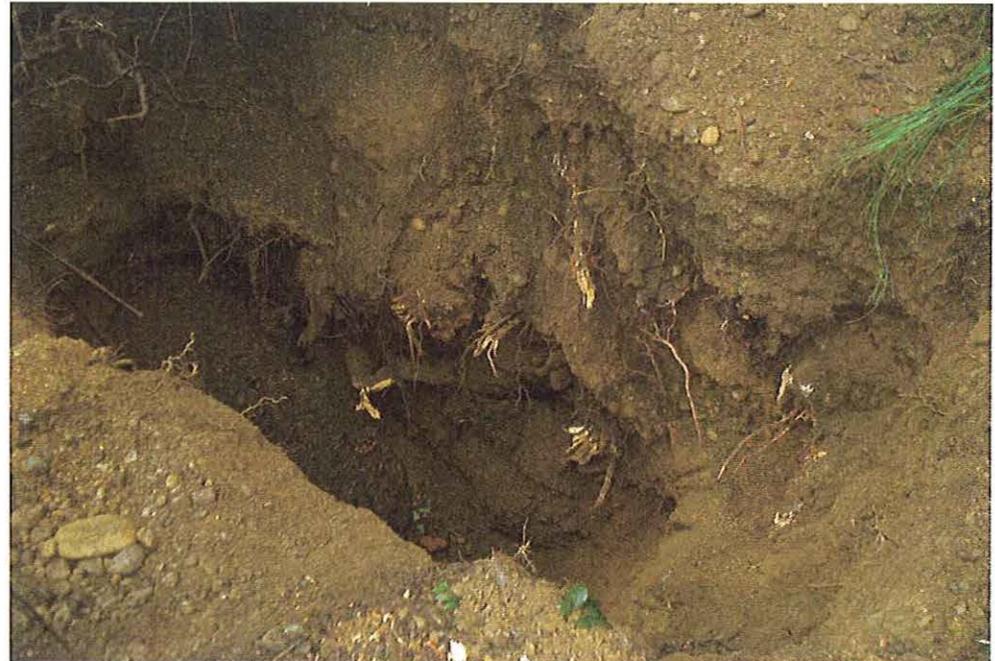
LOG OF TEST PIT  
 TP-4

DEPTH (feet)	SYMBOL	USCS SOIL CLASS.	DESCRIPTION	SAMPLE TYPE
0		SM	Brown, silty SAND with gravel, moist	
3		SP	Seam of gray fine to coarse SAND with gravel.	
	ML SM		Brown, SILT, silty SAND, and large woody debris [fill] Reddish brown, silty SAND with gravel and silt, moist	
6	ML		Brown SILT	○
	ML			
	SM SP		Reddish brown, fine to coarse SAND, few gravel, moist	○
9				
12			Test pit terminated at about 10 feet below the ground surface. No ground water encountered during this exploration.	
15

PHOTOGRAPH OF TEST PIT

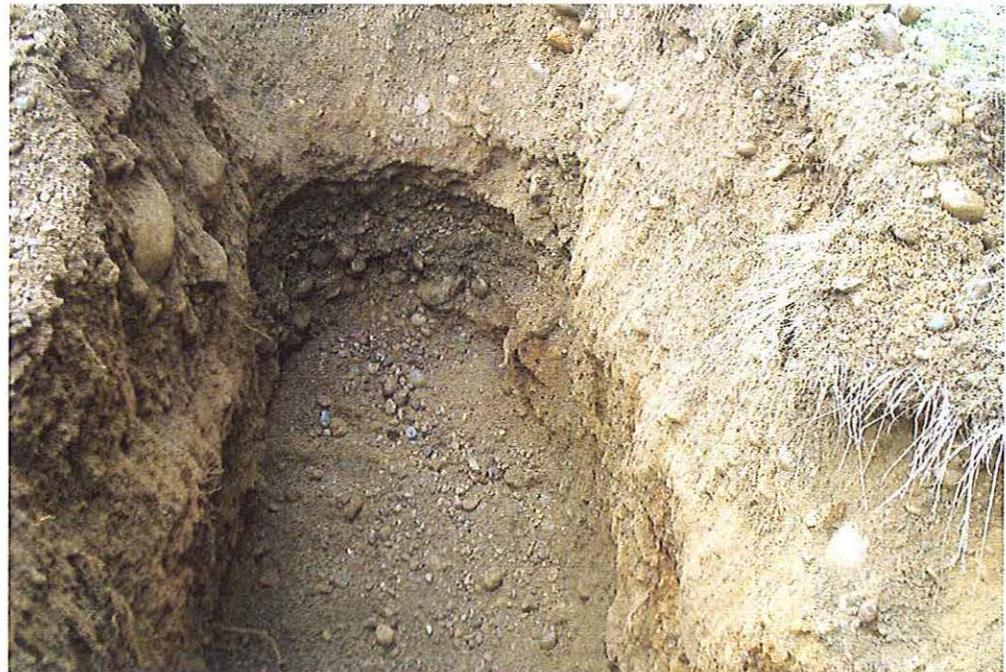
LOG OF TEST PIT  
 TP-6

DEPTH (feet)	SYMBOL	USCS SOIL CLASS.	DESCRIPTION	SAMPLE TYPE
0	SP		Gray, fine to medium SAND with gravel and cobbles, moist. [FILL?]	
3	ML SM		Reddish brown, silty SAND with gravel and silt lenses, moist.	
	GP		Lens of brown GRAVEL with sand (one sidewall only)	
	SM		Brown, silty fine to coarse SAND with gravel, moist, some silt lenses.	
6	SP		[FILL?] Brown, fine to coarse SAND with gravel and cobbles, moist.	
9	GW		Gray, well graded GRAVEL with fine to coarse sand and cobbles, moist.	
12	Test pit terminated at about 10 feet below the ground surface. No ground water encountered during this exploration.			
15

PHOTOGRAPH OF TEST PIT

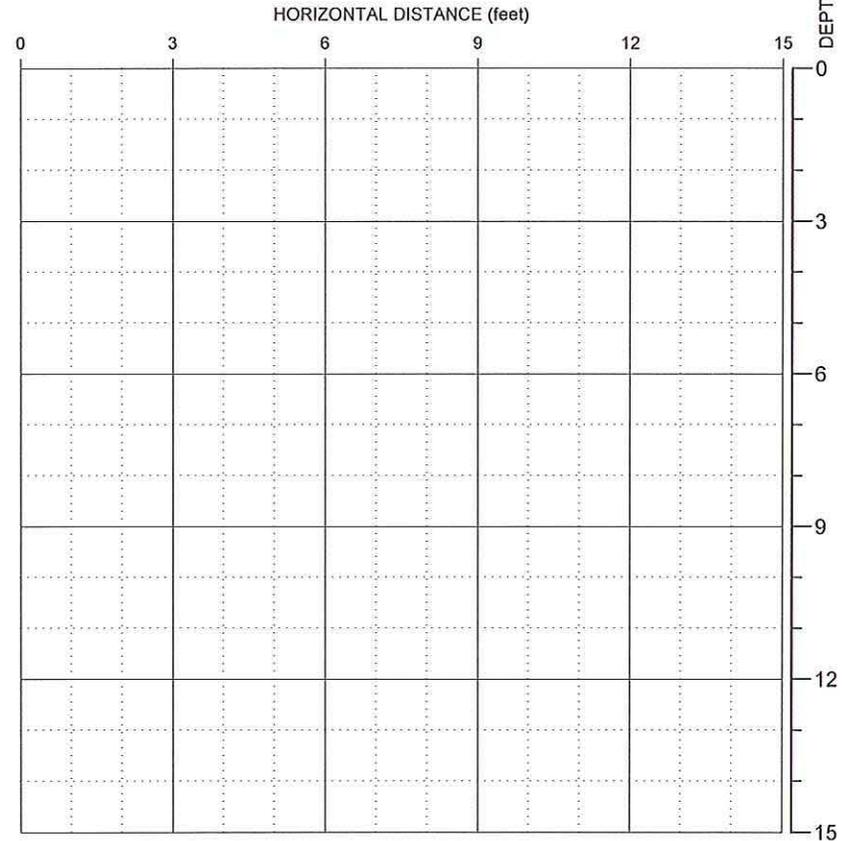
SKETCH OF SIDE OF PIT

DEPTH (feet)	SYMBOL	USCS SOIL CLASS.	DESCRIPTION	SAMPLE TYPE	SAMPLE NUMBER	MOISTURE CONTENT (%)	OTHER TESTS	GROUNDWATER
0			Forest duff, roots to 3 feet.					
0 - 3	SP		Loose gray and brown fine to medium SAND, moist. Slightly stratified, but no silt layers.  (OUTWASH)	○				
3 - 6			Loose, gray fine to medium SAND, some gravel and cobbles, moist.	○				
6 - 15			Test pit terminated at about 8 feet below the ground surface. No ground water encountered during this exploration. No caving observed.

TP-7 - This area, located at the edge of a steep (40 percent slope) bluff, is mapped as Alpine or Advance Outwash by Logan (2003), and Advance Outwash by Shannon & Wilson (1978). The soils map indicates Hoodspout (till-derived) soils in this area (Ness and Fowler, 1960). Areas uphill of TP-7, on flatter ground, are generally mapped as glacial till. Test pit TP-7 encountered clean, sandy outwash soils. Ground water was not encountered to a maximum depth of eight feet. Shallow ground water in this area likely follows the steep topography to the east, towards Hood Canal. Water infiltrated in this area will likely surface along the slope, or at the base of the slope, impacting downslope areas. Although this area has permeable outwash soils, rapid infiltration may not be feasible due to slope stability issues. According to Mason County Resource Ordinance (Ordinance No. 77 - 93), Chapter 17.01.100 – Landslide Hazard Area , Section A and E, “*Any area with a slope of forty percent or steeper and with a vertical relief of ten or more feet except areas composed of consolidated rock is classified as a landslide hazard area and will require a geotechnical report.*” Therefore, HWA recommends additional soil exploration and slope stability evaluation in this area in order to establish feasibility of infiltration.

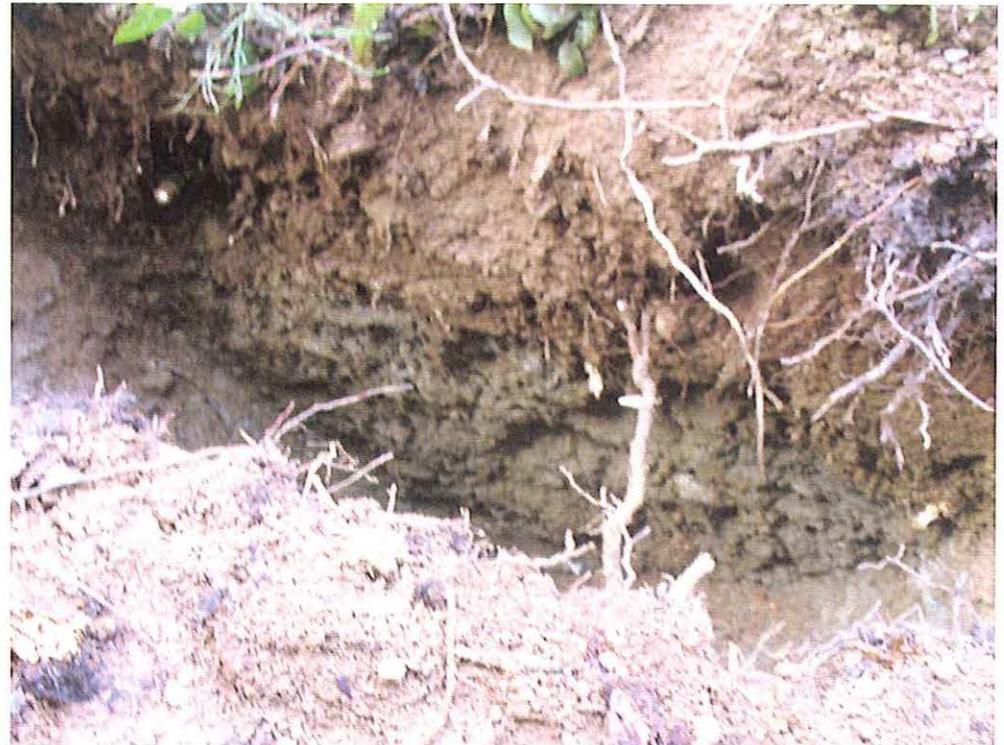
PHOTOGRAPH OF TEST PIT

DEPTH (feet)	SYMBOL	USCS SOIL CLASS.	DESCRIPTION	SAMPLE TYPE
0		ML	Soft, yellow brown to reddish brown, fine to coarse sandy, fine to coarse gravelly, SILT, roots and rootlets. Cobbles noted, organics. (TOPSOIL/WEATHERED TILL)	○
3		ML	Hard, olive gray, fine to coarse sandy, fine to coarse gravelly, SILT, moist. (GLACIAL TILL)	○
6	Test pit terminated at about 5.65 feet below the ground surface. No ground water observed during this exploration.			
9				
12				
15

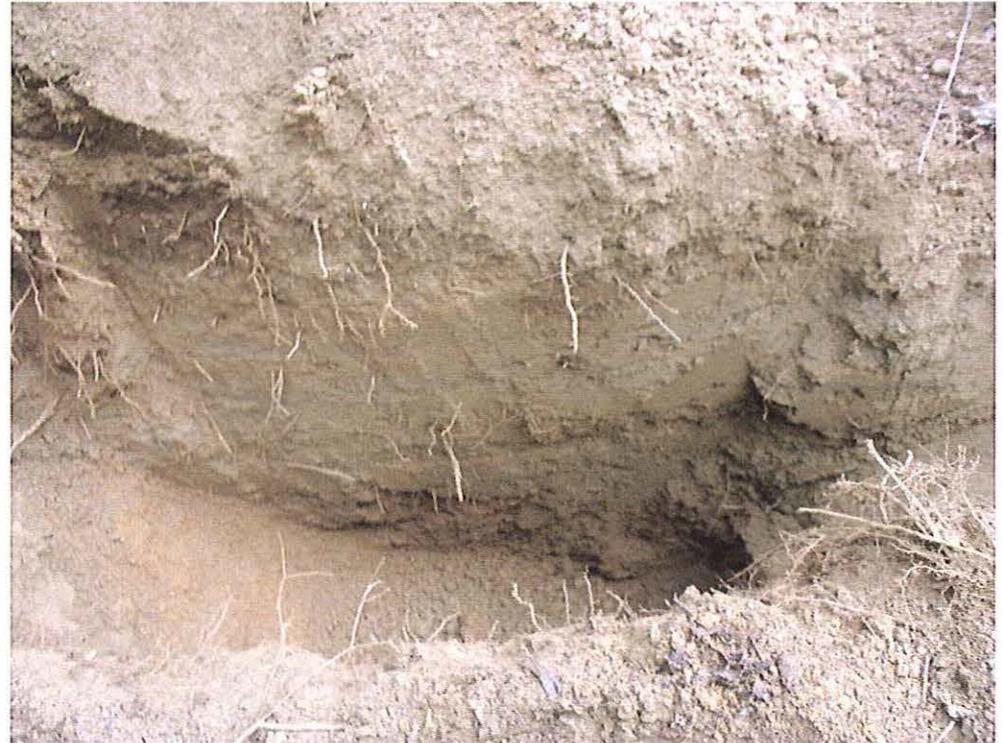
PHOTOGRAPH OF TEST PIT

DEPTH (feet)	SYMBOL	USCS SOIL CLASS.	DESCRIPTION	SAMPLE TYPE
0	SM		Loose, brown, silty, fine gravelly, fine to coarse SAND, roots and rootlets, moist, organics. (TOPSOIL)	○
1	ML		Soft to medium stiff, brown, fine sandy, SILT, scattered gravel, moist, roots and rootlets. Fine to medium sandy seams noted.	○
3	ML SM		(MASS WASTING DEPOSITS/WEATHERED NATIVE?) Alternating layers of medium stiff, brown to reddish, fine to coarse sandy, coarse gravelly, clayey, SILT with brown, silty, fine to coarse gravelly, fine to coarse SAND, moist.	○ ○ ○ ○ ○ ○
6	SM		Medium dense, reddish brown, silty, fine to coarse gravelly, fine to coarse, SAND. (WEATHERED NATIVE?)	○

Test pit terminated at about 7.6 feet below the ground surface.  
 No ground water observed during this exploration.  
 Minor caving observed from about 5.5 to 6 feet below the ground surface.

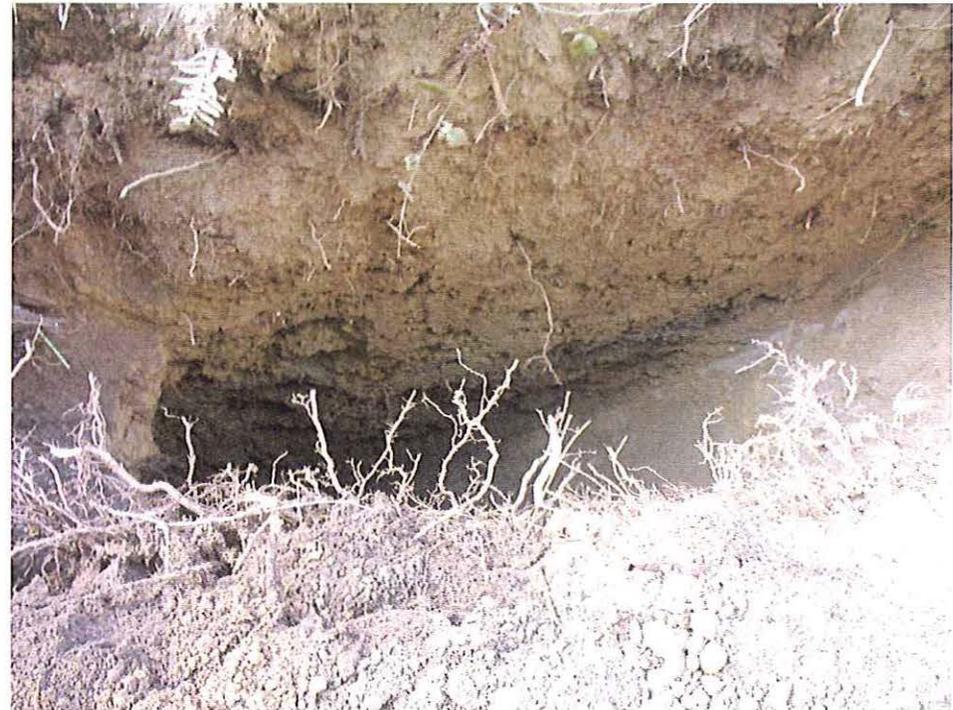
PHOTOGRAPH OF TEST PIT

DEPTH (feet)	SYMBOL	USCS SOIL CLASS.	DESCRIPTION	SAMPLE TYPE
0	SM		Loose, black to dark brown, silty, fine to coarse gravelly, SAND, moist, roots and rootlets.	
	SM		(TOPSOIL)	
	ML SM		Loose, dark brown, silty, fine to coarse gravelly, SAND, moist, roots and rootlets.	
			(WEATHERED TILL)	
3			Soft to medium stiff, reddish brown, fine to coarse gravelly, sandy SILT to silty, SAND, moist to wet. Roots noted.	
	GM		Very dense, gray, silty, fine to coarse sandy, fine to coarse GRAVEL, moist.	
			(GLACIAL TILL)	
6	GP GM		Very dense, gray, olive gray, slightly silty, fine to coarse, sandy, fine to coarse GRAVEL.	
			(ADVANCE OUTWASH)	
9	Test pit terminated at about 8.3 feet below the ground surface. No ground water seepage observed during this exploration.			
12				
15

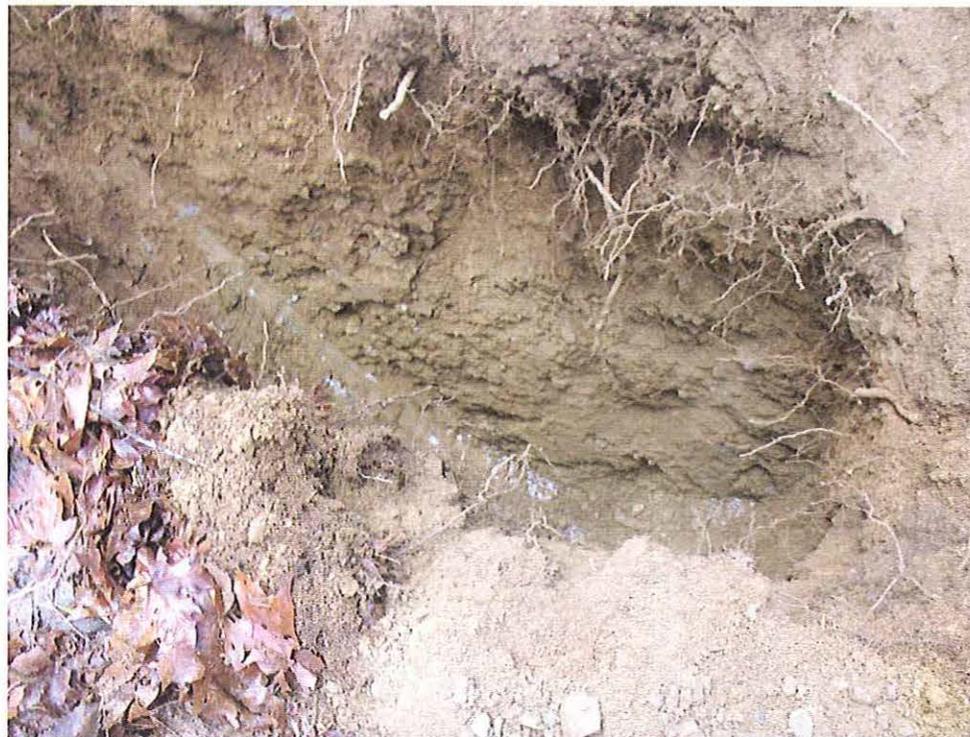
LOG OF TEST PIT  
 TP-10

DEPTH (feet)	SYMBOL	USCS SOIL CLASS.	DESCRIPTION	SAMPLE TYPE
0	ML		Soft, dark brown, fine to coarse sandy, fine to coarse gravelly, SILT, roots and rootlets, moist. <b>(TOPSOIL)</b>	○
3	SM		Loose to medium dense, yellow brown, silty, fine to coarse gravelly, fine to coarse SAND, moist, roots and rootlets. <b>(WEATHERED TILL)</b> Big boulder noted at about 2.5 feet below the ground surface.	○
6	GM		Very dense, gray, fine to coarse sandy, silty, fine to coarse GRAVEL. Cobbles noted. <b>(GLACIAL TILL)</b>	○
9			Test pit terminated at about 6.9 feet below the ground surface. Minor to moderate seepage observed at about 5.8 feet during this exploration. Minor cavings observed from about 2 to 3.5 feet and from 6 to 6.7 feet below the ground surface.	○
12				○
15				○

PHOTOGRAPH OF TEST PIT

TP10 – This test pit encountered a six foot thick veneer of glacial till over gravel (outwash) to the maximum excavated depth of eight feet. As in TP-2, this area may be suitable for rapid infiltration provided surficial low permeability soils are removed, or the facility is constructed below them. Additional exploration in this area would be required to assess the feasibility of rapid infiltration.

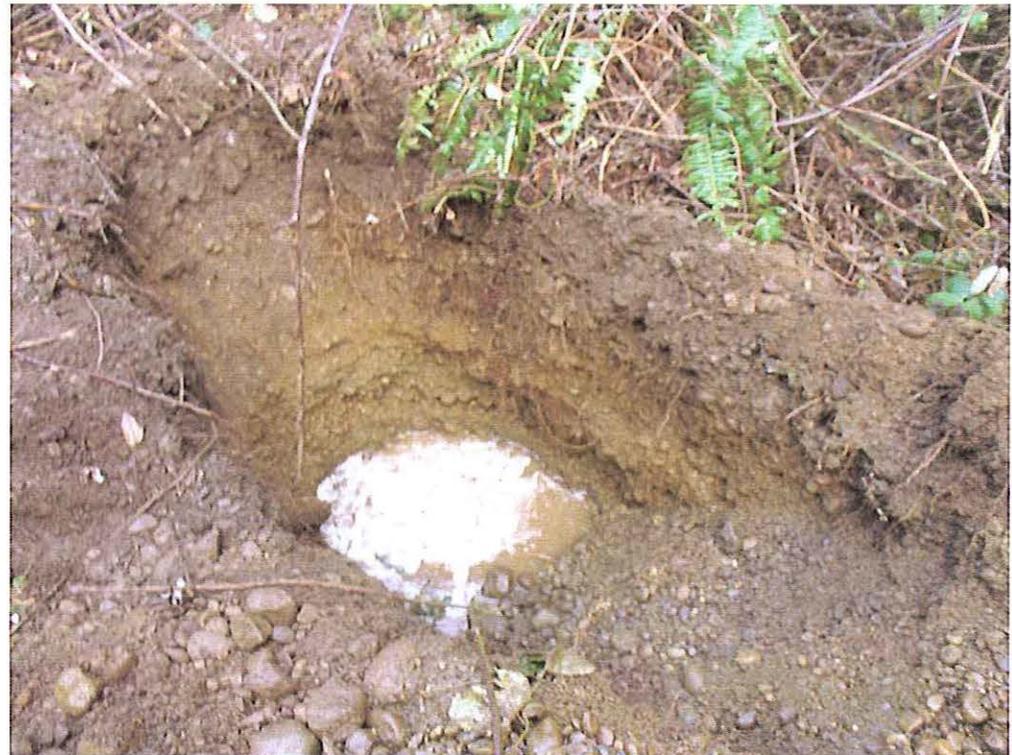
LOG OF TEST PIT  
 TP-11

DEPTH (feet)	SYMBOL	USCS SOIL CLASS.	DESCRIPTION	SAMPLE TYPE
0	ML	ML	Soft, dark brown, fine to coarse gravelly, fine to coarse sandy, SILT, organics, roots and rootlets, moist. (TOPSOIL)	○
3	SM	SM	Loose, brown, silty, fine to coarse gravelly, fine to coarse SAND, organics, moist, roots and rootlets. (WEATHERED OUTWASH)	○
3	SW	SW	Loose, olive gray, fine to coarse gravelly, fine to coarse well graded SAND with cobbles, wet. (RECESSIONAL OUTWASH)	○
6	Test pit terminated at about 5 feet below the ground surface. Moderate to heavy seepage observed at about 4.3 feet during this exploration.			
9				
12				
15

PHOTOGRAPH OF TEST PIT

Soils encountered in the test pits included dense silty sand (glacial till) in TP-11, and loose sand (recessional outwash) in TP-12 and TP-13. Shallow ground water was encountered in all three test pits, ranging from three to four feet below grade in TP-12 and TP-13, and 6 feet below grade in TP-11. Ground water, where encountered, is noted on the test pit logs. HWA conducted this study in winter, during a period of high seasonal ground water. Soil moisture/ground water conditions will likely change in response to rainfall, time of year, creek stage, and other factors. Shallow ground water gradient in this area is likely to the east, following topography.

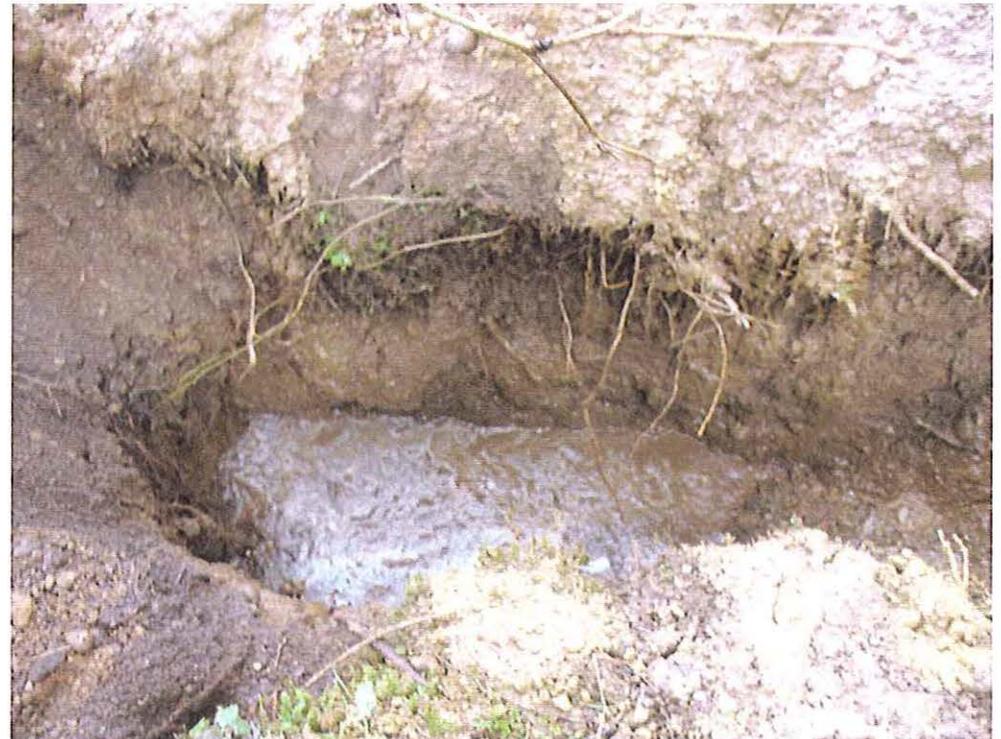
PHOTOGRAPH OF TEST PIT

DEPTH (feet)	SYMBOL	USCS SOIL CLASS.	DESCRIPTION	SAMPLE TYPE
0	SM		Loose, dark brown, silty, fine to coarse gravelly, fine to coarse SAND, roots and rootlets, moist. <b>(TOPSOIL)</b>	○
3	SM		Loose, reddish brown, silty, fine to coarse SAND, scattered gravel, moist to wet. <b>(WEATHERED OUTWASH)</b>	○
6	SW		Loose, olive gray, fine gravelly, fine to coarse well graded SAND, wet. <b>(RECESSIONAL OUTWASH)</b>	○

Test pit terminated at about 5 feet below the ground surface.  
 Heavy seepage observed at about 3.75 feet during this exploration.  
 Moderate caving observed from about 2 to 2.8 feet below the ground surface.

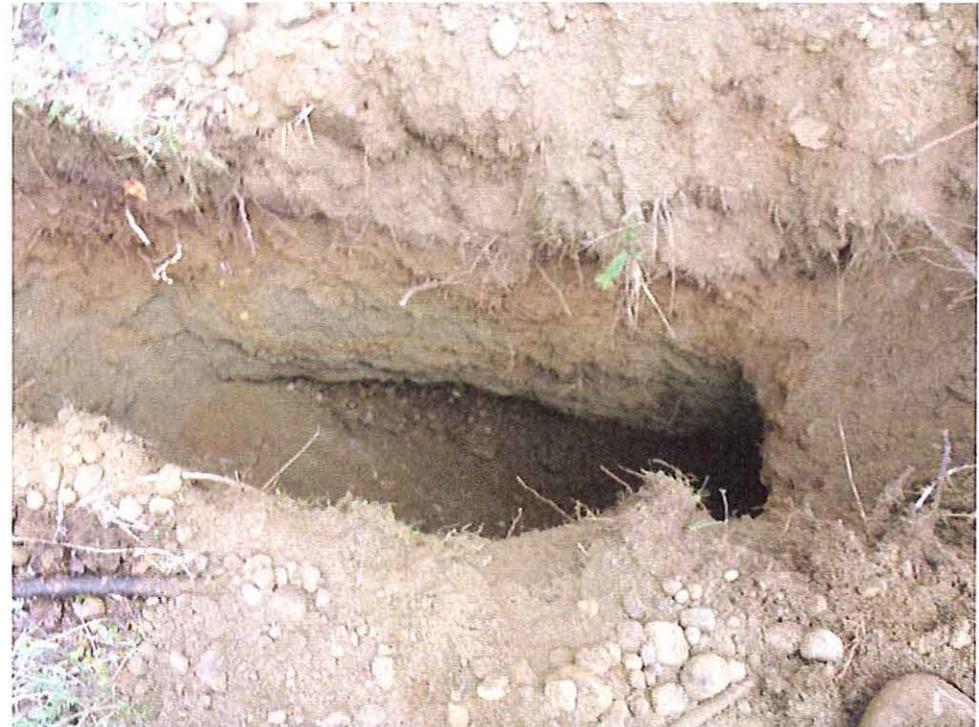
PHOTOGRAPH OF TEST PIT

DEPTH (feet)	SYMBOL	USCS SOIL CLASS.	DESCRIPTION	SAMPLE TYPE
0	SM		Loose, olive gray, silty, fine gravelly, fine to coarse SAND, organics, moist.	
	ML SM		(TOPSOIL) Soft, reddish brown, fine to coarse gravelly, fine to coarse sandy, SILT to fine to coarse SAND, roots and rootlets. Cobbles, boulders noted.	
3	SP		(WEATHERED OUTWASH) Medium dense, olive gray, slightly silty, fine to coarse gravelly, fine to coarse SAND. (ADVANCE OUTWASH?) Sand becoming coarse.	
6	GP		Medium dense, brown to olive brown, slightly silty, fine to coarse sandy, fine to coarse GRAVEL, moist.	
9	GW		Medium dense, olive gray, slightly silty, fine to coarse, well graded GRAVEL with fine to medium SAND, moist.	
12			Test pit terminated at about 9.25 feet below the ground surface. No ground water encountered during this exploration. Moderate caving observed from about 4.5 to 8 feet.	
15

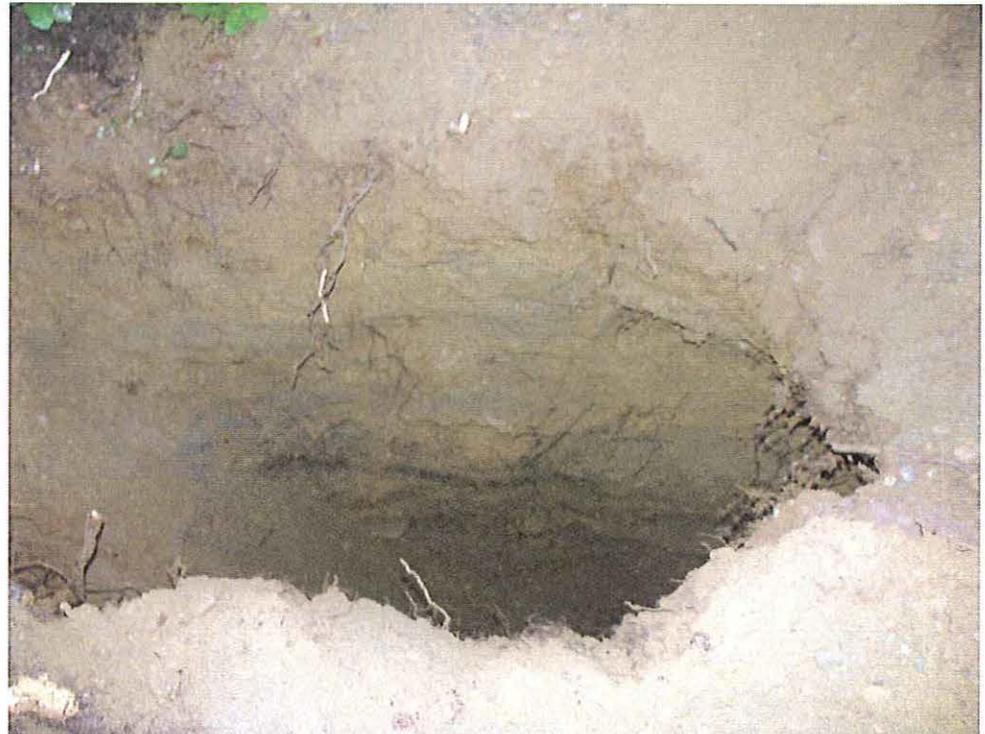
PHOTOGRAPH OF TEST PIT

DEPTH (feet)	SYMBOL	USCS SOIL CLASS.	DESCRIPTION	SAMPLE TYPE
0	SM		Loose, brown, silty, fine gravelly, fine to medium SAND, organics, moist, roots and rootlets.	○
	SM		(TOPSOIL) Loose to medium dense, laminated, olive gray and olive brown, slightly silty, fine to coarse gravelly, fine to coarse SAND, moist, roots and rootlets. (WEATHERED OUTWASH)	○
3	SP		Loose to med. dense, olive gray, sl. silty, fine to med. SAND, moist. Scattered fine to coarse gravel.	○
	SP		(ADVANCE OUTWASH?)	○
	SM		Loose to medium dense, olive gray, slightly silty, fine to coarse gravelly, fine to medium SAND, moist. Traces of till noted.	○
6	GW			○
	GP		Loose to medium dense, olive gray, slightly silty, well graded GRAVEL with fine to medium SAND, moist. Traces of till noted.	○
			Medium dense, olive brown, fine to medium sandy, fine to coarse GRAVEL, moist. Cobbles noted.	○
9				
12				
15

Test pit terminated at about 8.75 feet below the ground surface.  
 No ground water encountered during this exploration.  
 Moderate caving observed from about 1.5 to 3.0 feet.

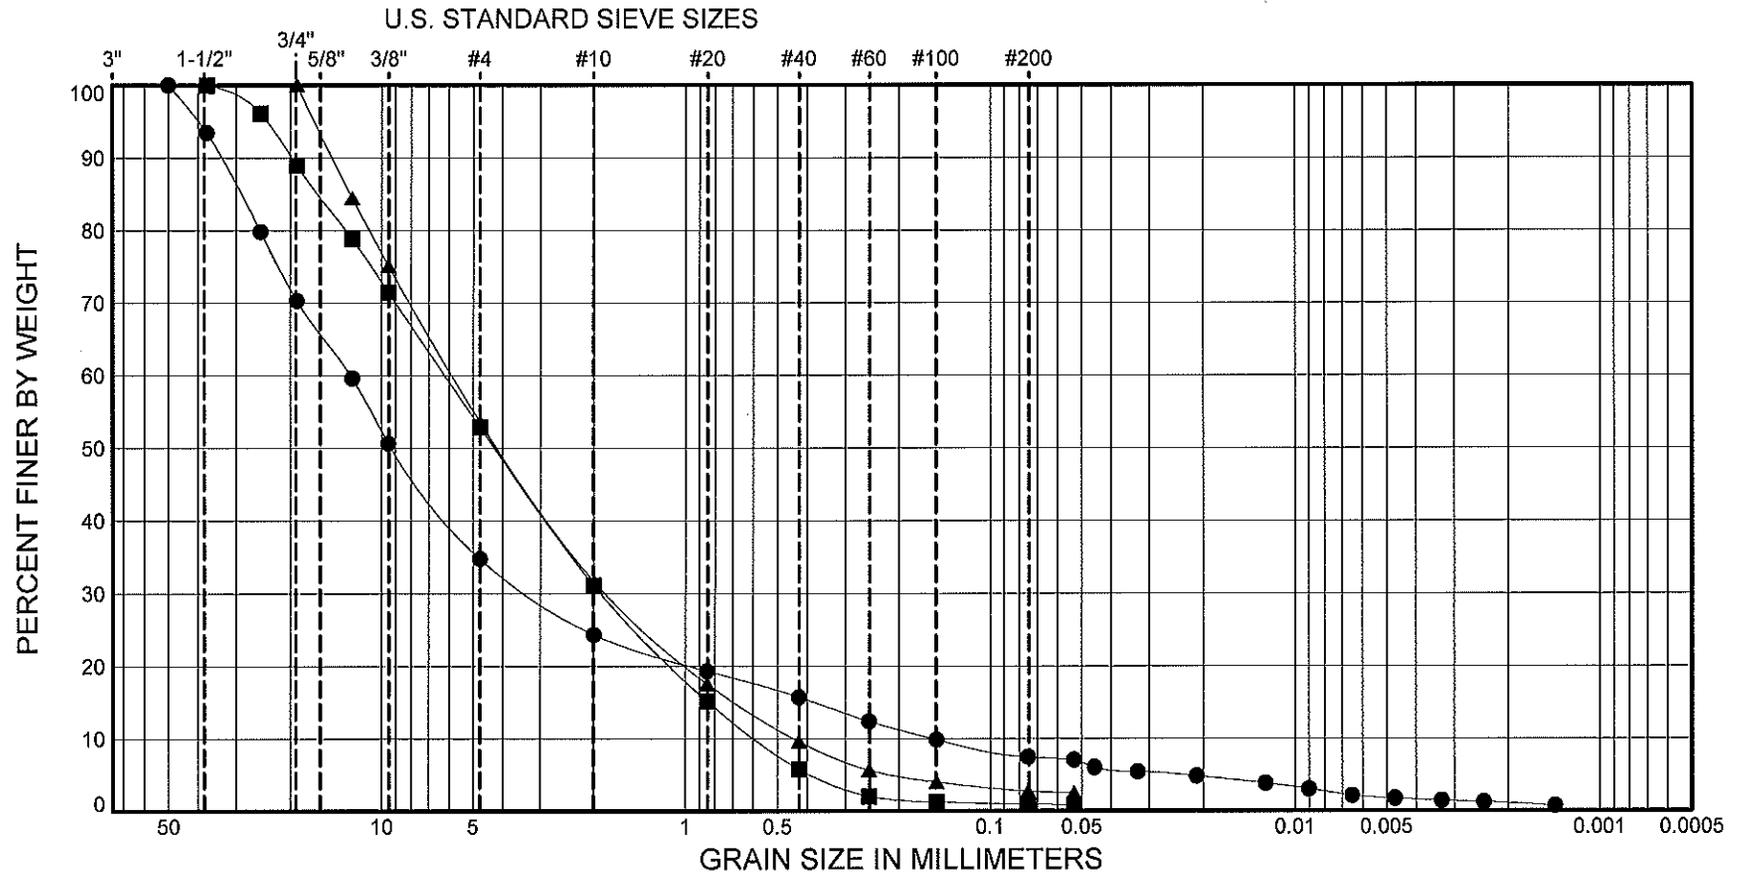
The grain size distribution of selected soil samples was determined in general accordance with ASTM D 422. Grain size distribution curves for the tested samples are presented in figures B-1 through B-4.

SYMBOL	SAMPLE	DEPTH (ft)	CLASSIFICATION OF SOIL- ASTM D2487 Group Symbol and Name	% MC	LL	PL	PI	Gravel %	Sand %	Fines %
●	TP-10	S-7	7.6 - 8.1 (GP-GM) Brown, poorly graded GRAVEL with silt and sand	7				65.3	27.3	7.4
■	TP-12	S-3	4.0 - 4.5 (SW) Brown, well graded SAND with gravel	13				47.1	52.0	0.9
▲	TP-13	S-3	4.5 - 4.8 (SW) Brown, well graded SAND with gravel	15				46.4	50.9	2.7

Infiltration rates can be estimated from grain size distribution data using the USDA textural analysis approach. HWA analyzed 11 soil samples collected from test pits for grain size distribution and textural classification in accordance with ASTM test procedures, corrected to approximate the USDA procedures. Table 2 shows the results of the grain size analyses and Appendix B presents the soil laboratory data.

Based on the USDA grain size method, laboratory test results indicate estimated long-term infiltration rates of two in/hr for most of the sandy soils encountered in our explorations at the Parks campground, Parks drainfield, and at TP-4 and TP-6 in the north Reservation area. USDA infiltration rates at the new housing area range from 0.25 to 0.5 in/hr at TP-10 and TP2, respectively.

Based on the ASTM grain size method, our laboratory test results indicate estimated infiltration rates of up to 9 in/hr for sandy soils encountered at the Parks campground, TP-2, TP-4, and TP-6; ranging from 2 to 6 in/hr at the Parks Drainfield; and 2.4 in/hr at TP-10.

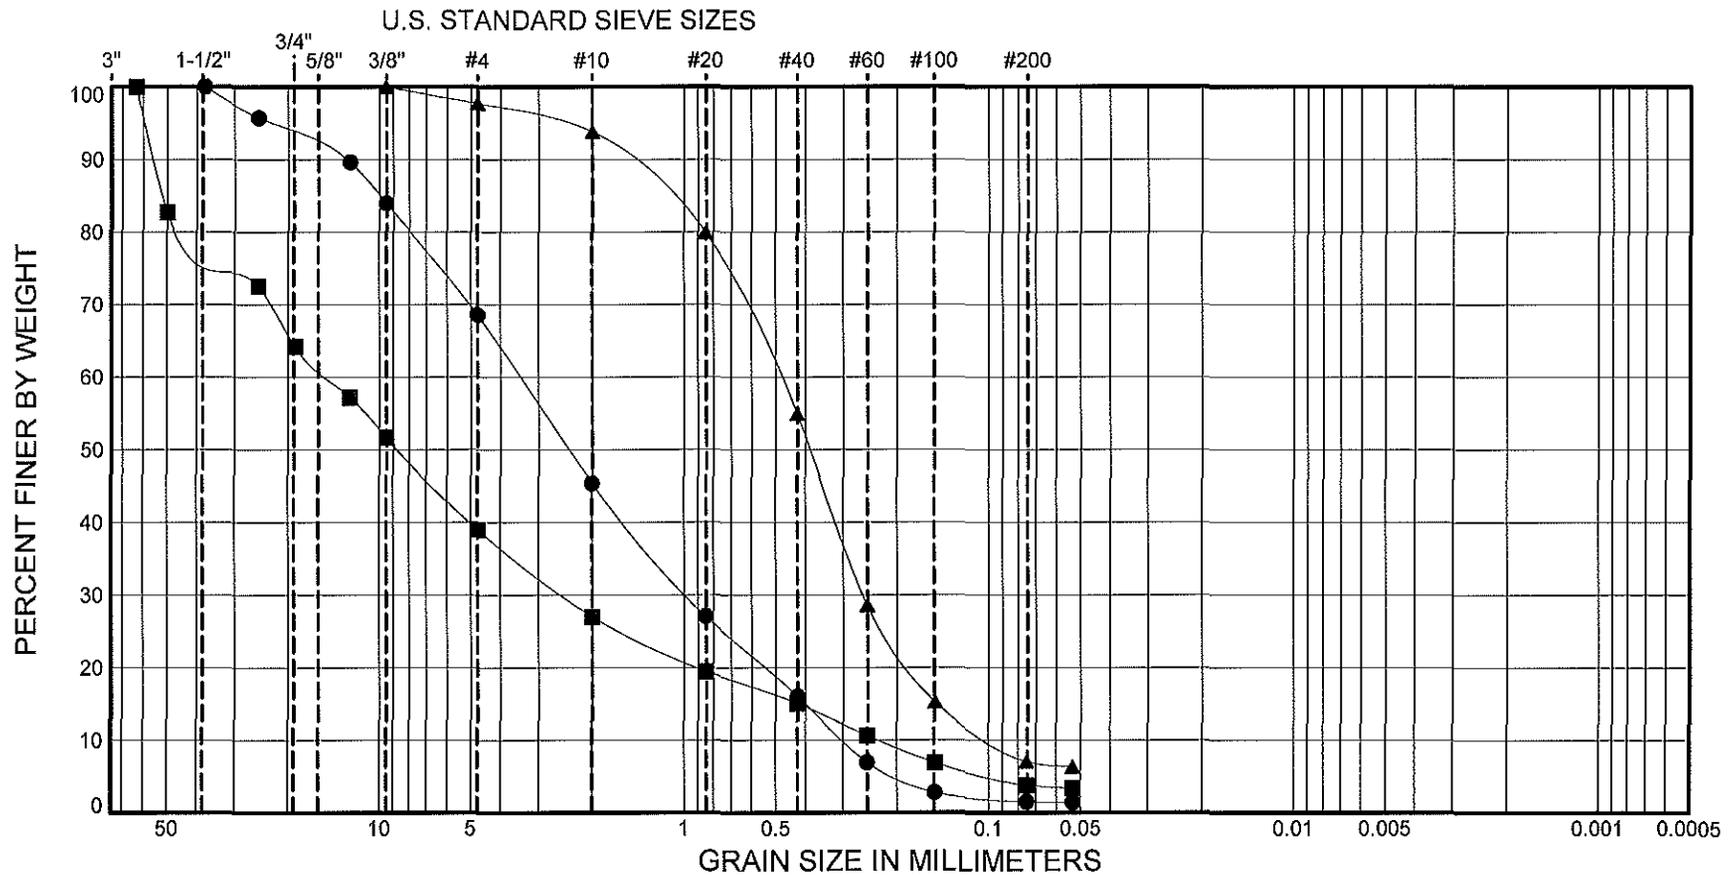
SYMBOL	SAMPLE	DEPTH (ft)	CLASSIFICATION OF SOIL- ASTM D2487 Group Symbol and Name	% MC	LL	PL	PI	Gravel %	Sand %	Fines %
●	TP-14 S-2	2.5 - 3.5	(SP) Brown, poorly graded SAND with gravel	7				31.5	67.0	1.5
■	TP-14 S-5	8.5 - 9.0	(GW) Brown, well graded GRAVEL with sand	6				61.0	35.2	3.8
▲	TP-15 S-3	3.5 - 4.0	(SP-SM) Brown, poorly graded SAND with silt	14				2.3	90.7	7.0
