# HWA GEOSCIENCES INC.

HWA Project No. 2006-172-300

Subject: **INFILTRATION EVALUATION  
WATER QUALITY PROJECT PLANNING  
POTLATCH "BUBBLE" AND CORE RESERVATION PLANNING AREAS  
MASON COUNTY, WASHINGTON**

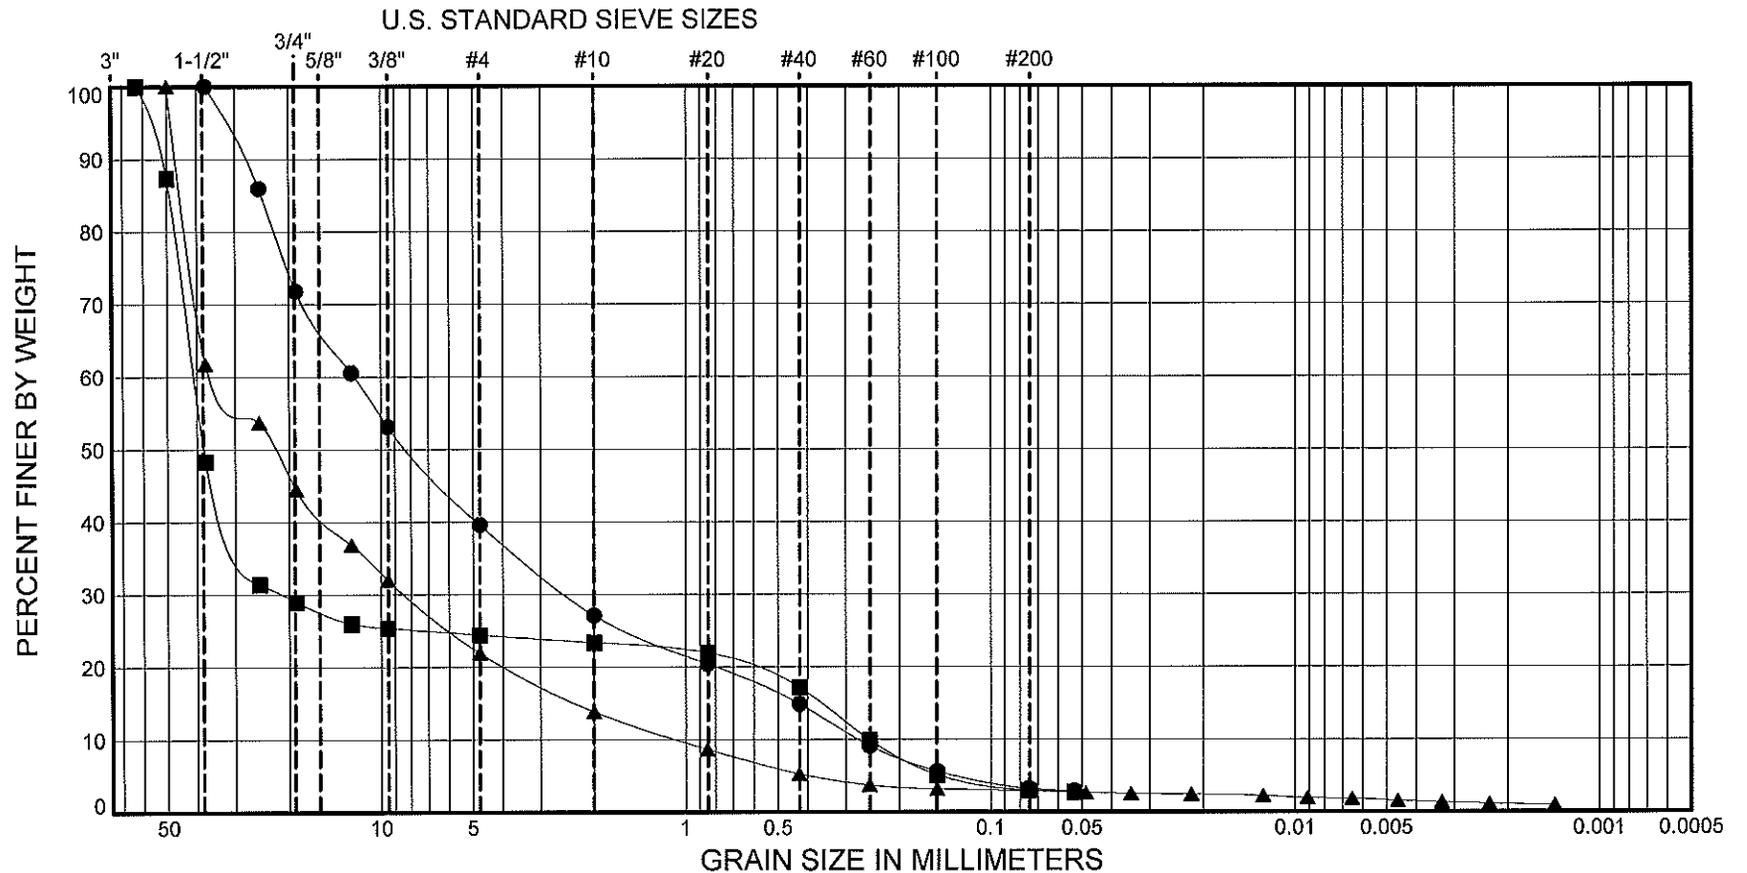
PARTICLE-SIZE ANALYSIS  
OF SOILS  
METHOD ASTM D422

SYMBOL	SAMPLE	DEPTH (ft)	CLASSIFICATION OF SOIL- ASTM D2487 Group Symbol and Name	% MC	LL	PL	PI	Gravel %	Sand %	Fines %
●	TP-15 S-4	5.3 - 5.5	(GW) Brown, well graded GRAVEL with sand	6				60.4	36.4	3.2
■	TP-15 S-5	6.5 - 6.8	(GP) Brown, poorly graded GRAVEL with sand	6				75.6	21.4	2.9
▲	TP-2	6.0 - 6.5	(GP) Brown, poorly graded GRAVEL with sand	4				78.1	19.0	2.9

Infiltration rates can be estimated from grain size distribution data using the USDA textural analysis approach. HWA analyzed 11 soil samples collected from test pits for grain size distribution and textural classification in accordance with ASTM test procedures, corrected to approximate the USDA procedures. Table 2 shows the results of the grain size analyses and Appendix B presents the soil laboratory data.
