WEBB HILL BIOSOLIDS FACILITY HYDROGEOLOGIC INVESTIGATION - PHASE 1 Mason County, Washington

**Prepared for: Mason County Department of Community Development,
on behalf of WRIA 16 Planning Unit**

Project No. 070041-001-01 • September 6, 2007

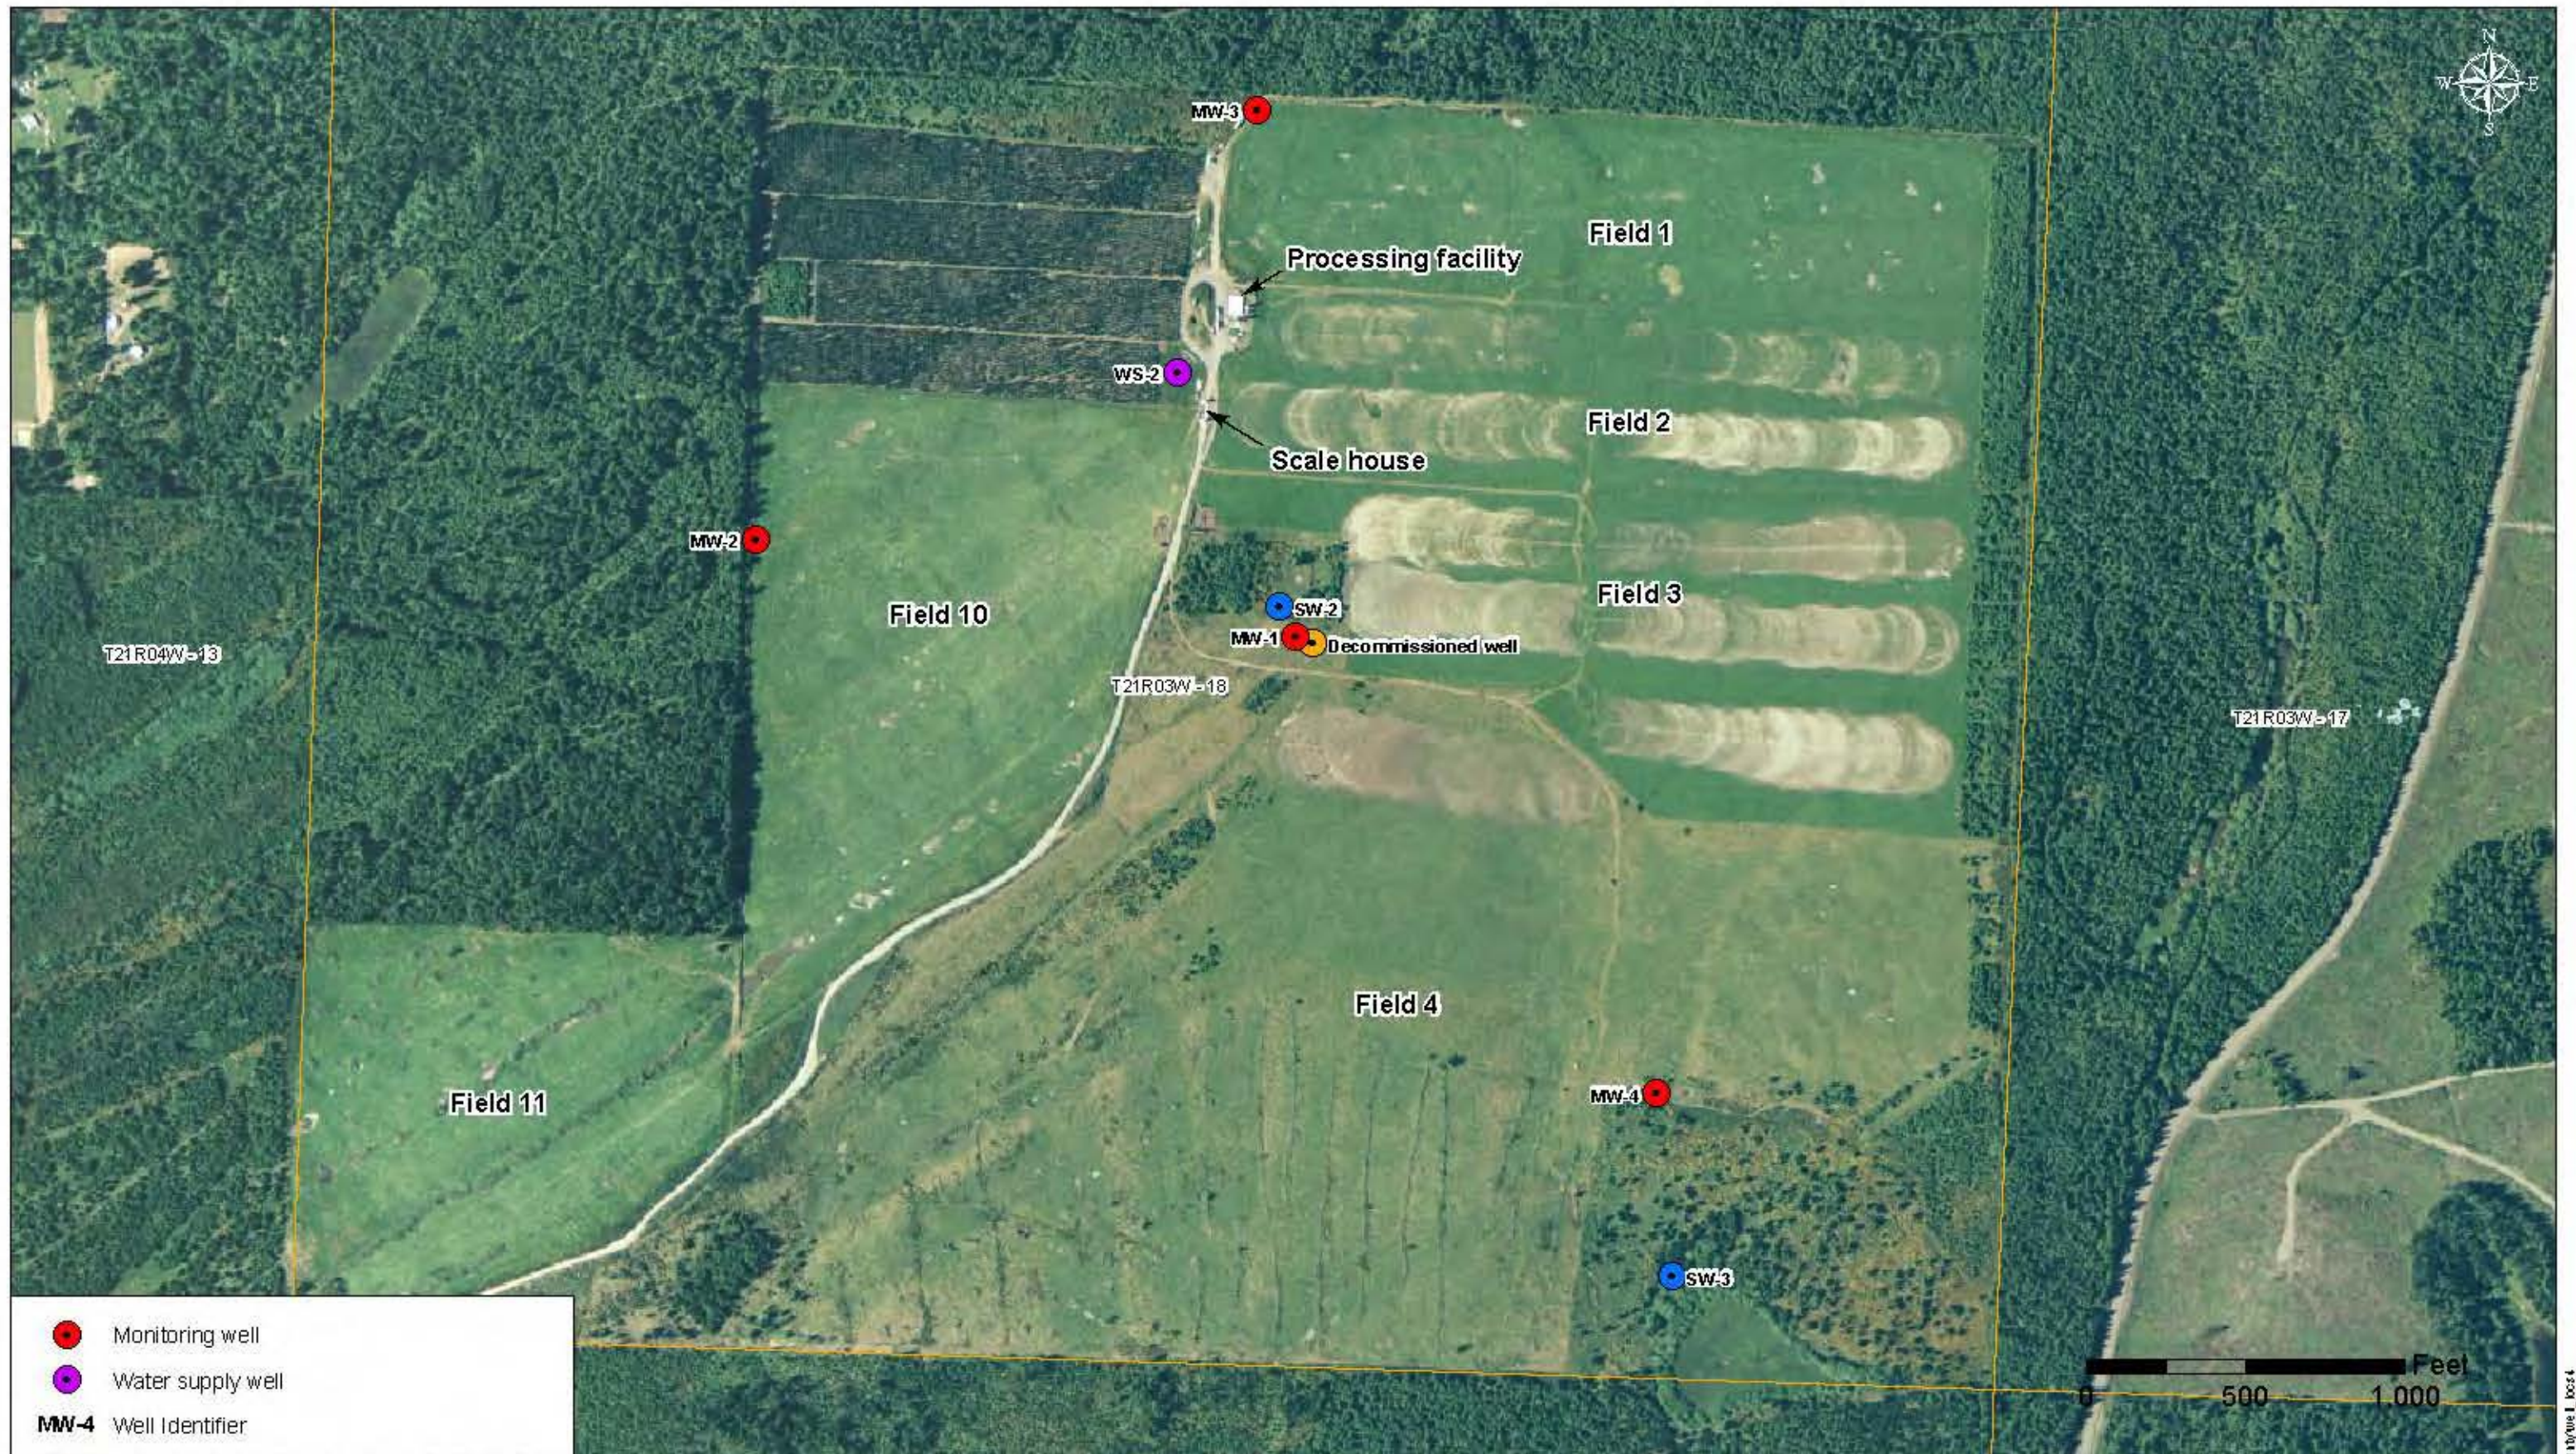
DATE:	June 2007	PROJECT NO.:	070041
DRAWN BY:	EWM	FIGURE NO.:	1.2
CHECKED BY:	ACM		
APPROVED BY:	ACM

- Monitoring well
- Water supply well
- MW-4** Well Identifier
- Decommissioned well (location approximate)
- Surface water sample location
- Sections

Monitoring well MW-1 lies down gradient of application fields 1, 2 and 3 (Figures 1.2 and 4.2) and shows degraded water quality in comparison to background well MW-3. This well exhibited the greatest nitrate concentration (13.3 mg/L) of the monitored wells. Relative to background conditions at MW-3, the pH (6.7) and dissolved oxygen (8.85 mg/L) were depressed and specific conductance (374 umhos/cm) elevated.

lies downgradient of the east portion of field 4 (Figures 1.2 and 4.2). Similar to well MW-1, dissolved oxygen and pH were depressed relative to background conditions and specific conductance was elevated. Changes in dissolved oxygen, pH, and specific conductance between MW-3 and MW-4 were similar to the changes between MW-3 and MW-1.
