# Fecal Coliform Monitoring in the Hoodspout Area 2003-2006

Prepared by:  
Stephanie Kenny

Mason County Health Services  
Shelton, WA

October 2006

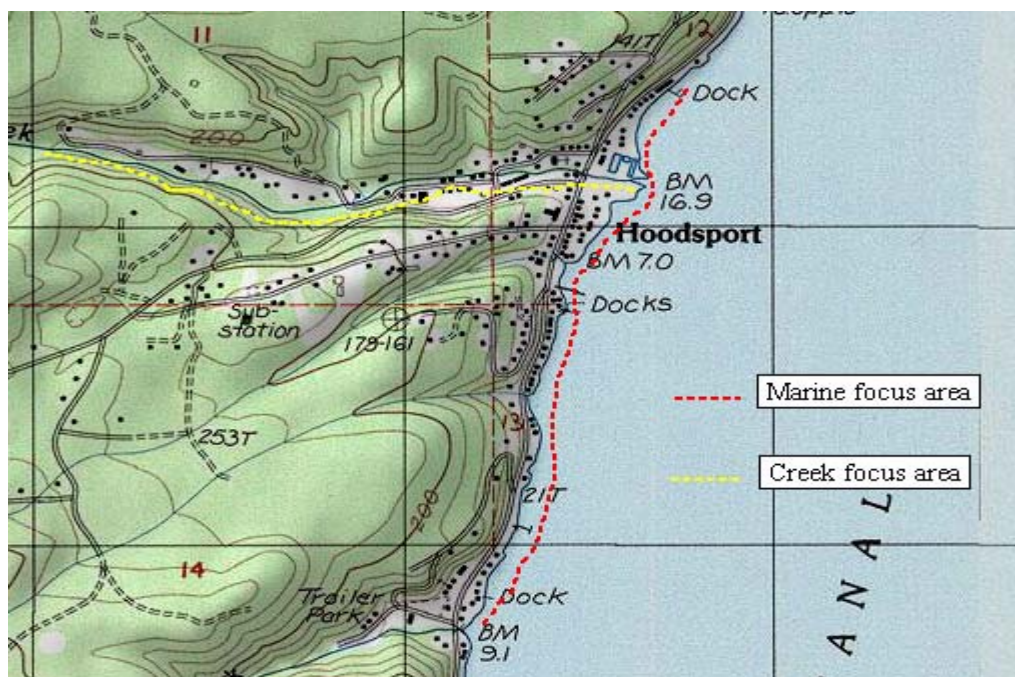
Figure 1. Beach and Creek Focus Areas

The study had two focus areas. The first area was approximately 1.1 mile of marine shoreline along US Highway 101 between the 23400 block and the 24500 block. The second focus area was lower Finch Creek from the point at which it enters the residential area along Finch Creek Road to the mouth of the creek. See Figure 1.

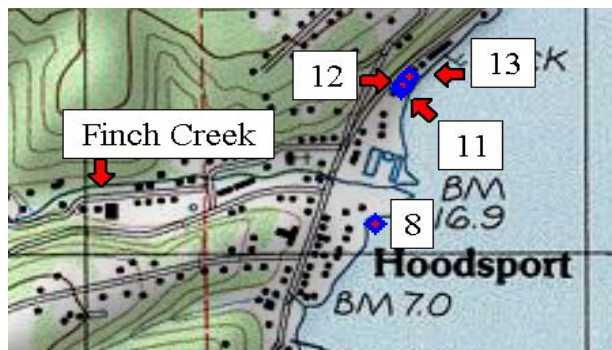
Figure 2. Residential Sources

Stations 11,12, and 13 are residential source stations with poor water quality. Station 8 should probably also be included in this group, although it is located in a commercial area the primary influence on the sampling station are residential . See Figure 2.

The primary sources of fecal contaminants from these stations are likely to be residential septic, pet waste and wildlife waste from the area immediately surrounding the sample station.

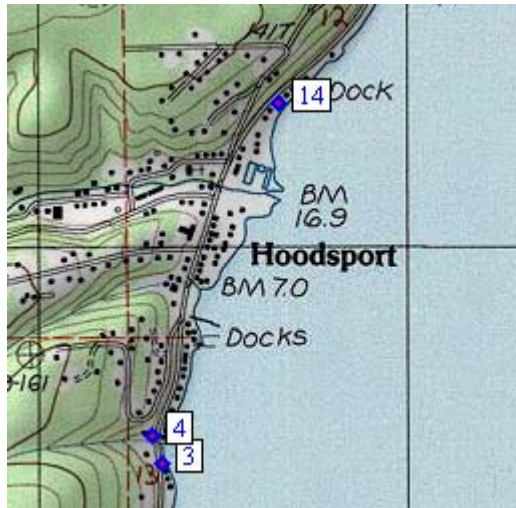
Figure 3. Residential Stormwater Sources

Stations 3, 4 and 14 are residential stormwater source stations with poor water quality. See Figure 3. The primary sources of fecal contaminants from these stations is likely to be pet waste and wildlife waste that has been flush into the stormwater drainage system from the surrounding area. Residential septic may also be a contribute.

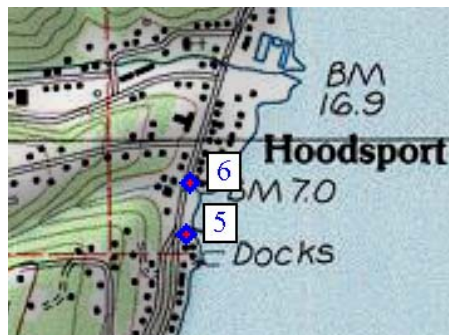
Figure 4. Commercial Stormwater Sources

Stations 5 and 6 are commercial stormwater source stations with poor water quality. See Figure 4. These station drain to the beach from the commercial development on the shoreline just south of Lake Cushman Rd. Pet and wildlife waste would be likely sources of contamination draining to these stations. Commercial septic systems could also contribute. The lack of natural treatment due to large amounts of impervious surface may also add to the fecal coliform loading.

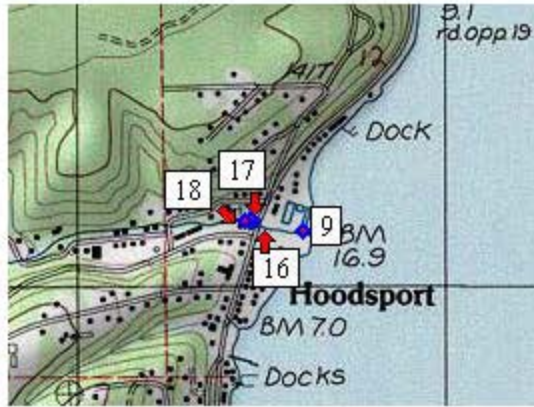
Figure 5. Finch Creek Sources

Stations 9, 16, 17 and 18 are Finch creek stations with poor water quality. See Figure 5. Finch creek meets water quality standards in the residential area along much of Finch Creek Rd., but water quality degrades in the last couple hundred feet as the creek enters the mixed use commercial/residential area.
