Mason County Public Health

Hood Canal Pollution Identification and Correction Project Final Report December 2008

Prepared for Washington State Department of Ecology

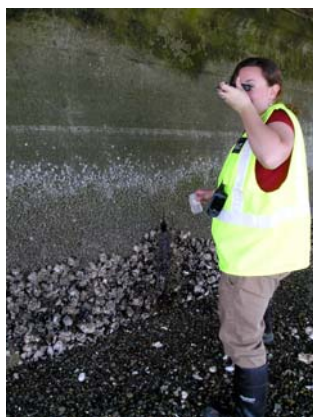
Prior to QAPP development, no salinity readings were taken (as in Kitsap PIC protocols). However, fecal coliform bacteria have reduced life expectancy in water with higher salinity, as reflected in the different state standards for fresh and marine water. Many drainages, including bulkhead drains during outgoing tides, can exceed 20 parts per thousand (ppt). Kathy Krogslund, the University of Washington Marine Chemistry Lab (UWMCL) Manager, uses a range of salinity from 0-25ppt for freshwater, 25-30ppt as transitional, and 30+ppt as marine concentrations. Initially, Mason County Water Quality staff accepted the 0-25 ppt values for freshwater. Staff began taking salinity readings in March 2006 using a Vista A366ATC Refractometer. Early readings were likely skewed to higher levels due to a faulty calibration knob; a new refractometer was purchased and the older instrument was reconditioned by Seattle (Davis) Calibration lab in December 2006. Therefore, salinity readings were absent from July 2005-March 2006, were unreliable from March 2006-December 2006, and were taken regularly with a calibrated Vista A366ATC Refractometer beginning in January 2007.

Using a Refractometer to Determine Salinity

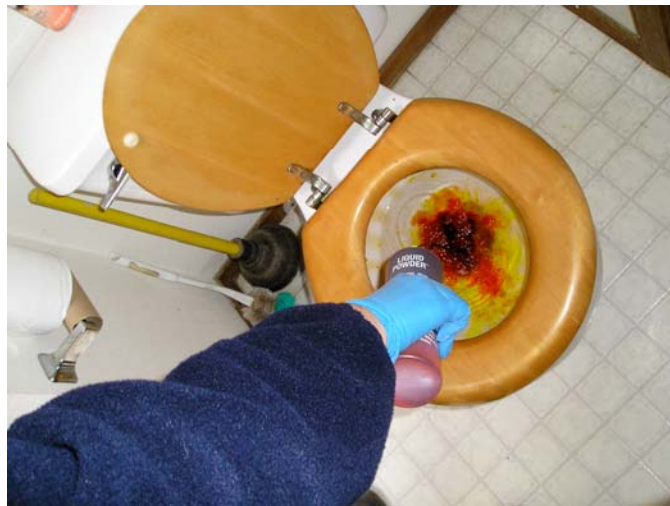
Staff then requested that a dye test be performed; all requested dye tests were permitted. If more than one system in the same vicinity were to be dye tested, different dyes would be used. Similarly, if an OSS was repaired or replaced, a different dye would be used in the follow-up dye test. Fluorescein is a commonly used indicator dye, therefore when dye was found in background charcoal packets, Ozark Underground Laboratory (used for dye analysis) recommended that subsequent results be 10x background to be considered “significant”.

Dye Introduction into an OSS

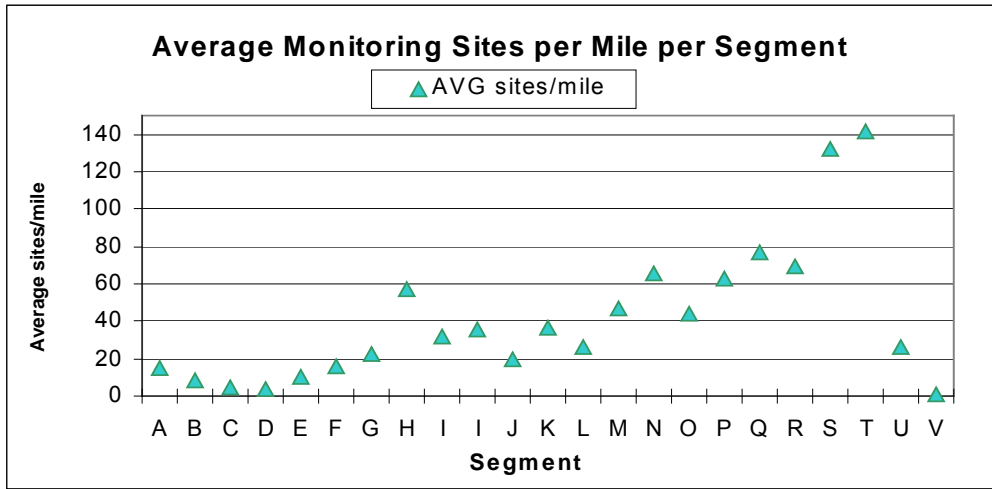
Figure 2. Average Monitoring Locations per Mile

MCPH determined the average monitoring locations per mile, by segment, within the project area (see Figure 2. Average Monitoring Location per Mile). The average sites per mile is useful in determining which segments had the most run-off during the time that MCPH performed the water quality monitoring. Segments with more water are of more concern because of the potential inundation of onsite septic systems (OSS), which can stress or cause failure of the systems. This is especially evident in segment T, which had the highest average elevated fecal coliform sites/mile, and also has the highest amount of identified OSS failures. Since the primary method that MCPH uses to identify an OSS failure requires elevated FC results and a positive dye test, MCPH may not identify an OSS that is failing into the groundwater.

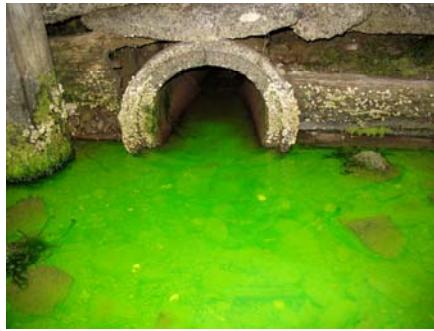
Dye in the Marine Water from an OSS with a Broken Transport Line

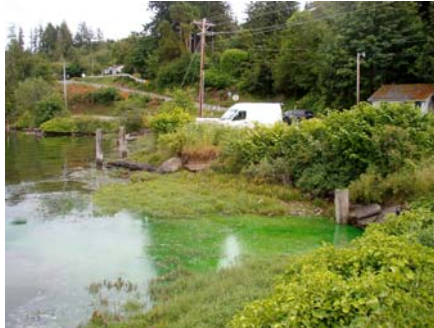
Dye in the Marine Water from an OSS with a Broken Transport Line

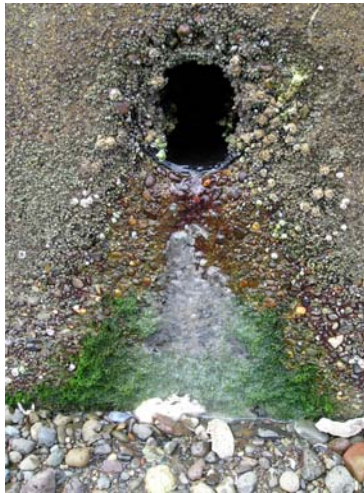
- One (1) OSS failure was visually identified as having a direct discharge out of bulkhead drains combined with elevated fecal coliform results of ≥ 1600 fecal coliform/100-mL of water and elevated nutrient levels of 14.5 mg/L ammonia and 1.34 mg/L of orthophosphate. After attempting to make contact at the property several times, MCPH notified the owner of the failure by mail. The property was a vacation rental that has been vacant since identification of the failure. The owner is trying to sell the property. MCPH has “tagged” the parcel in Tidemark (MC’s Permit tracking database) as having a failing OSS, so that potential buyers can be aware of the current status of the OSS.

OSS effluent flowing out of a Bulkhead Drain into Hood Canal

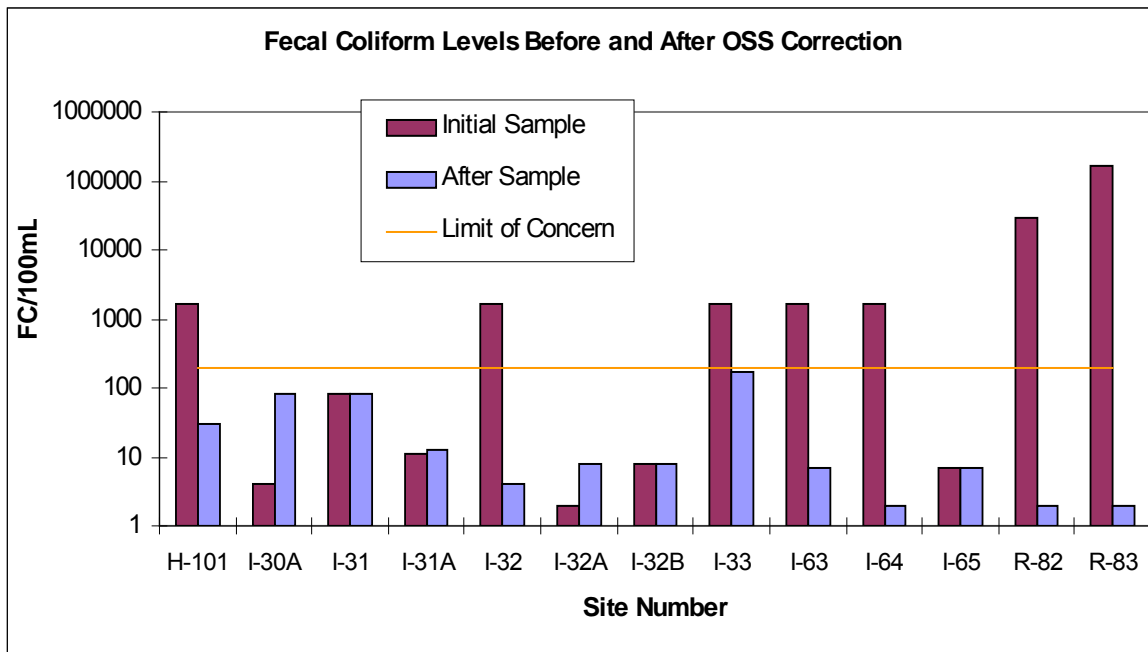
Figure 23. Fecal Coliform Levels Before and After OSS Correction

Note: Logarithmic Scale

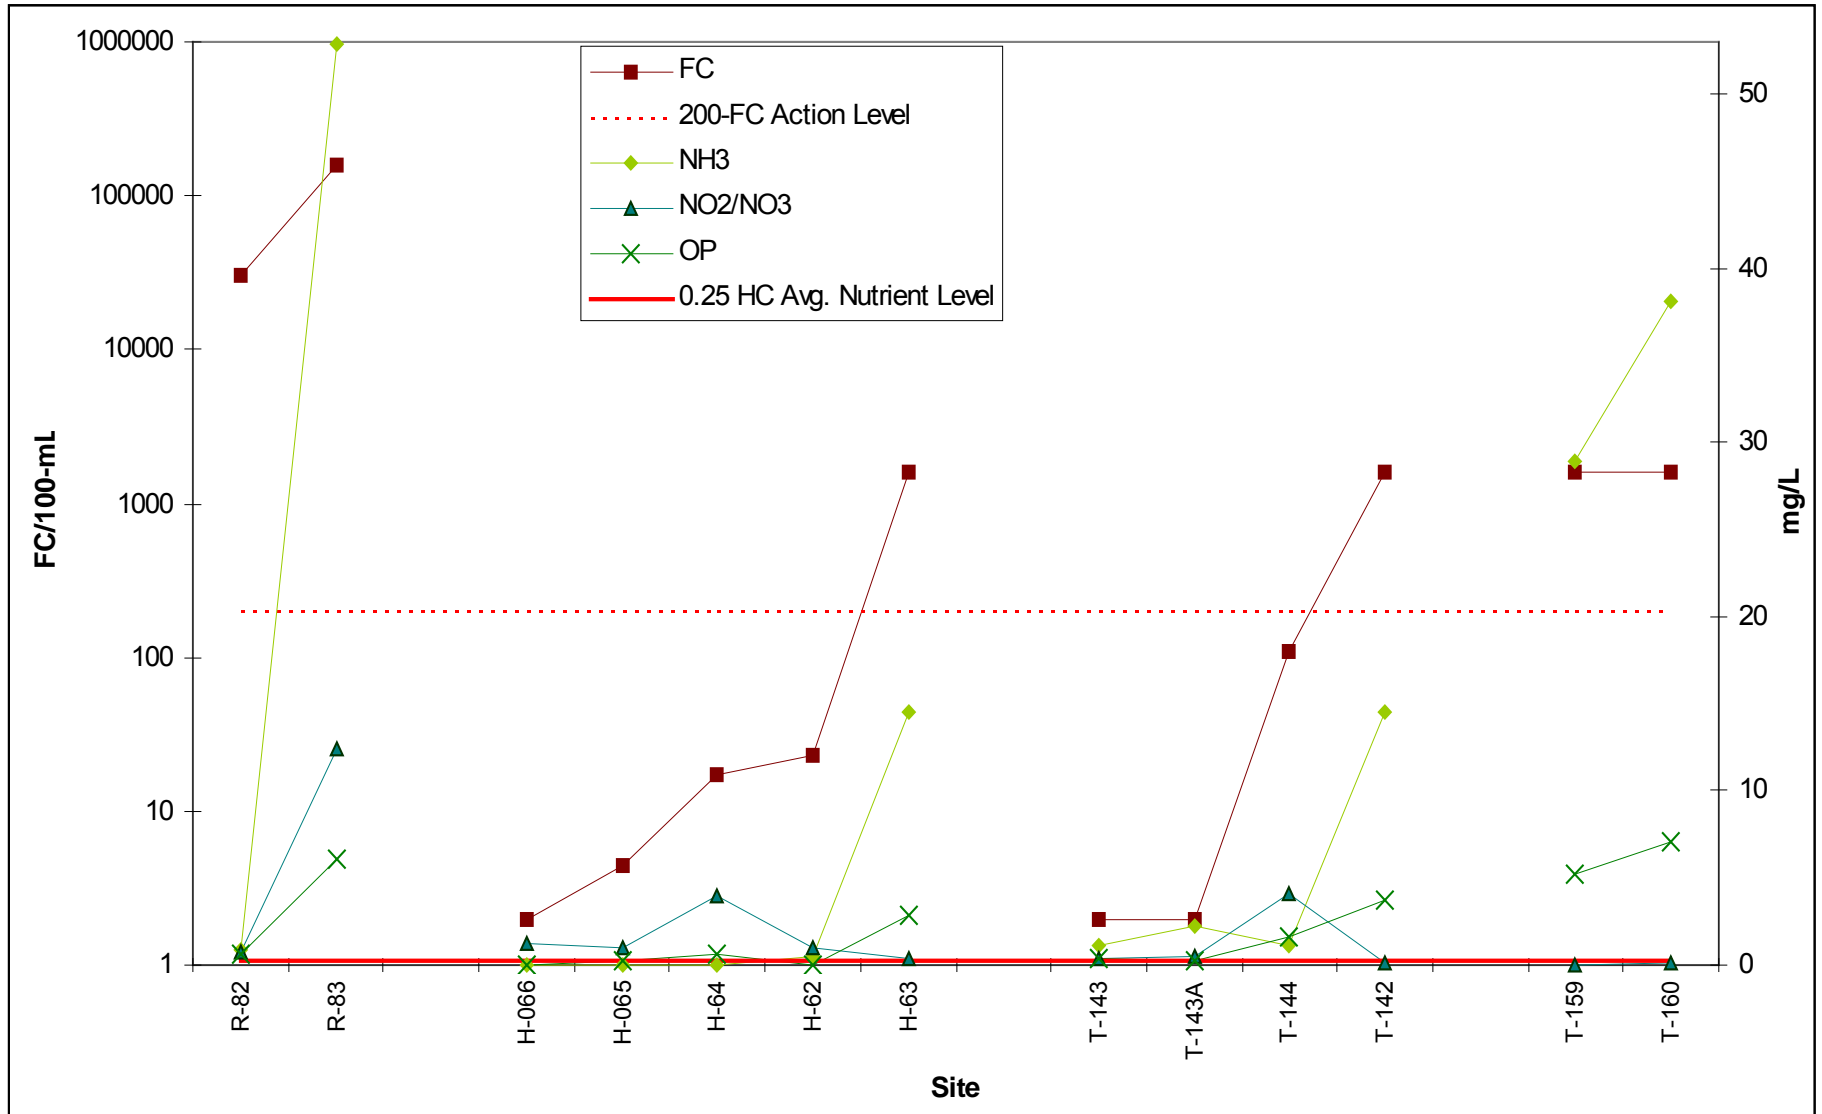
Figure 24. Nutrients (Results >3mg/L) and Fecal Coliform Levels Associated with OSS Failure

Note: FC sale is logarithmic

When these figures were created, 3 mg/L was arbitrarily chosen to optimize the detail of the scale for each sample set. What this accidentally demonstrated in Figure 24, monitoring locations with nutrient results greater than 3mg/L, is that the results for NH₃ and OP are the predominately elevated values. While in Figure 25, monitoring locations with nutrient results less than 3 mg/L, the predominately elevated nutrient results are NO₂/NO₃. MCPH hypothesizes that these results correlate to the distance the failure is from the monitoring location. MCPH recommends that additional analysis be performed to determine the distance from each OSS to the monitoring locations.

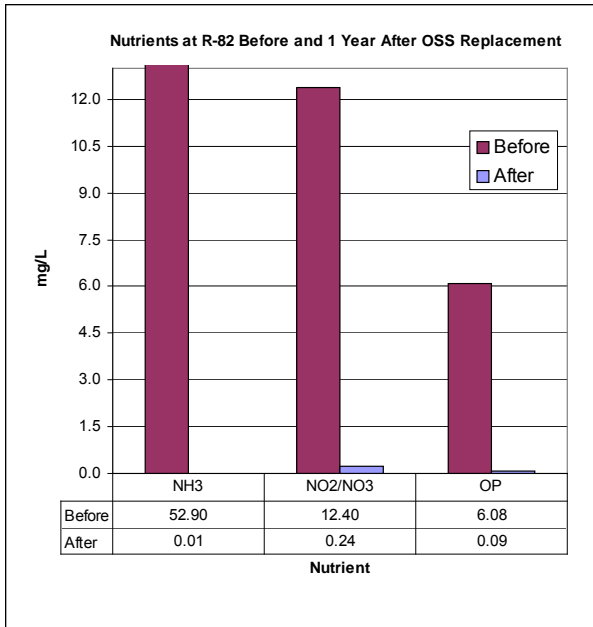
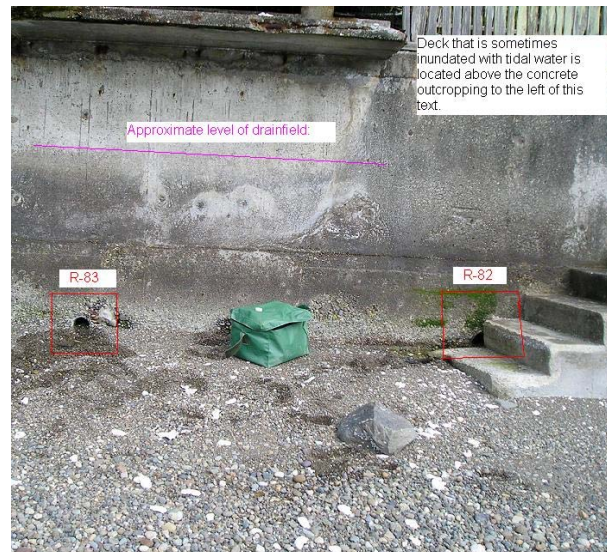
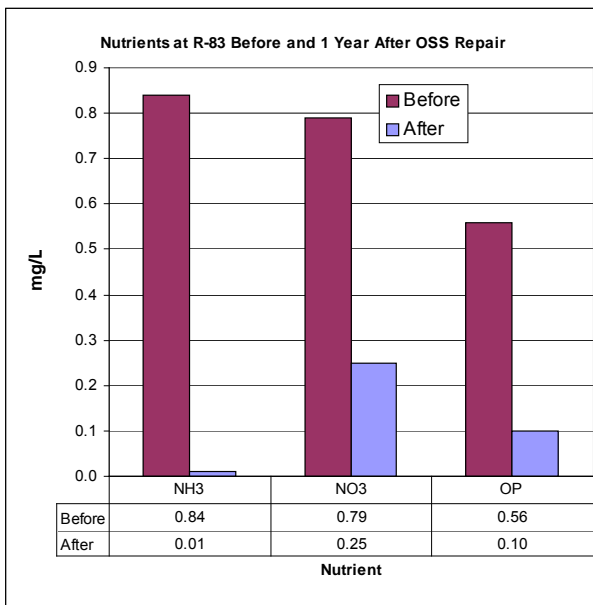
Figures 25 and 26 – Nutrient Results at R-82 and R-83

This property had a gross failure. The OSS was located within 15' of the bulkhead. The OSS was a gravity system. In the photo there are monitoring locations R-82 and R-83, and the approximate location of the OSS (~15' behind the bulkhead). The owner stated that sometimes the marine water would come up over his deck (located above the OSS), meaning that the OSS was most likely directly discharging to Hood Canal.

The initial confirmation fecal coliform results at the monitoring location were 30,000 (R-82) and $\geq 160,000$ (R-83) per 100-mL of water. At these monitoring locations, all of the nutrient results were above the 90th percentile prior to the OSS repair. The nutrient results were significantly more elevated in the R-82 sample than in the R-83 sample. Although both of these monitoring locations had very low flows, the nutrient levels at R-82 may, in part, be due

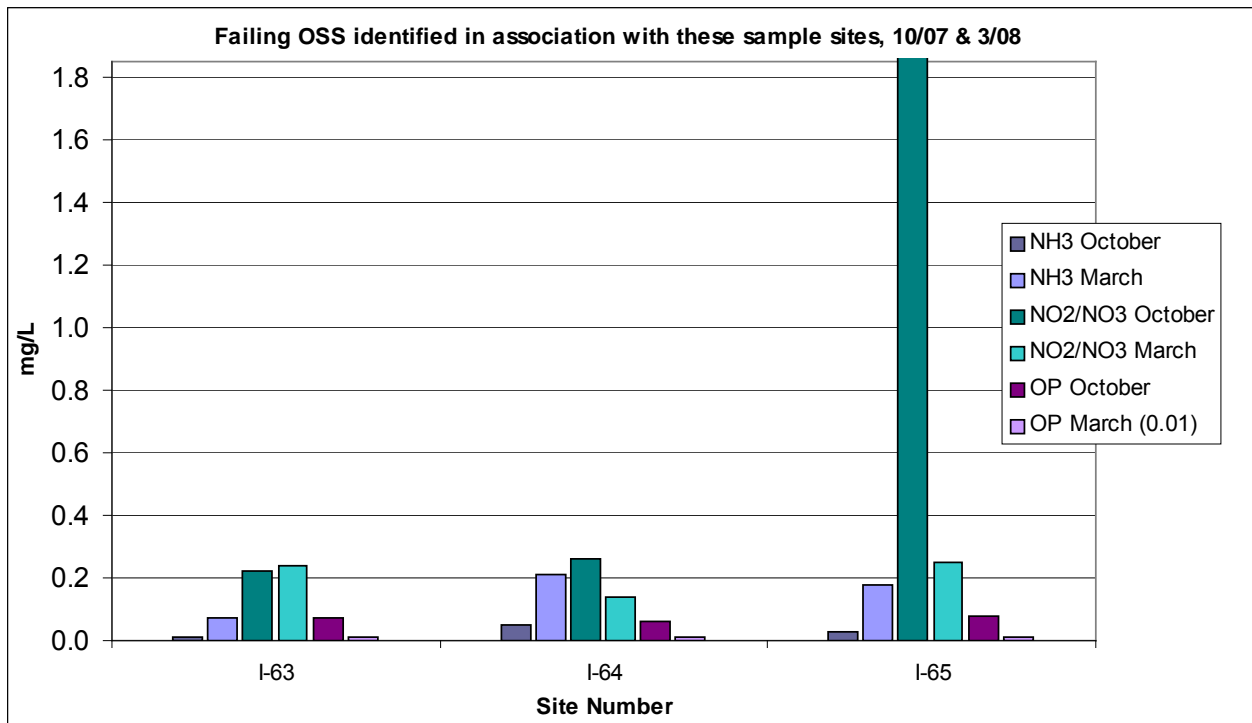
Figure 27. Nutrient Results from Monitoring Locations I-63, I-64 and I-65

MCPH has sampled at this property three (3) times, October and November 2007 and March 2008. Figure 27 only includes the results from the October and March monitoring events. The results of the monitoring that occurred in November 2007 were similar to the October monitoring event. The November monitoring event was the confirmation sample taken prior to the sanitary survey. Between the October/November and March monitoring events, there were reductions in NO₂/NO₃ (except at I-63), OP and fecal coliform results. While at the same time, there were slight increases in NH₃. These changes may be due to an elevated water table or anoxic conditions in the soil coupled with decreased use by the owner.

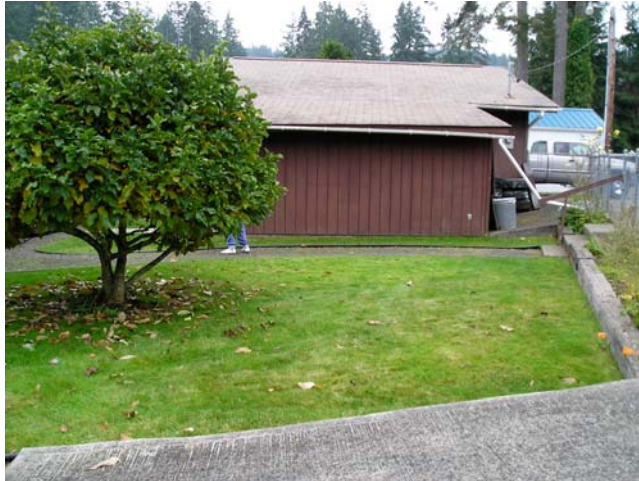
*Area of the Drainfield – The Camille Tree Roots were in the Drainfield Laterals
The tree was removed when the new OSS was installed.*

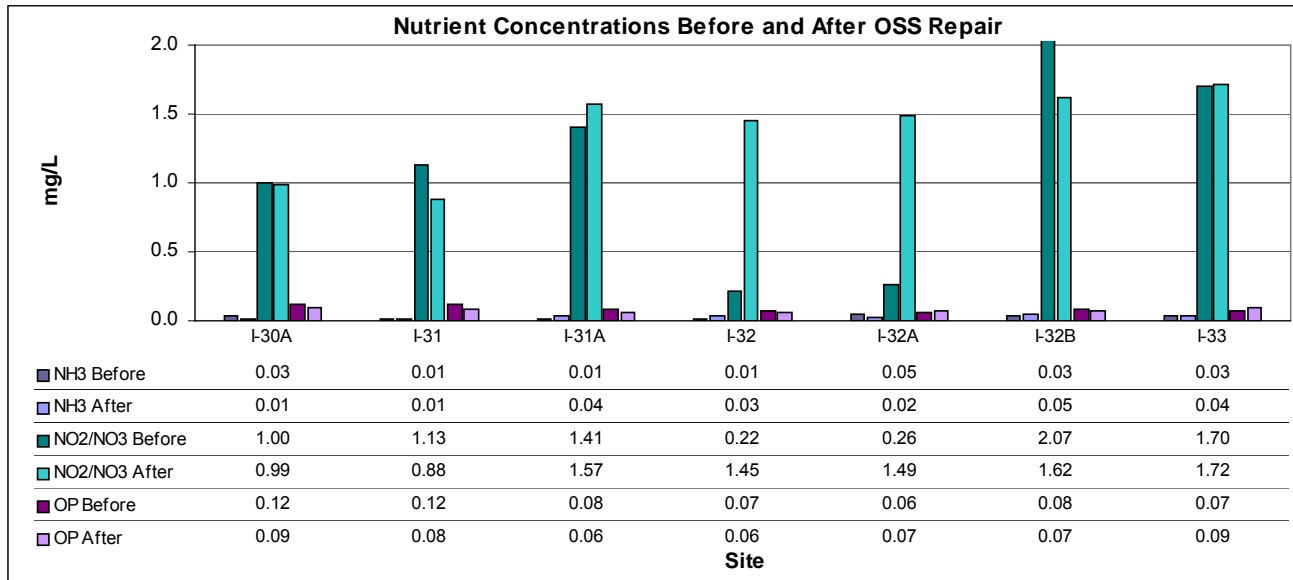
Figure 29. Nutrient Results from Monitoring Locations I-30A to I-33

Monitoring occurred on four different dates at the three (3) original sampling sites. The first monitoring event was in September 2007, followed by a confirmation sample December 2007. Post-repair monitoring was performed in February and July 2008. MCPH performed a sanitary survey at the site in December 2007. At that time, the owner informed us that the septic tank had been pumped in November 2007. This may help explain the reduction in fecal coliform results between the September 2007 and December 2007 monitoring events.

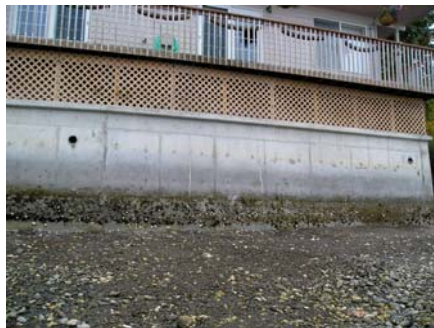
Monitoring Locations I-30A to I-33 are at the Bottom of the Bulkhead

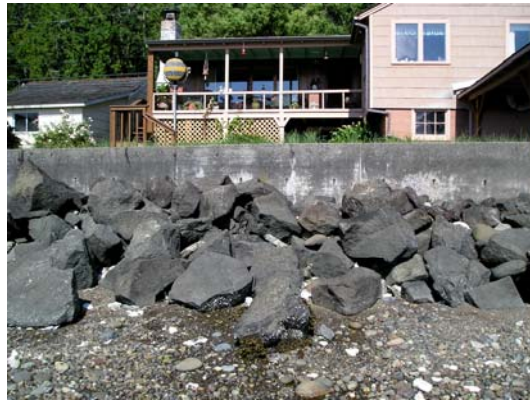
This property had an old gravity OSS that was located in fill on the waterfront side of the house. The install date of this OSS was unknown. The property is surrounded by water on three sides (two small creeks and Hood Canal) and is backed by US Highway 101, leaving little room to install an OSS that meets current OSS treatment standards. The drainfield was located less than 20' from the bulkhead. MCPH did not find any questionable sample results from either of the streams. The sample location of concern was at about the mid-point of the property out on the beach.

Property Associated with Site H-101 – Drainfield Located between the House and the Bulkhead
