**North Shore Hood Canal
Pollution Identification and Correction Project
Final Report
December 2011**

Prepared for the Washington State Department of Ecology

Centennial Clean Water Fund Grant Number: **G10000122**

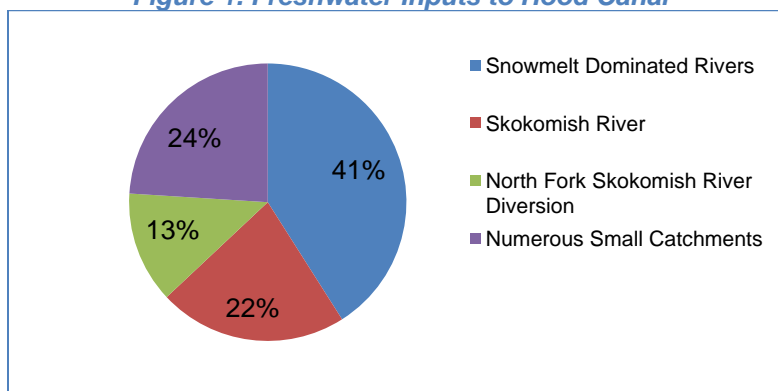
Figure 1. Freshwater Inputs to Hood Canal

Western Washington rains contribute large volumes of water that flow into Hood Canal and most deep infiltration is prevented by an underlayment of till and basalt compounded by a sloped and developed shoreline. This large volume of freshwater carries untreated pollutants and contributes to the highly stratified temperature and salinity of Hood Canal. In addition, there is a shallow sill located at the entrance of Hood Canal. The sill tends to retain the water, reducing the water exchange in Hood Canal and estimates of complete water exchange rates are in the magnitude of years (Hannafious, 2005). The slow exchange rate plus the temperature and salinity gradients limit mixing, causing oxygen to diminish with depth.

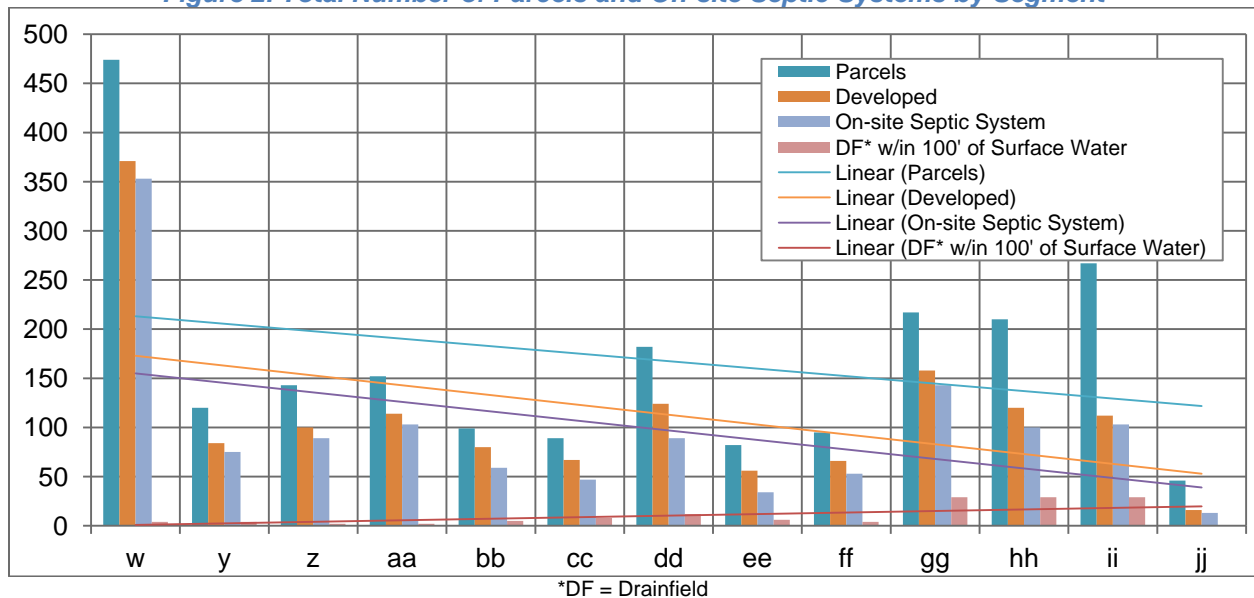
Figure 2. Total Number of Parcels and On-site Septic Systems by Segment

There is an average density within the study area of 1 OSS per 0.42 acre. As-built (final installation) records exist for 509 sites (39%), while 151 sites (12%) do not have as-built records.² There are ~134 sites (10%) where the drainfield (df) is known to be within 100' of the shoreline, while 523 (40%) sites have a known drainfield location that is greater than 100' from the surface water or the OSS has a variance to have the df within 100' of surface water³ (see **Figure 2. Total Number of Parcels and On-site Septic Systems by Segment**).⁴

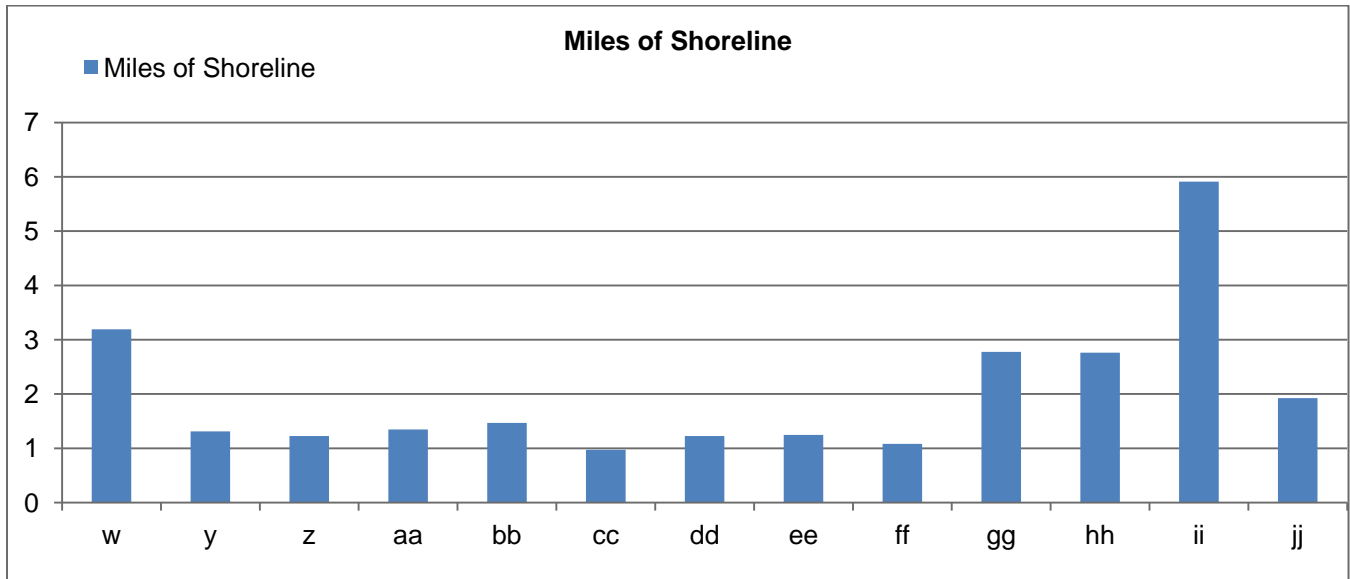
Figure 5. Approximate Lengths of each Segment

The length of each segment is not directly proportional to the area (see **Figure 5. Approximate Lengths of each Segment** and **Figure 6. Approximate Area of each Segment (Acres)**). This is important to consider when looking at development and septic system densities from within each segment. The average area of a segment that is 1 mile long by 1000' wide is 121 acres; while 640 acres represents a square mile. Segment breaks were originally determined under the original HCPIC project. Due to some errors in the field, the original segments v and x are both represented within segment w. Segment ii includes areas of the original area of jj and jj now represents a portion of segment kk (see **Map 2 Original Segments** compared to **Map 1 Northshore HCPIC Final Project Boundaries**).

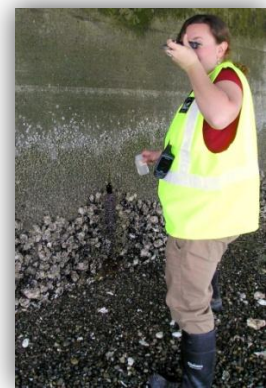
Photo 22 Staff uses a Refractometer to Determine Salinity

Salinity measurements were taken in the field using a refractometer and the reading was recorded in the field notebooks.

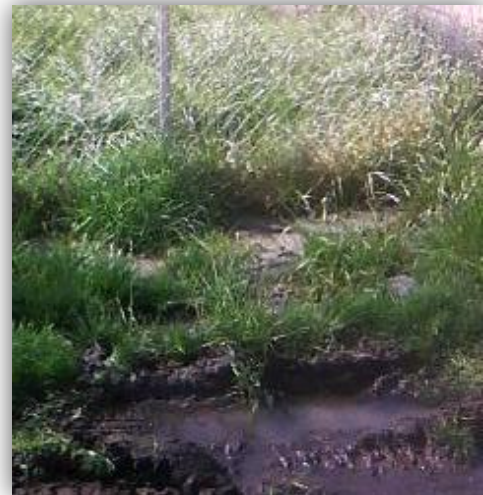
Photo 29 Surfacing Sewage

System components were evaluated from surface observations only. Staff inspected for obvious signs of failure such as surfacing sewage or sewage odors. Staff also inspected for signs of poor system location or physical damage such as evidence that the drainfield was being driven upon, gutter downspouts directed toward system components, or cracked tank lids. Dye tests were performed when indicated, to identify any OSS/surface water connection, incomplete treatment, greywater discharges, etc.

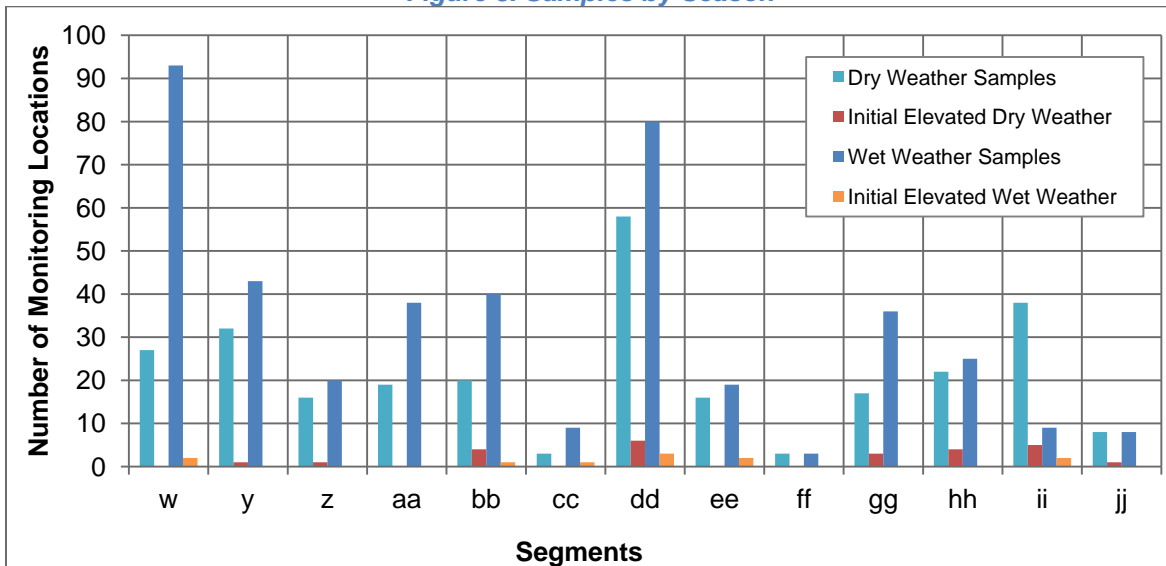
Figure 8. Samples by Season

MCPH compared samples collected during the dry season and wet season and the number of elevated samples from each season. There was a 20% increase in the number of wet weather monitoring locations versus dry weather monitoring locations, while there was a 24% decrease in the total number of elevated samples from wet weather to dry weather. MCPH hypothesizes that this is due to the seasonal nature of many of the residences in this area. If an OSS was failing, it would be unlikely that MCPH would be able to identify it when the residence is not being occupied.

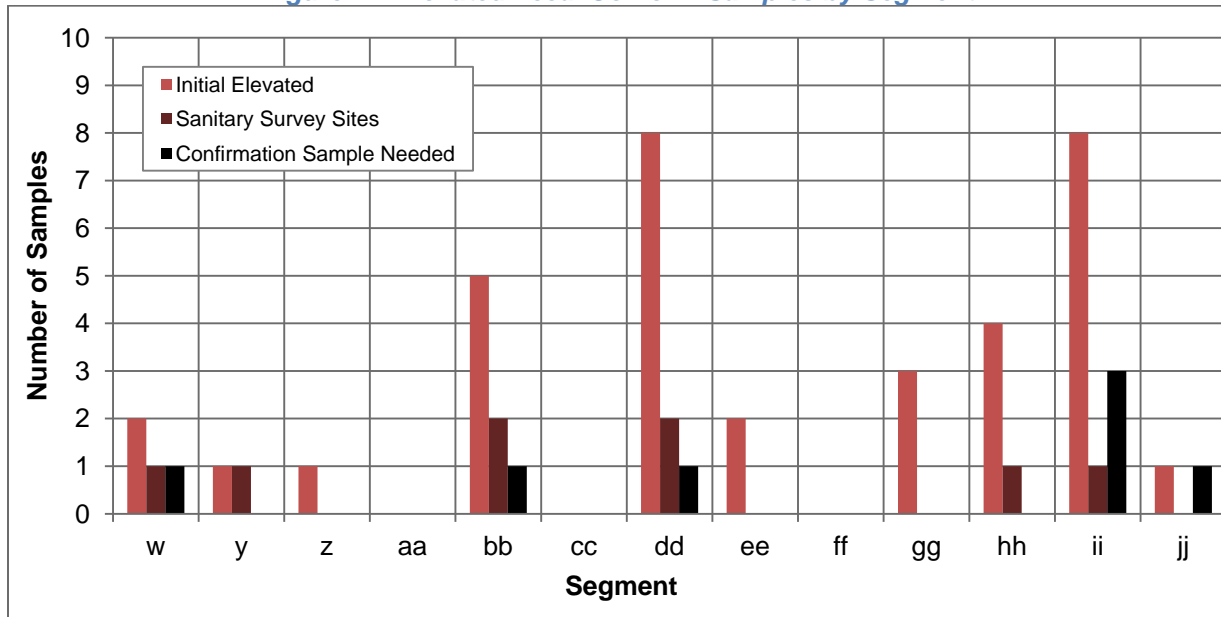
Figure 11. Elevated Fecal Coliform Samples by Segment

Therefore, those segments with more surface water are more likely to produce the necessary evidence of an OSS failure, while MCPH will find it more difficult to identify OSS failures in those segments where there are fewer discharges. This is evident in segment dd, which had the highest density of monitoring locations and the highest number of elevated fecal coliform sites/mile.
