MASON COUNTY HEARING EXAMINER AGENDA

RE: Mason County Development Regulations Variance Request by Kevin Nunamaker (DRV2024-00005).

Wetland Report

Geotechnical Report

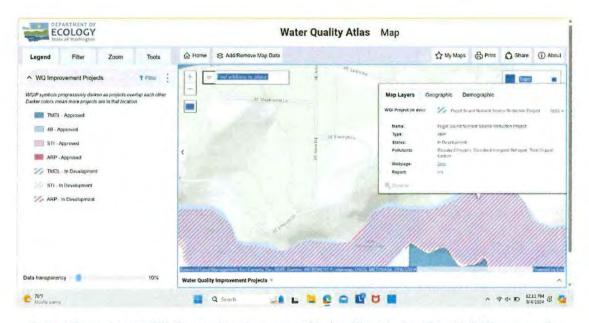
Figure 4: Screen Capture of Washington State Department of Ecology Water Quality Atlas with TMDL water quality improvement projects data visible.

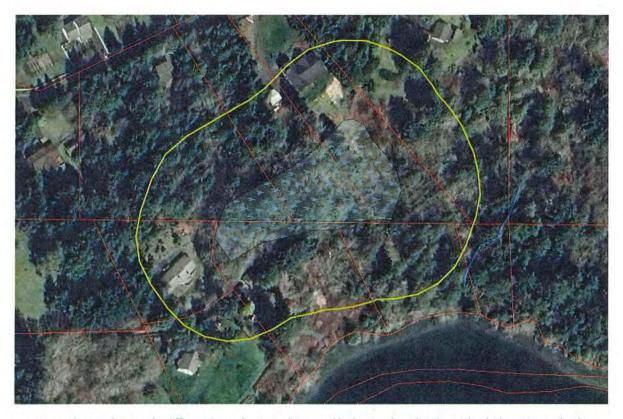
Figure 10: Map showing the different Cowardin cover classes and hydroperiods within the wetland. The entire wetland is permanently inundated with water seeping from a groundwater source. The yellow line is 150ft from the wetland edge for reference and scoring of the functions of the wetland.

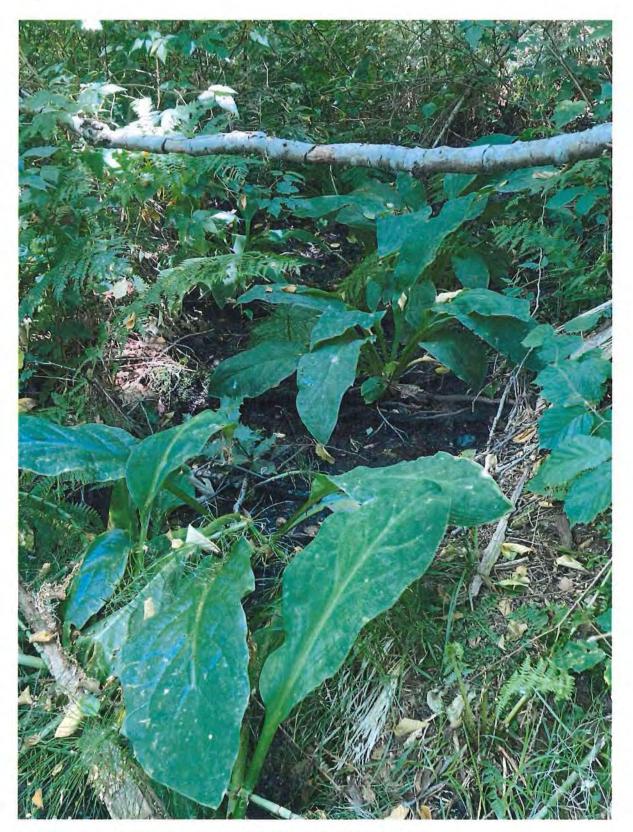
Site Photo 1: Image showing typical vegetation observed in the delineated slope wetland.

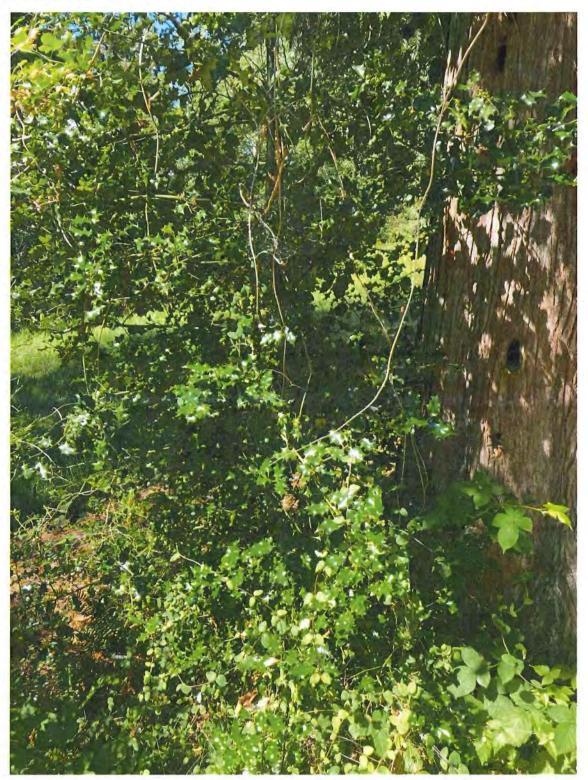
Site Photo 1: Image showing some of the noxious English holly to be removed from the property

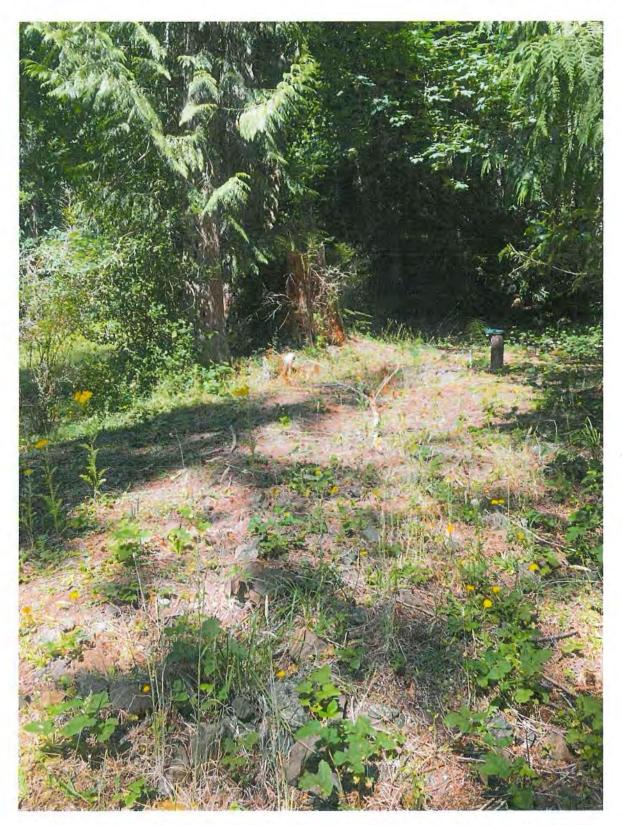
Site Photo 2: Image showing the location of the existing well and proposed building area of the proposed 500ft² accessory building.

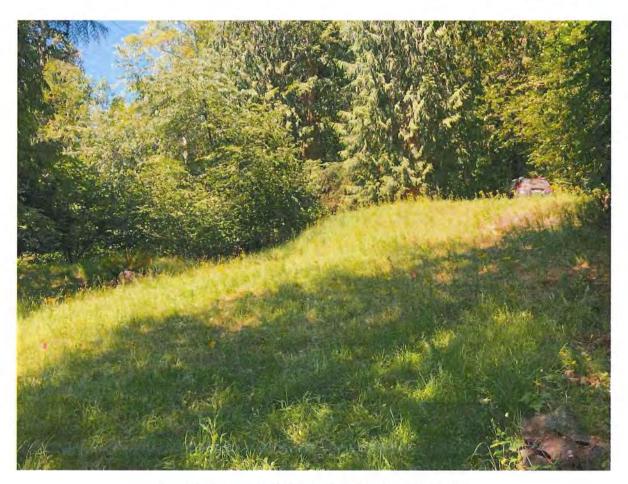
Site Photo 3: Image showing the building area of the proposed SFR.

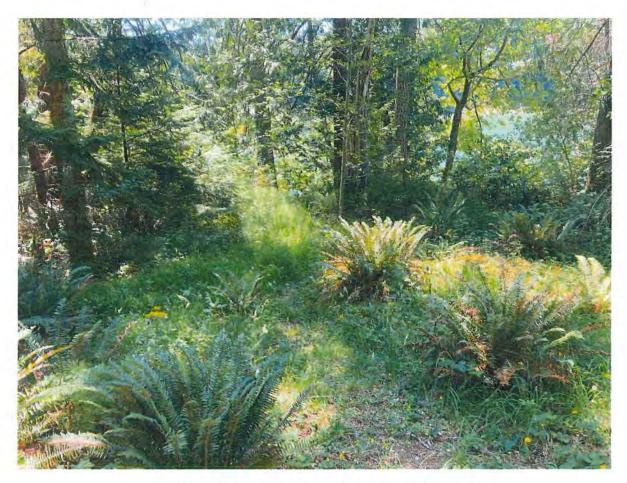
Site Photo 4: Image showing a portion of the proposed mitigation area.

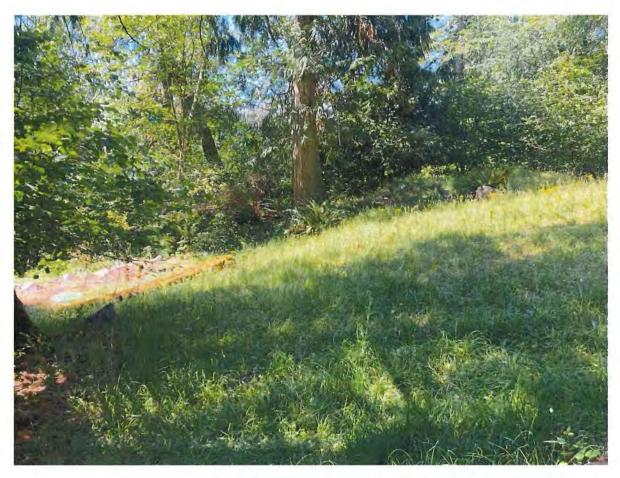
Site Photo 5: Image showing the location of the existing septic system and the location of one of the proposed mitigation areas.

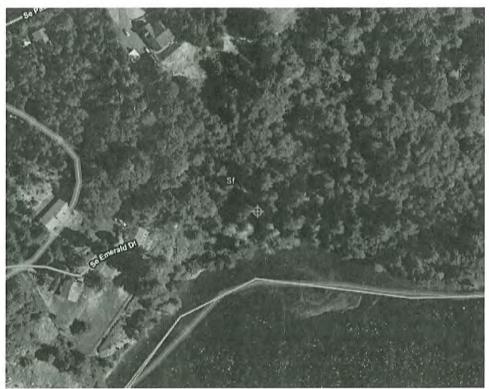
Soil Survey From USDA Natural Resources Conservation Service

According to the "Soil Survey of Mason County," by the United States Department of Agriculture, Soil Conservation Service (SCS), the site soils are described as Shelton gravelly sandy loam with 5% - 15% slopes. See the soil map below.

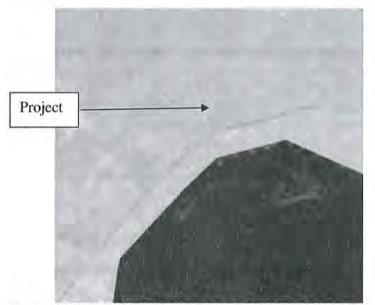
Map from Washington State Department of Ecology Website

According to the Coastal Zone Atlas of Mason County, Washington, the project is within and near terrain labeled 'Stable' and 'Unstable' regarding potential landslide activity. Descriptions of these mapping units may be found in the aforesaid Atlas. A Stability Map from the Coastal Zone Atlas for the general area of this project is provided below:

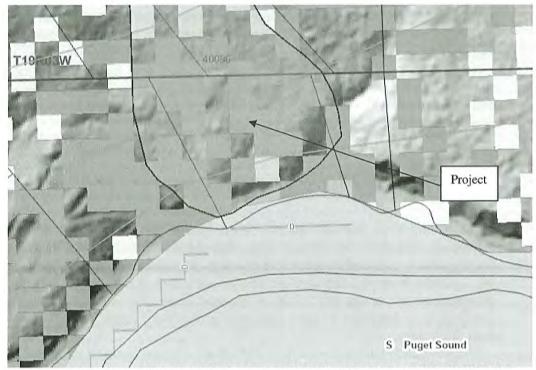
Resource Map from Washington State Department of Natural Resources Website

According to the Resource Map from the Washington State Department of Natural Resources (DNR), the project is not within terrain labeled 'highly unstable' relating to soils. DNR labeled portions of this project as medium and high slope instability with relation to slopes. A Resource Map from the DNR Forest Practices Application Review System is provided below:

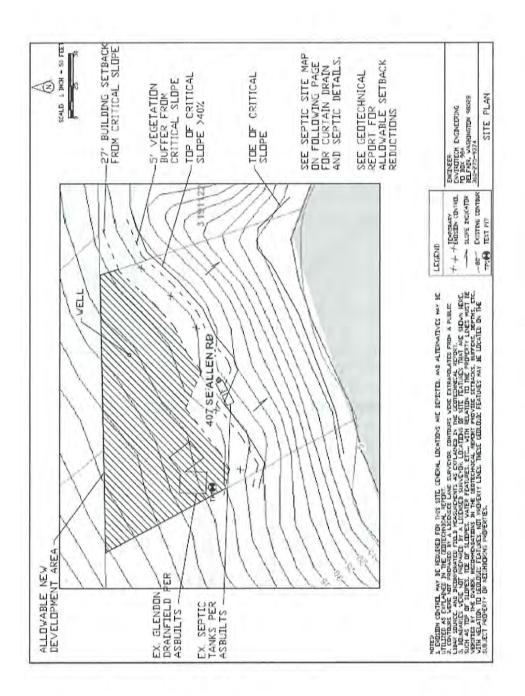
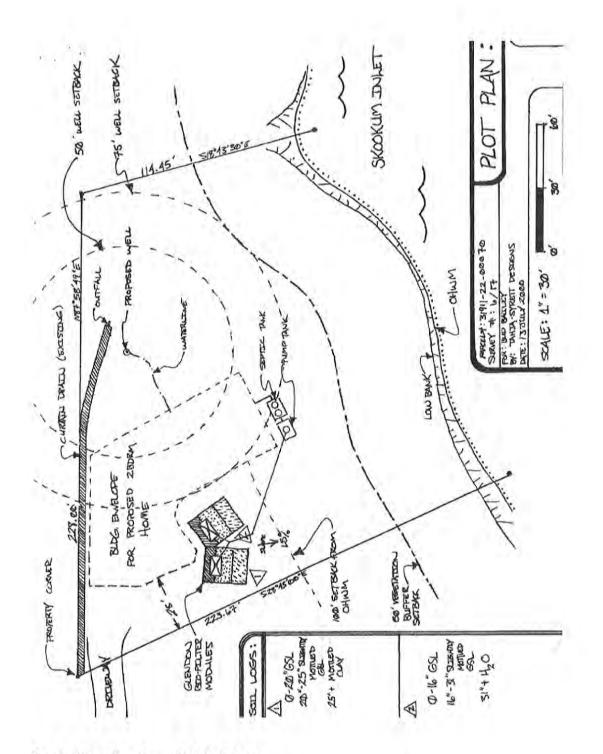
GEOTECHNICAL SITE PLAN

Septic Site Plan from Tahja-Syrett
