WEBB HILL BIOSOLIDS FACILITY HYDROGEOLOGIC INVESTIGATION - PHASE 1

Mason County, Washington

Prepared for: Mason County Department of Community Development, on behalf of WRIA 16 Planning Unit

Project No. 070041-001-01 • September 6, 2007

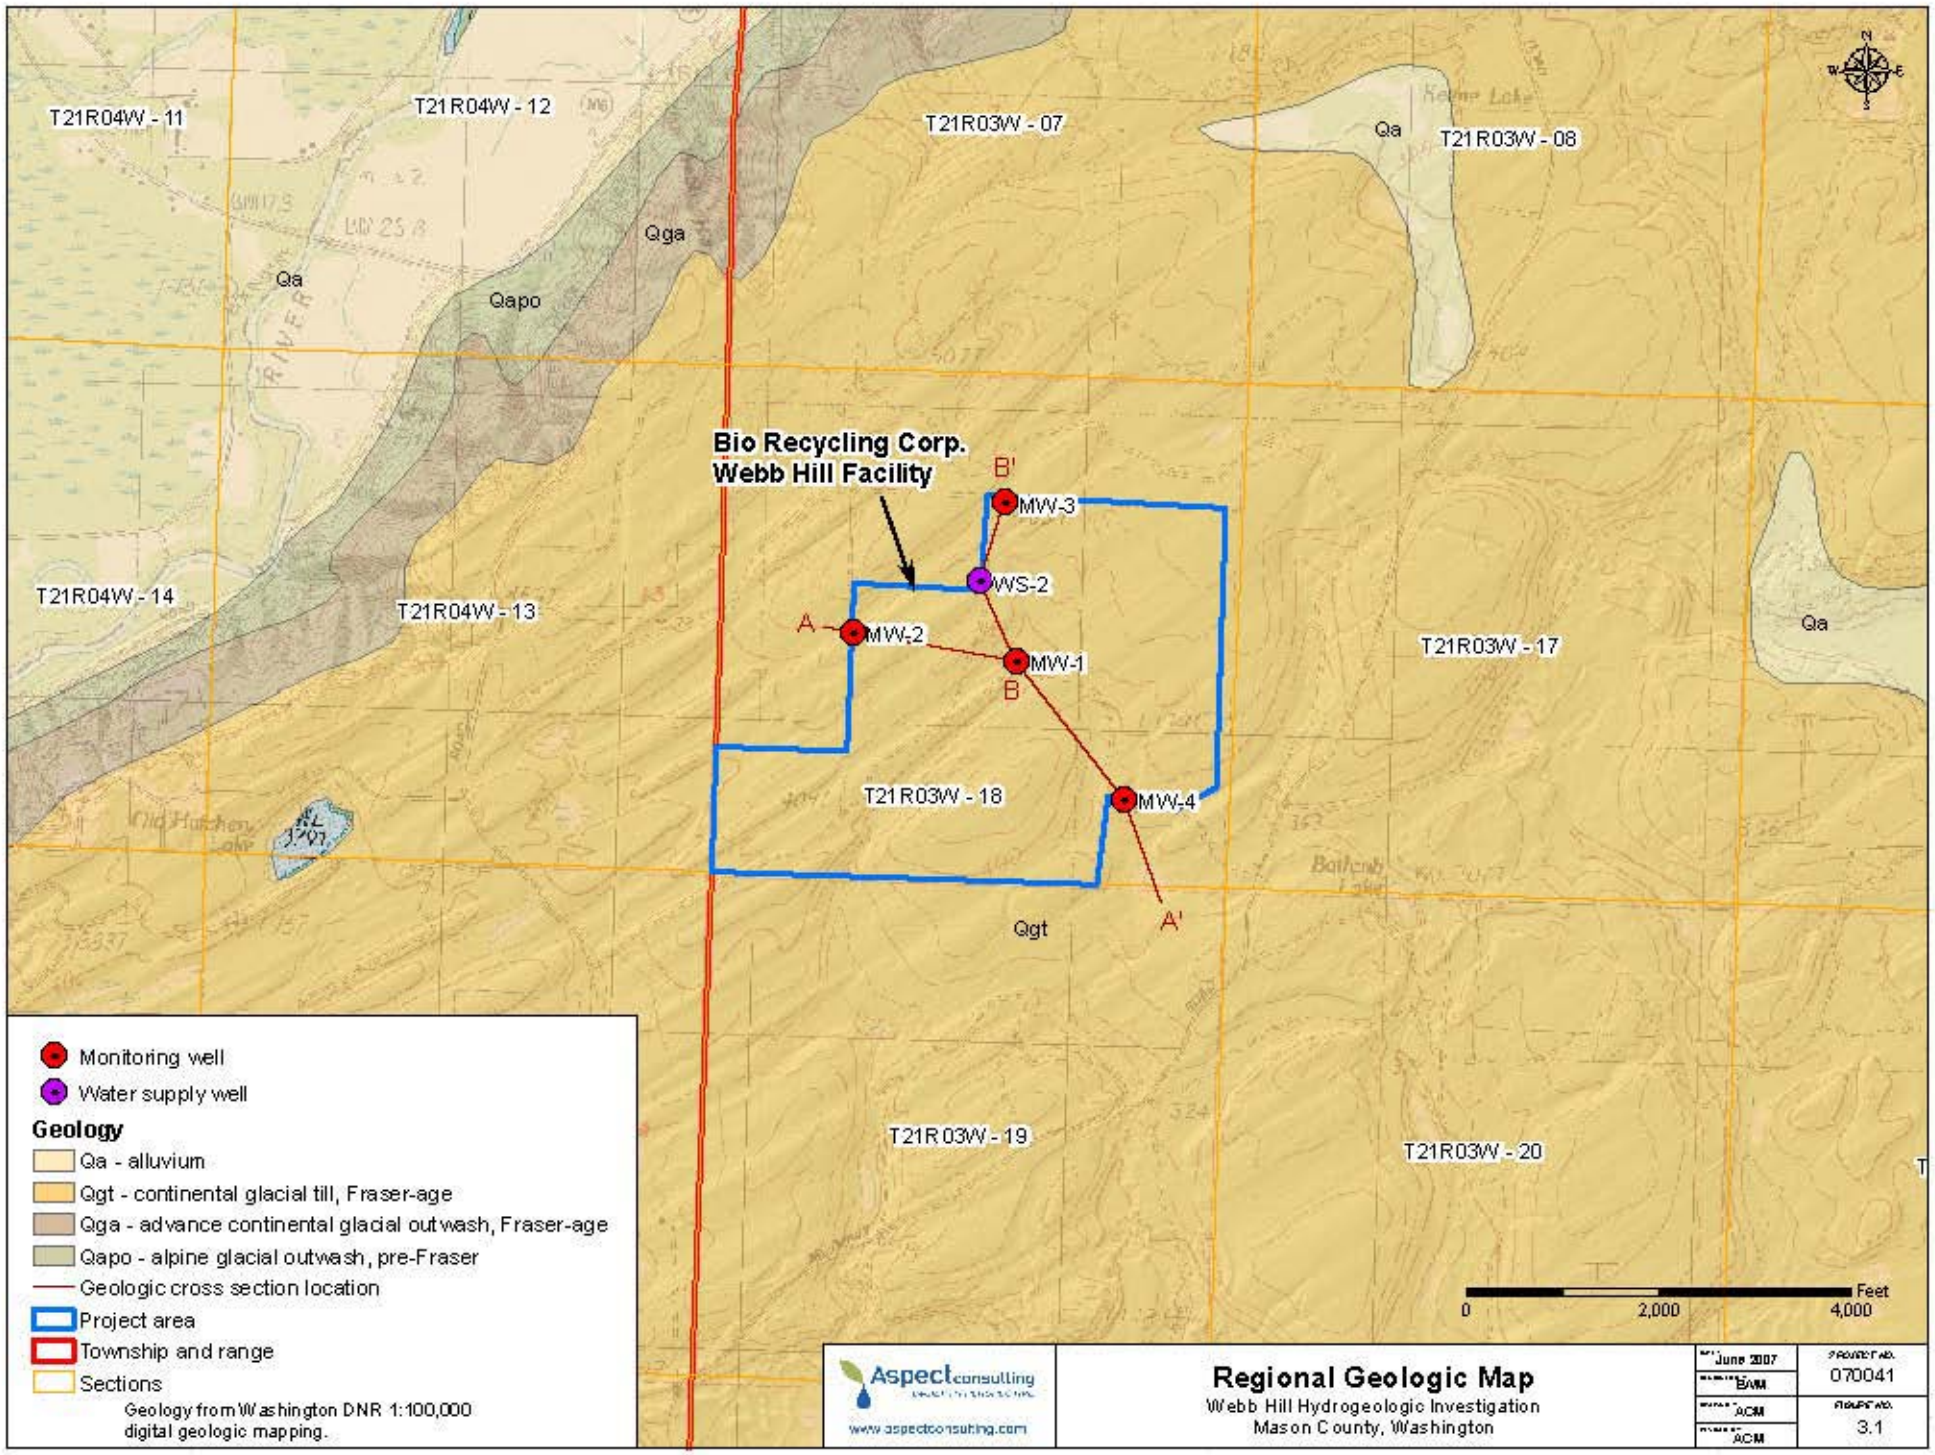
Regional Geologic Map

Geologic conditions were previously investigated during test pit explorations at the site (HWA, 1999) and through mapping being performed by Mike O'Neil as part of Geomap NW (http://geomapnw.ess.washington.edu). The Geomap NW project is ongoing and updated mapping of the project area was not available for this report. Previously mapped geologic conditions from Washington Department of Natural Resources (DNR) are presented on Figure 3.1.

the lower sections and coarsens upward as the glacier advanced south and deposition occurred closer to the glacial front by higher energy streams proximal to the glacier. The Vashon Advance Outwash is a regionally important aquifer. Advance Outwash has been mapped overlying the alpine outwash in exposures along the east side of the Skokomish River valley (Figure 3.1) and may be present near the base of the on-site monitoring wells.

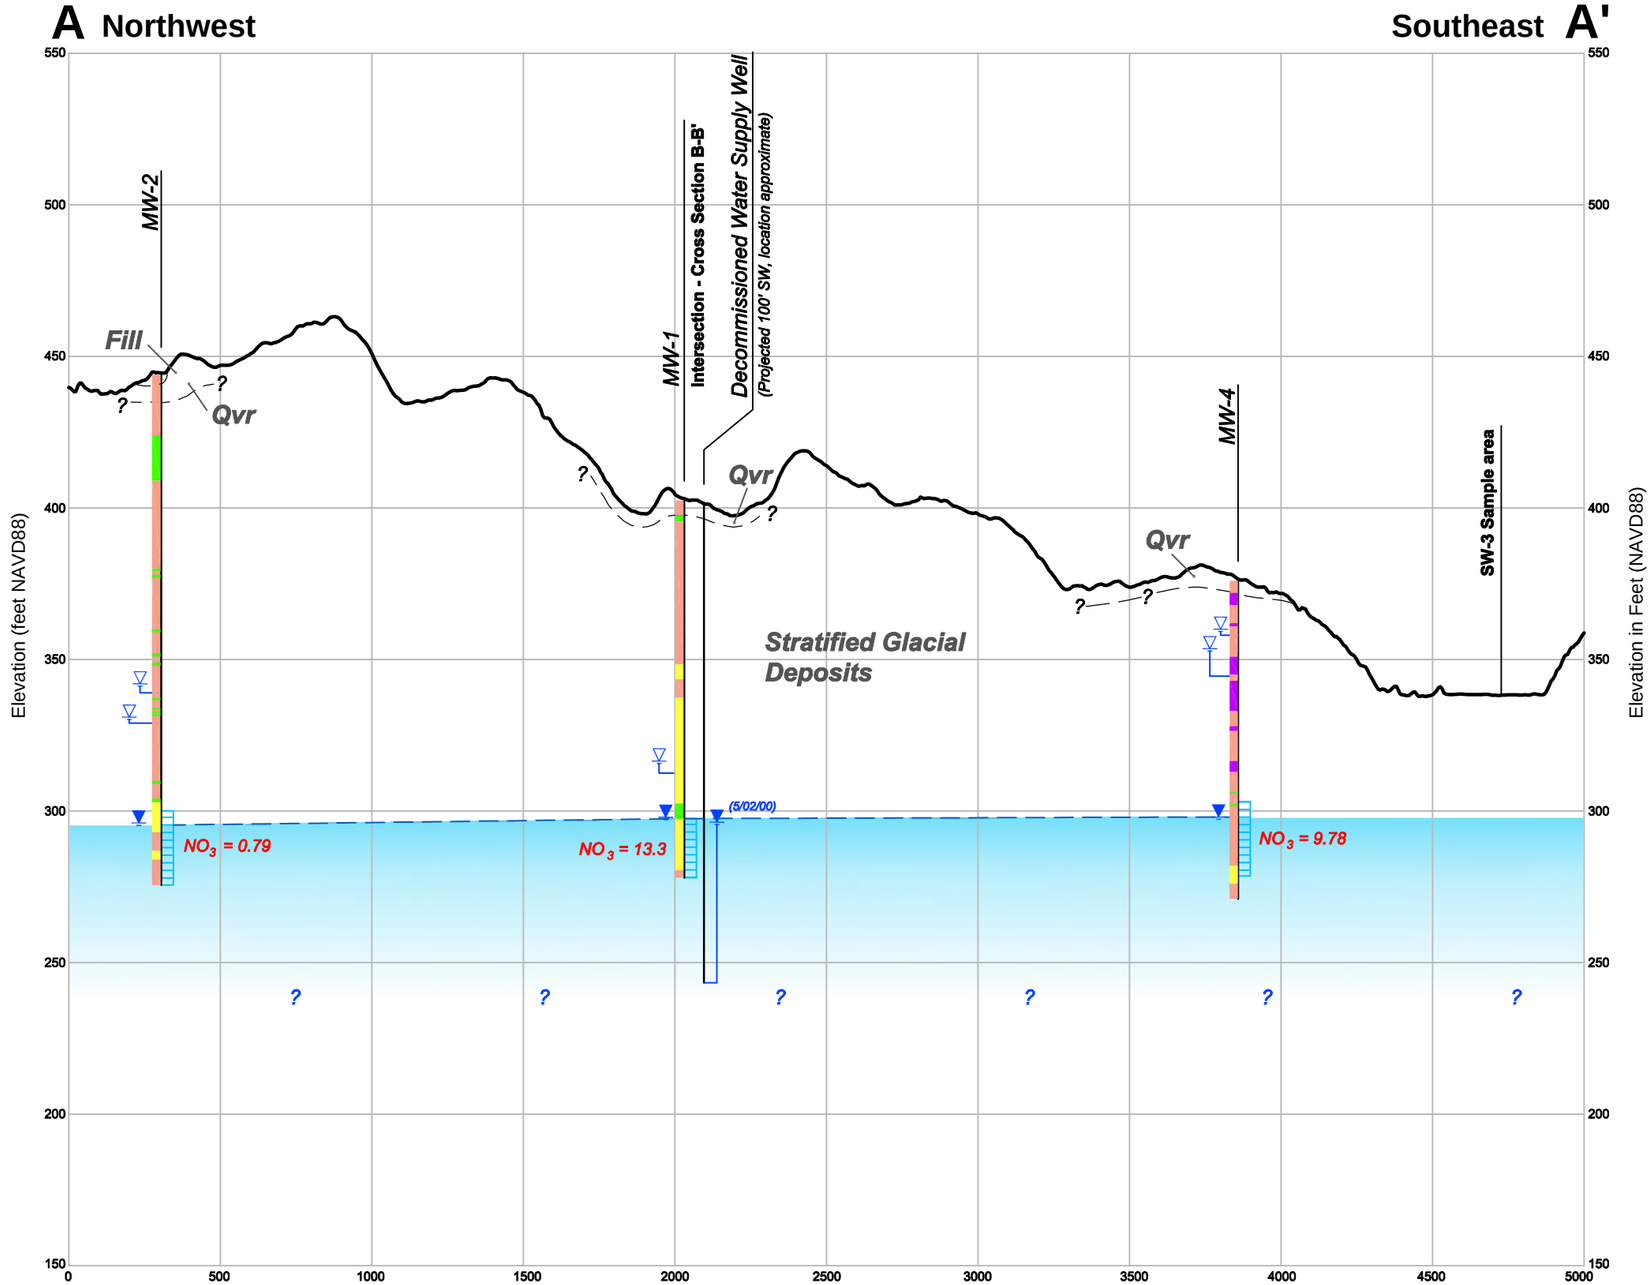
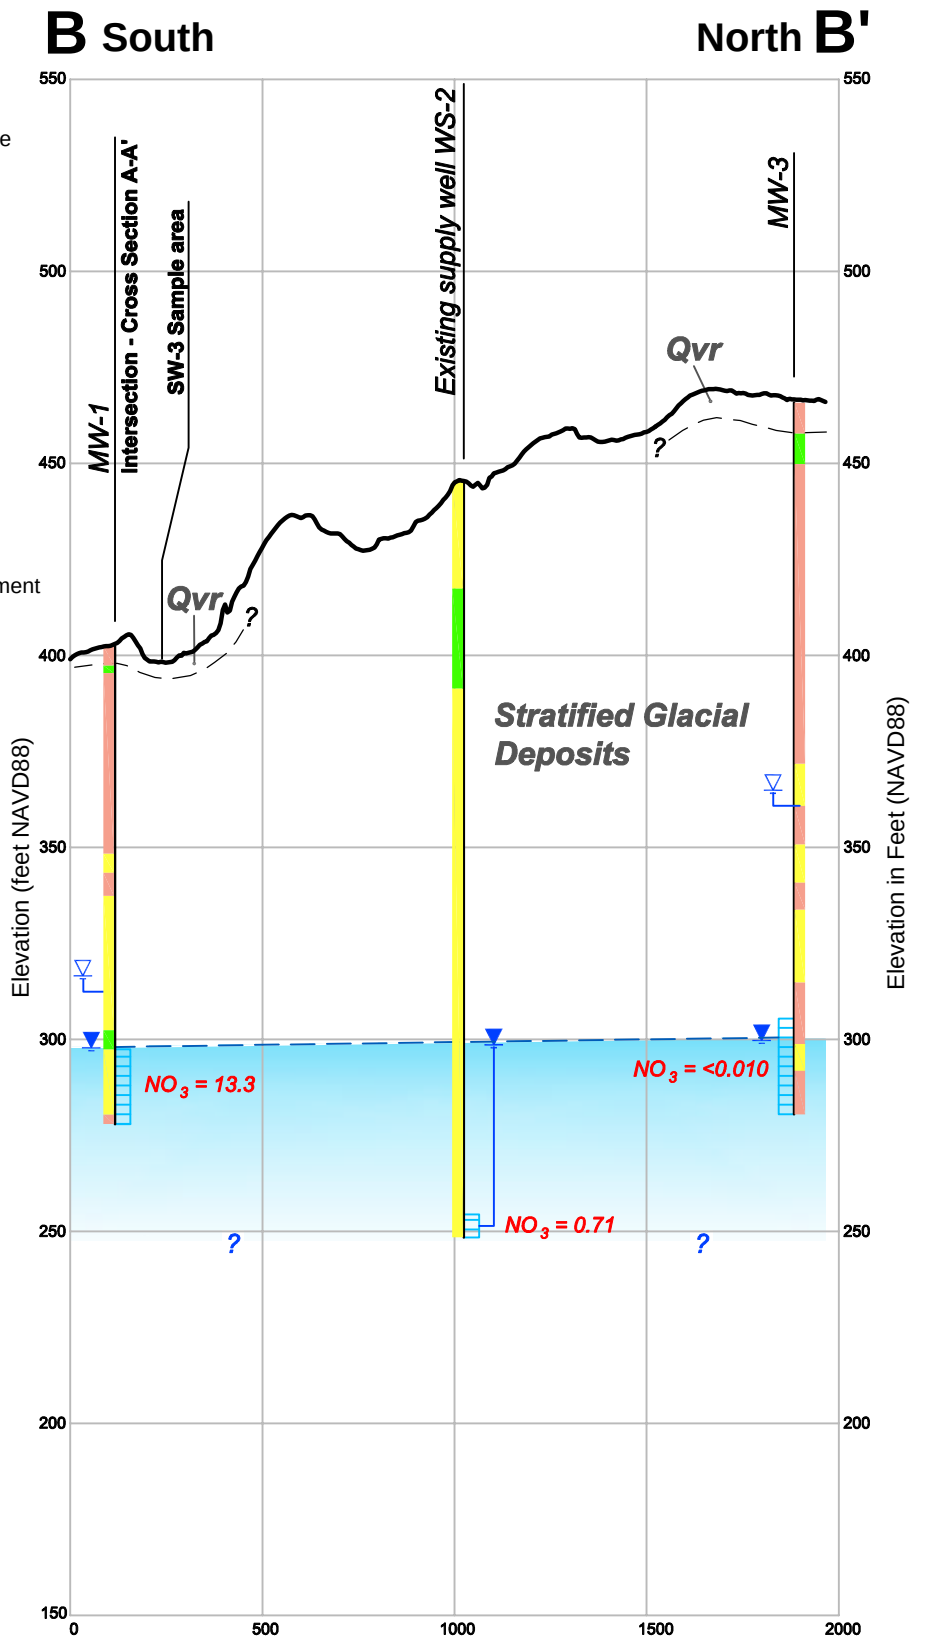
During this investigation, detailed geologic data was obtained during the drilling and logging of four monitoring well boreholes using rotosonic drilling methods and continuous sampling. Detailed geologic logs are presented in Appendix B. Two geologic cross sections were developed through the facility and are presented on Figures 3.2 and 3.3. Cross section location lines are presented on Figure 3.1.

The deposits exhibit a significant degree of heterogeneity, varying both laterally and vertically. Vertical variability was observed by changes in soil classification on a fine scale (0.5-foot) and by the presence of thin till layers at different elevations in the borings. Lateral variability was indicated by qualitative differences between boreholes (e.g., multiple till layers and fine scale variations in MW-2, a single till layer overlying the glaciofluvial deposits in MW-3, and silt layers in MW-4) and by the inability to correlate soil layers between boreholes.

Although the deposits were found to be heterogeneous, some generalities on the distribution of these deposits may be made. In general, the occurrence of cleaner sands and gravels increases with depth. A sequence of clean sand and/or gravel was present beneath elevation 300 feet in each of the boreholes. Thick clean sand and/or gravel sequences up to 30-foot-thick were identified in monitoring wells MW-1 and MW-3. Fewer and thinner clean sand interbeds were identified in monitoring wells MW-2 and MW-4 (Figure 3.2). The increase in well-sorted, fluvial deposits with depth suggests that the deeper portion of the deposits may be part of or grading into a proglacial advance outwash sequence. A thick sequence of coarse sand and gravel logged by the driller of the on-site water supply well WS-2 was identified down to elevation 250 feet (about 30 feet below the monitoring wells) and suggests that the clean sand and gravel identified in the monitoring wells are at the top of a thicker sequence of advance outwash deposits.

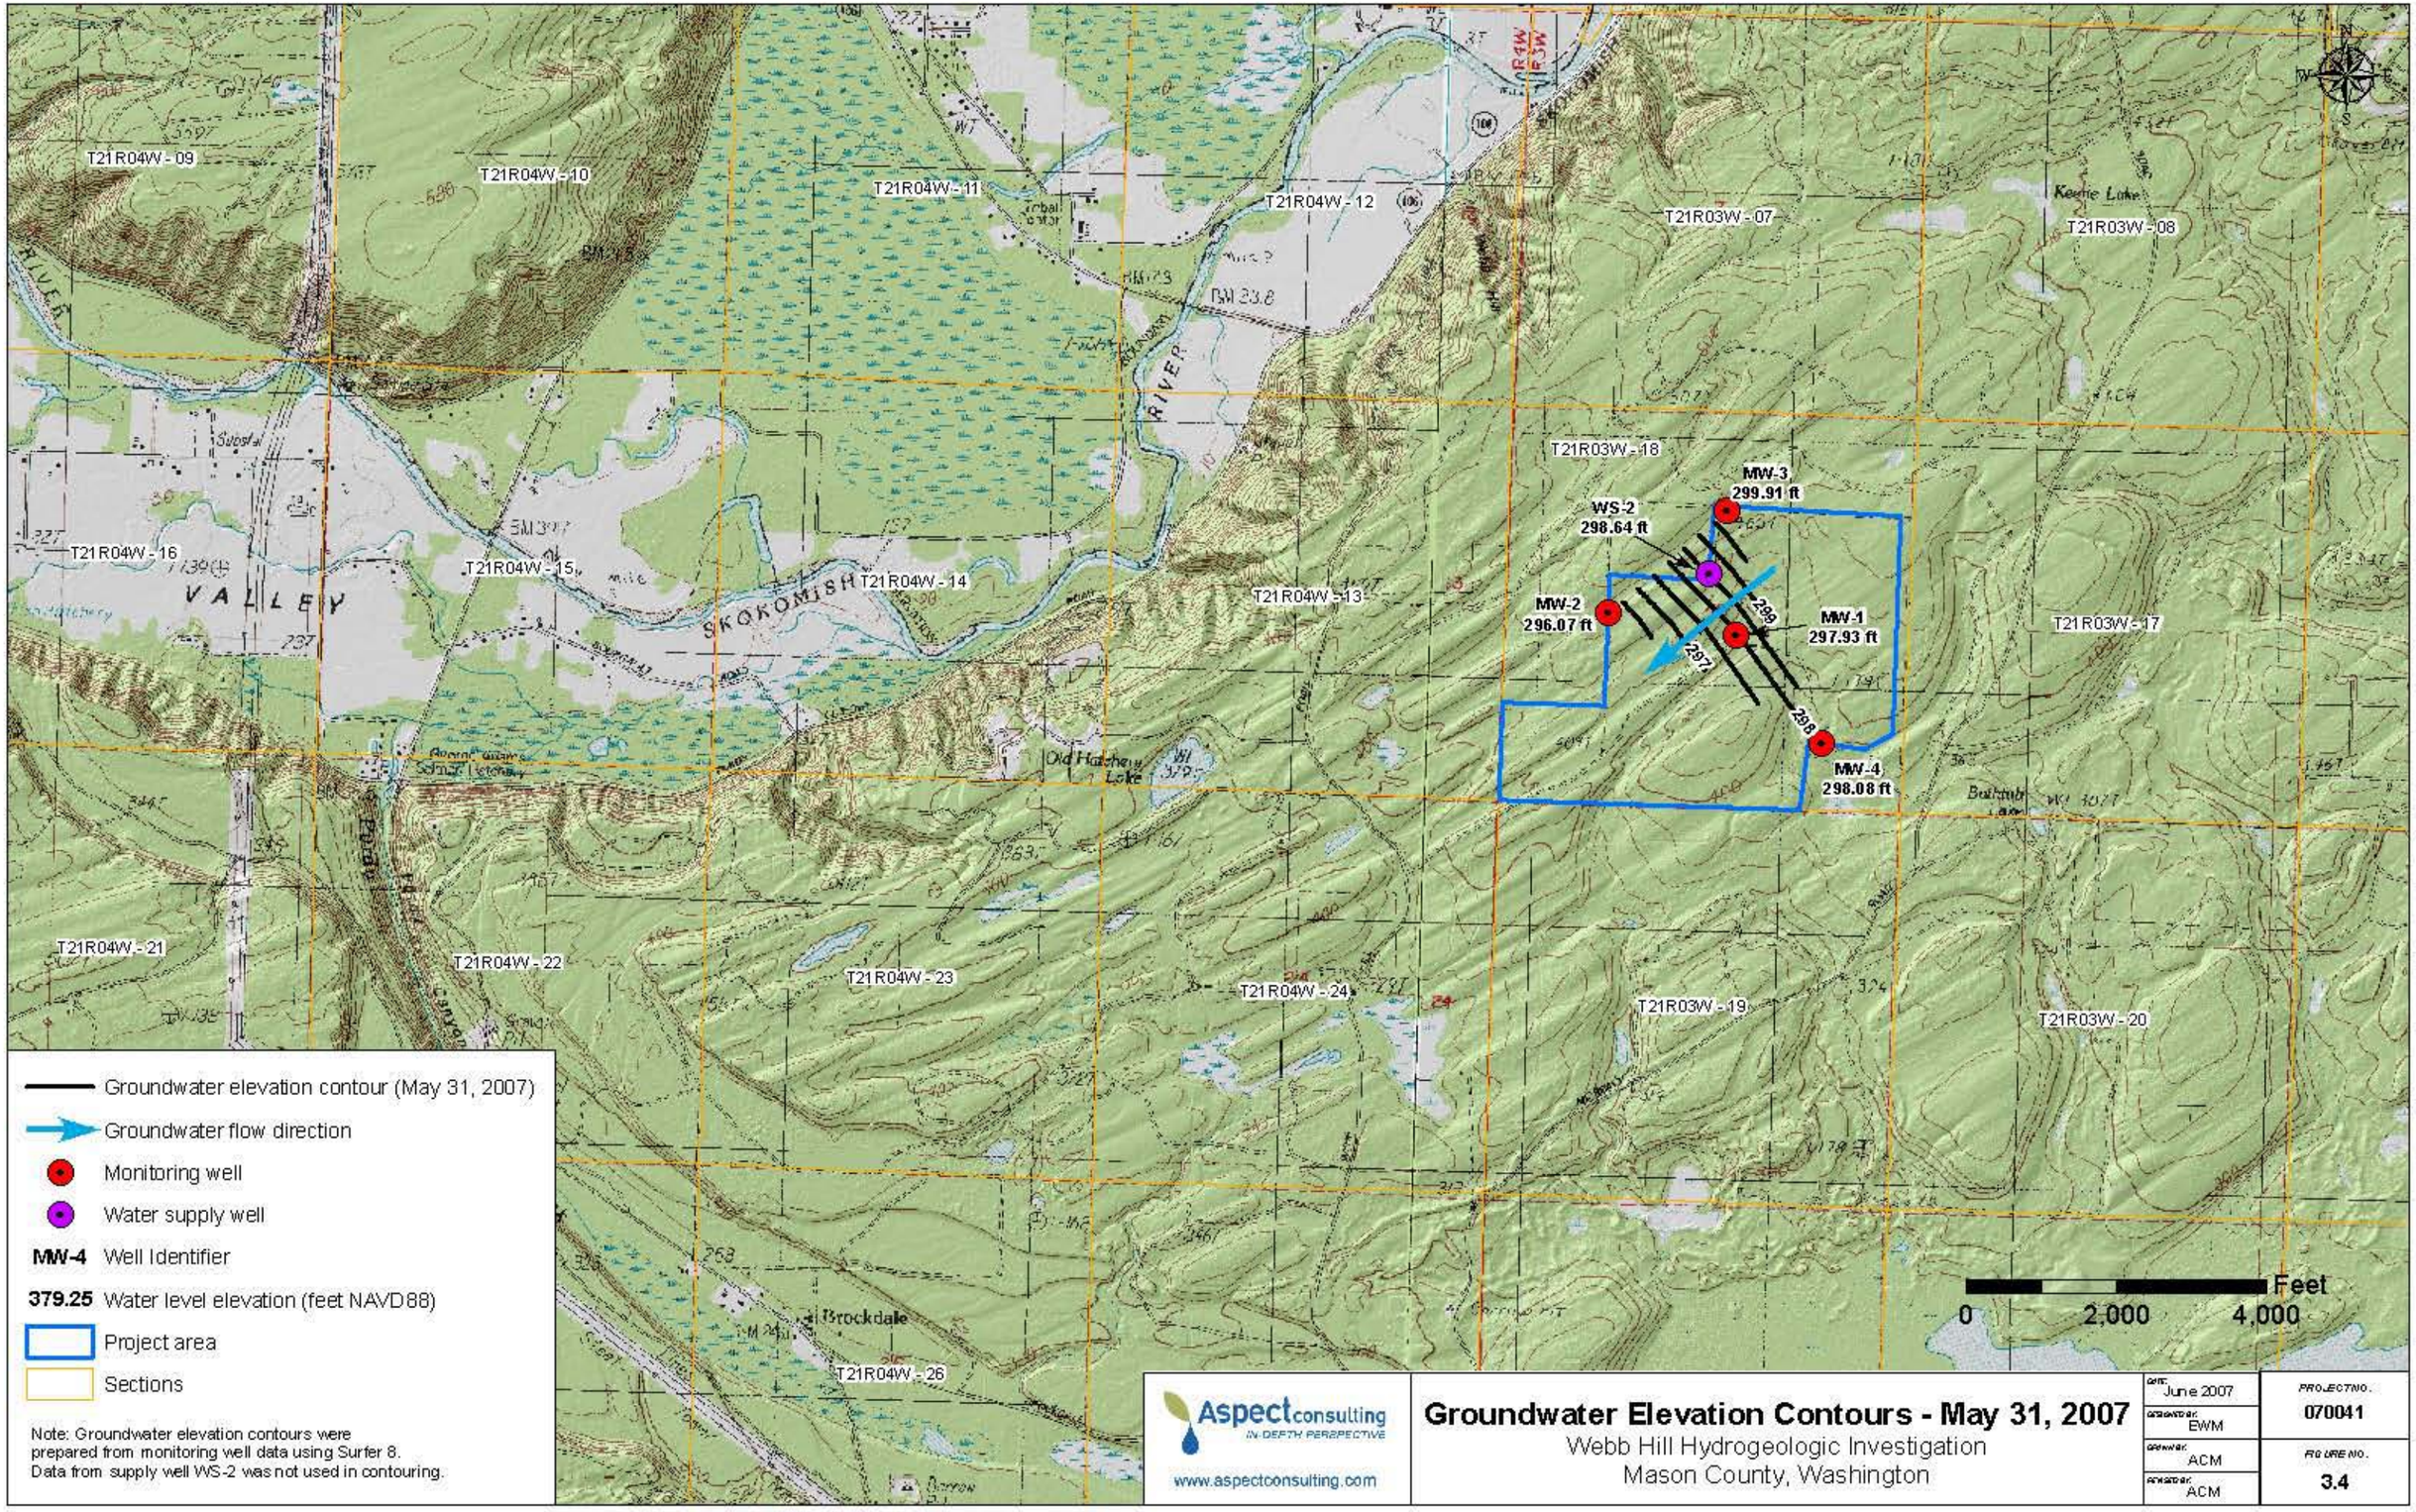
Groundwater Elevation Contours - May 31, 2007

The possibility of groundwater flow toward either Hood Canal or the Skokomish River had been raised by Black (2006). The observed data in May 2007 indicate that a groundwater high exists on the north side of the site and that groundwater flow is southwesterly and away from Hood Canal. However, since the gradient is relatively flat, additional water level measurements are necessary to define the seasonal and longer-term changes in the groundwater gradient. Three discharge directions may be speculated based on the observed May 2007 gradient: (1) Projection of the flow direction southwest suggests discharge into Purdy Creek, (2) Flow could swing southerly and discharge into Cranberry Lake, or (3) Flow could swing westerly and discharge into the Skokomish River. Flow paths may also diverge, resulting in a complex discharge pattern. Off-site water level measurements will be required to define the groundwater discharge area.

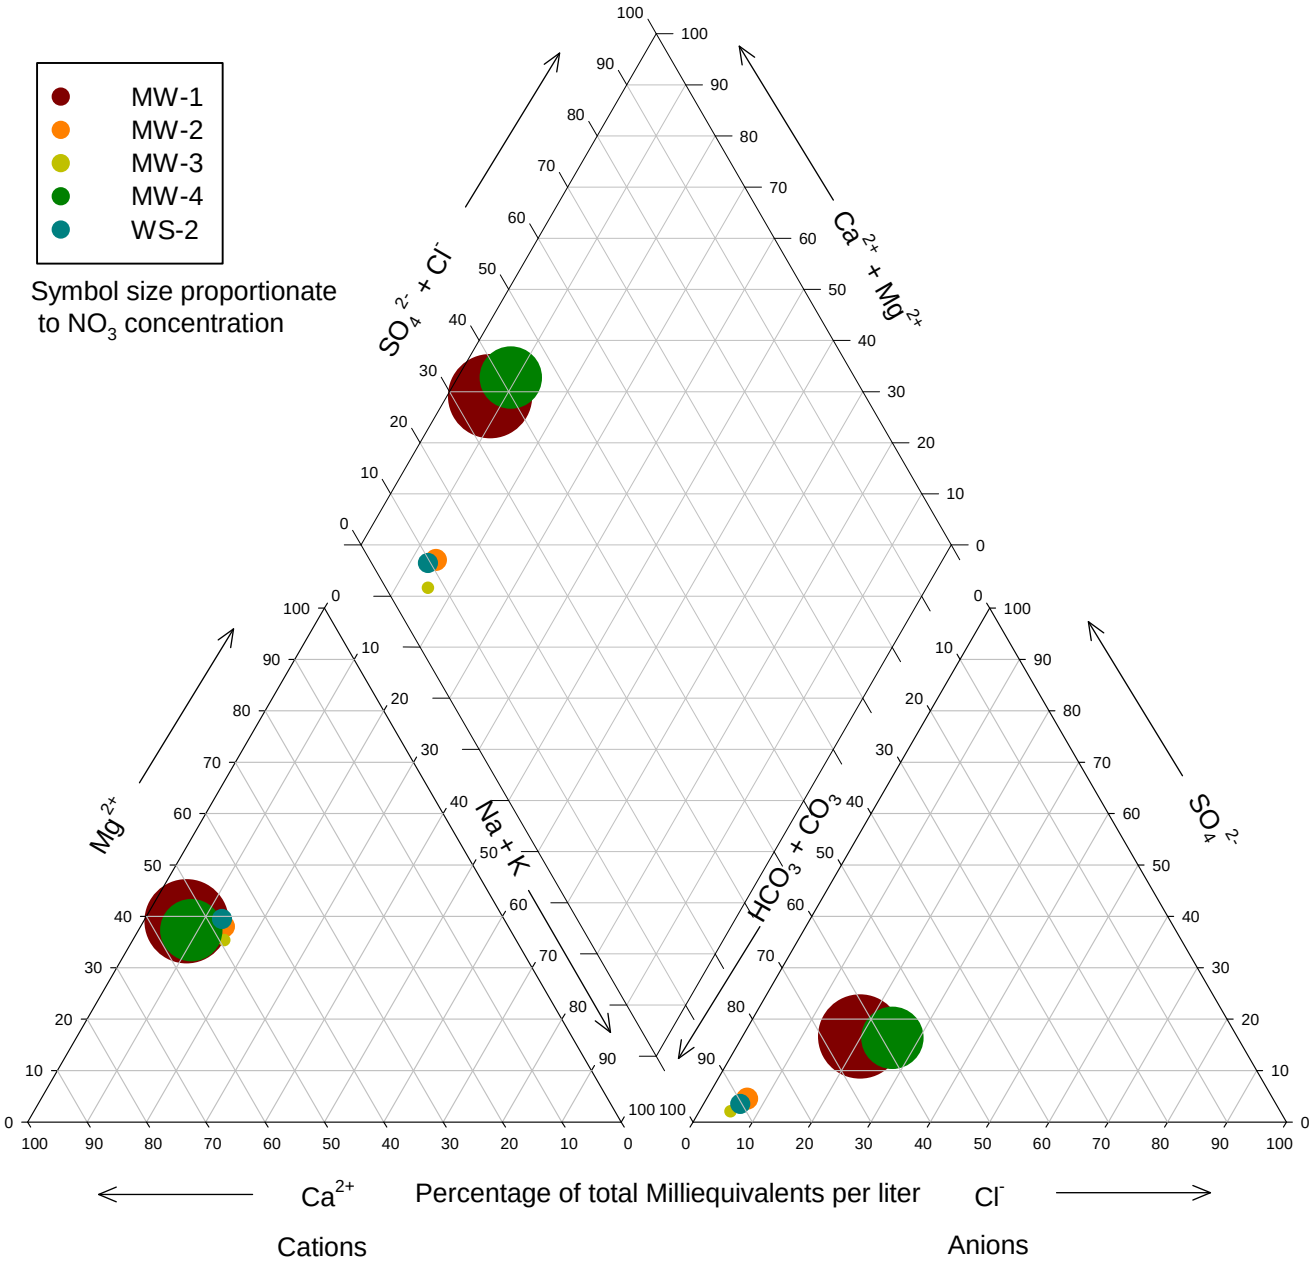
Figure 4.1
Piper Diagram - Webb Hill Monitoring Wells and On-site Supply Well WS-2 (May 30 and 31, 2007)
Webb Hill Hydrogeologic Investigation
Mason County, Washington
P:\Webb Hill\Groundwater Sampling\Piper Plot.JNB

Monitoring well MW-2, located downgradient of field 10, exhibited a low nitrate concentration of 0.78 mg/L. The water type for MW-2 shown on the piper plot in Figure 4.1 (orange dot) lies on a mixing line between impacted water (indicated by MW-1 and MW-4) and background water (MW-3), but is most similar to the background water type indicated by monitoring well MW-3. The position on the mixing line suggests a very slight impact from the biosolids operation; however, additional sampling may prove conditions at well MW-2 to be within background conditions.

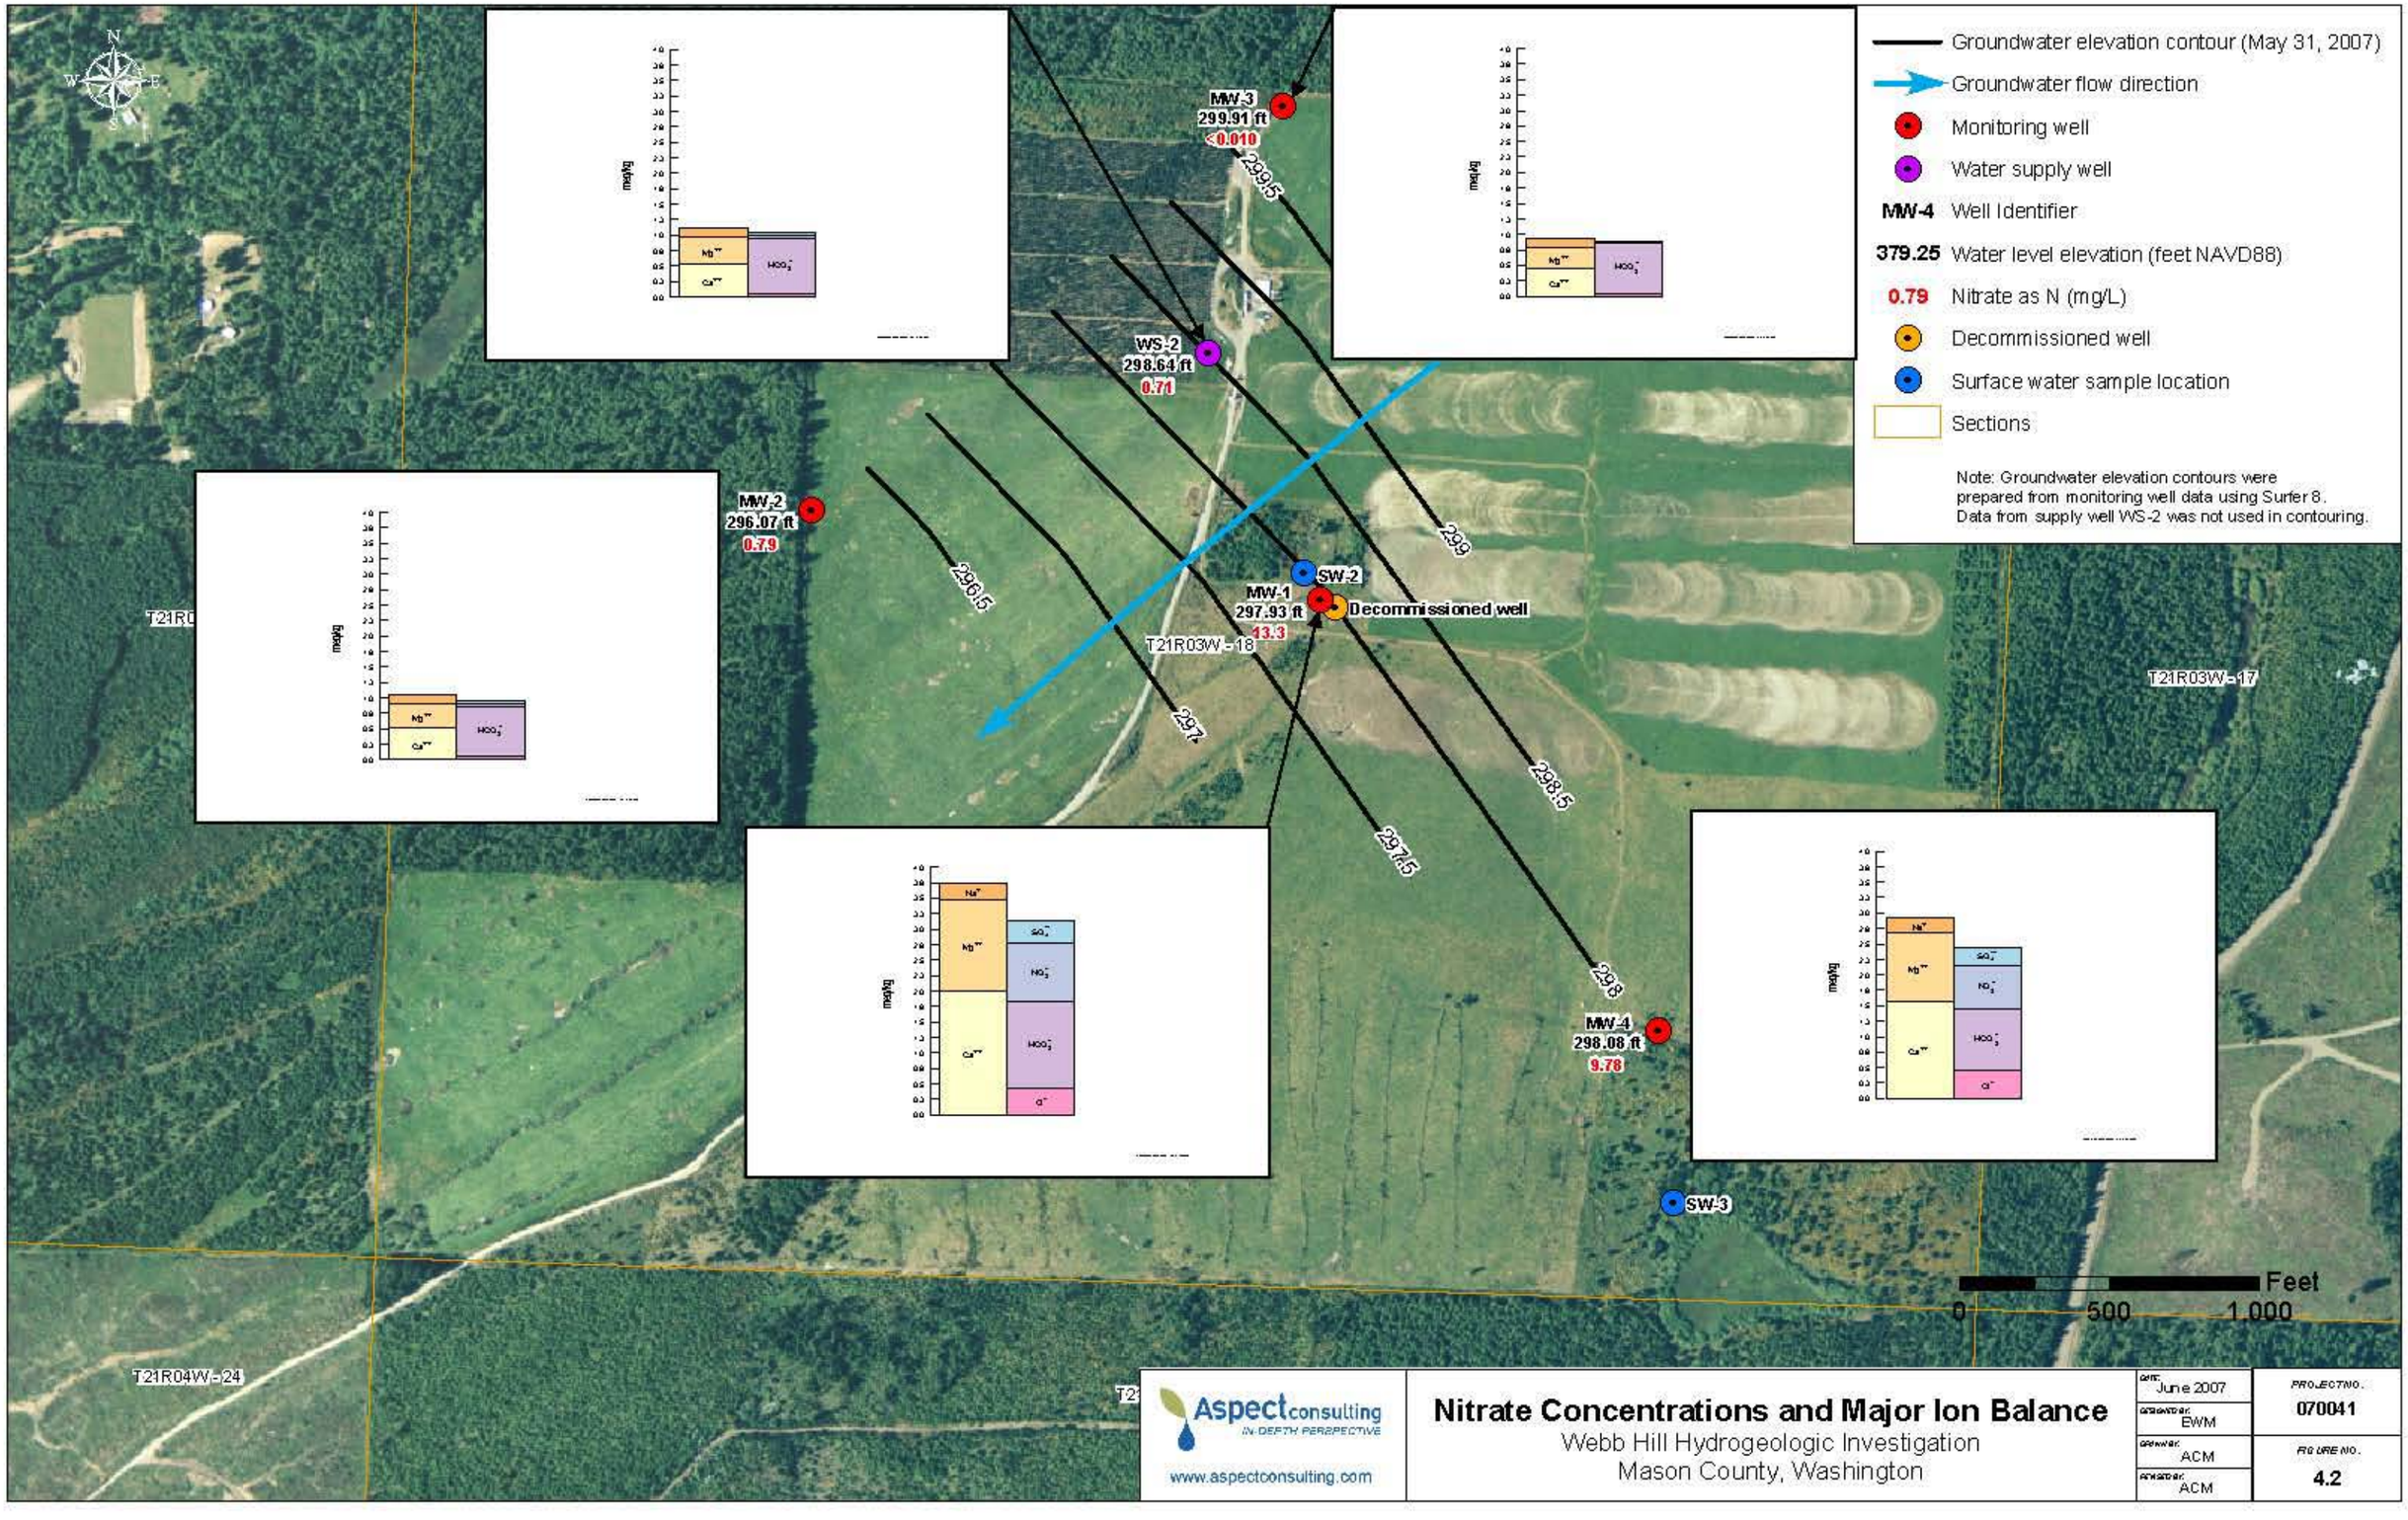
Nitrate Concentrations and Major Ion Balance

Monitoring well MW-3 lies hydraulically upgradient of the application area and is considered representative of background conditions. Nitrate concentrations in this well were less than the detection limit (<0.01 mg/L) (Figure 4.2). The well had low specific conductance (82 umhos/cm) indicating low total dissolved solids. pH was slightly basic (7.3) and a dissolved oxygen of 9.71 mg/L was near saturation. The dissolved oxygen content and pH were the highest measured in the monitoring wells. Oxidation-reduction potential of 92 mV indicates oxidizing conditions are present in the aquifer, consistent with the high dissolved oxygen level. Calcium and magnesium are the dominant cations and bicarbonate is the dominant anion at well MW-3. The cations and anions are in close balance (Figure 4.2).

Monitoring well MW-1 lies down gradient of application fields 1, 2 and 3 (Figures 1.2 and 4.2) and shows degraded water quality in comparison to background well MW-3. This well exhibited the greatest nitrate concentration (13.3 mg/L) of the monitored wells. Relative to background conditions at MW-3, the pH (6.7) and dissolved oxygen (8.85 mg/L) were depressed and specific conductance (374 umohs/cm) elevated.

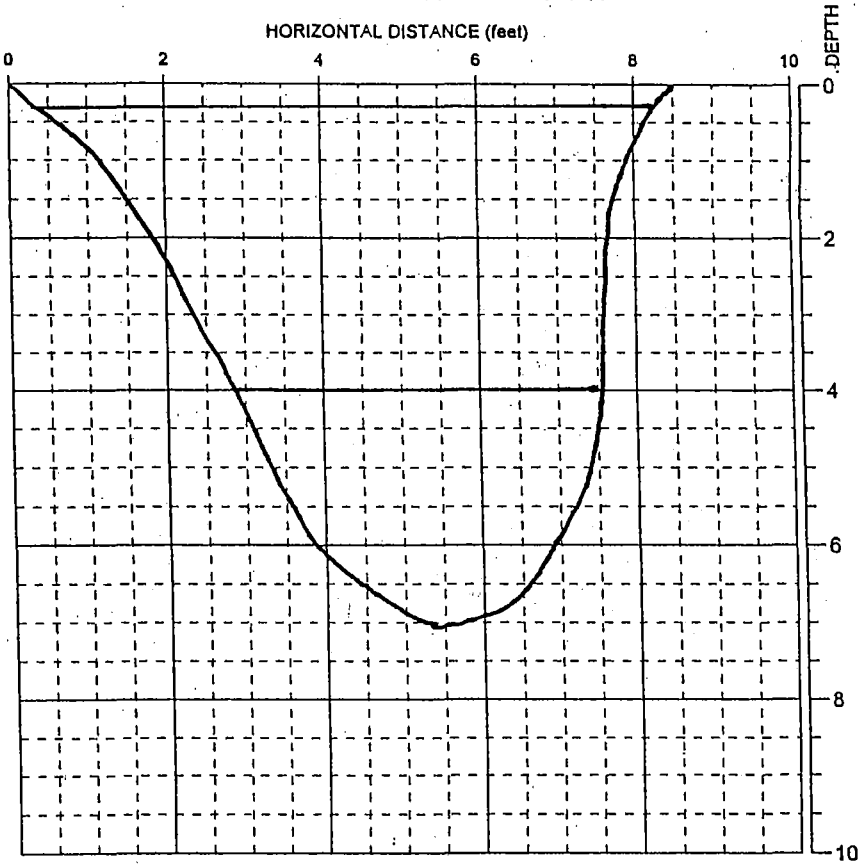
SKETCH OF SOUTH SIDE OF PIT

DEPTH (feet)	SYMBOL	USCS SOIL CLASS.	DESCRIPTION	SAMPLE TYPE	SAMPLE NUMBER	MOISTURE CONTENT (%)	OTHER TESTS	GROUNDWATER
0			Stiff, brown, fine sandy SILT, moist. Rootlets. Trace fine gravel. (TOPSOIL)					
		ML SM	Medium dense to dense, reddish brown, gravelly, sandy SILT, moist. Cobbles. Gravel and cobbles are embedded in finer grain matrix. Possibly boulders. (WEATHERED GLACIAL TILL)					
4		SM	Very dense, gray to brownish gray, gravelly, silty SAND to sandy SILT, moist. Cobbles. Gravel and cobbles are embedded in finer grain matrix. Large cobbles and possibly boulders. (GLACIAL TILL)		S-1	14		
8			Bottom of excavation at 7 feet.					
			No groundwater or caving observed during excavation.					
10
